# Port Engineers Department Port of Cape Town

## AN INVESTIGATION WITH RECOMMENDATIONS OF THE PRESENT CONDITIONS SURROUNDING THE CAISSON EXTENSION TO THE MAIN BREAKWATER AT THE PORT OF CAPE TOWN.

JUNE 1997

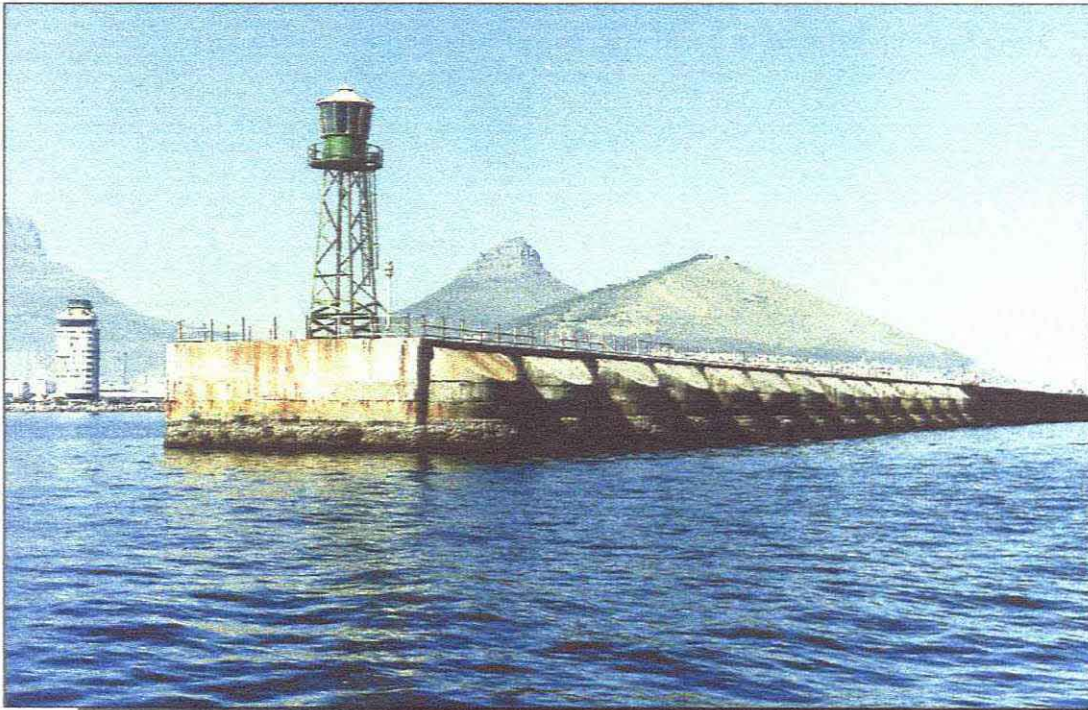
Alkali aggregate reaction is present in the concrete capping. This has caused cracks in the capping with the subsequent deterioration thereof.

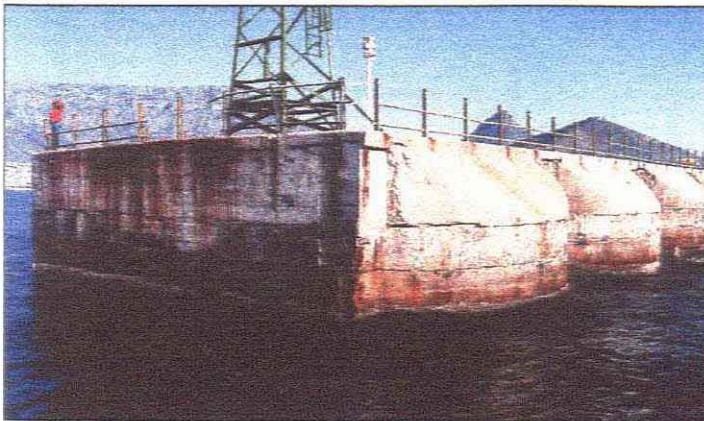
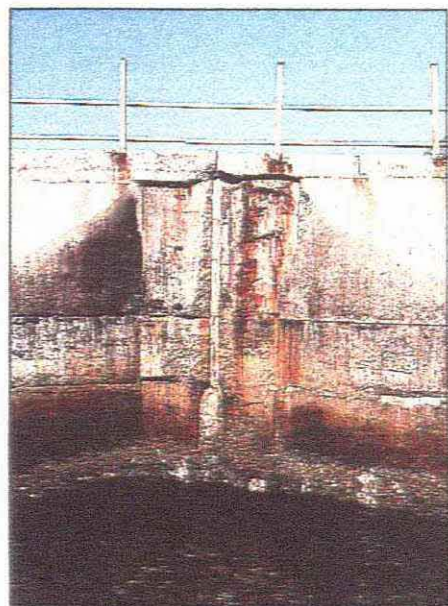
Photograph group - C

The concrete capping is also deteriorating due to the large number of wave attacks on the structure.

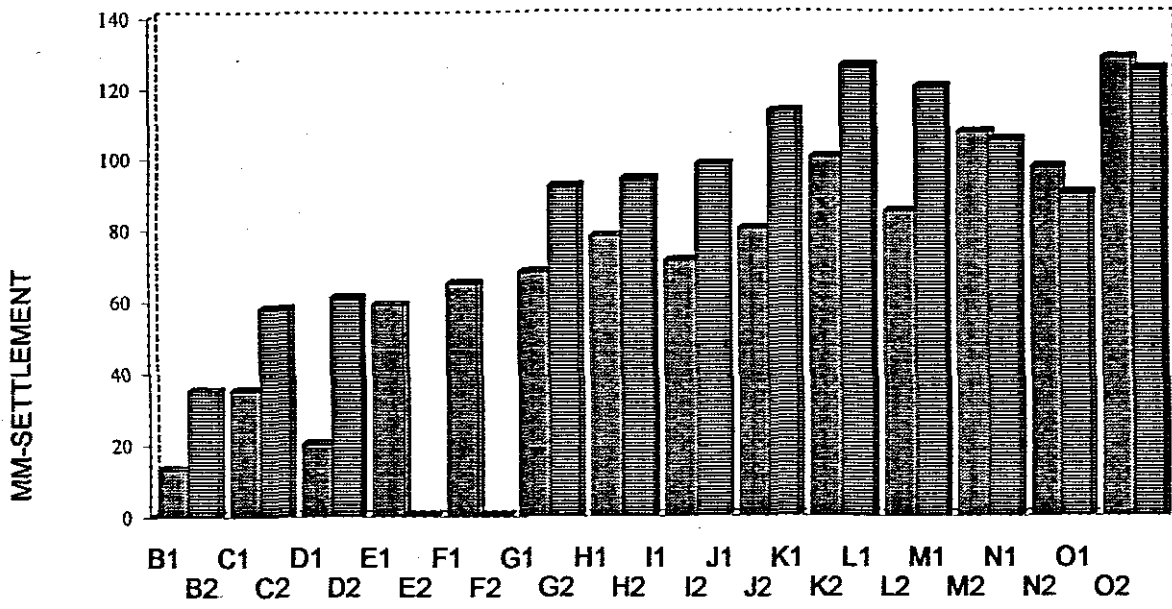
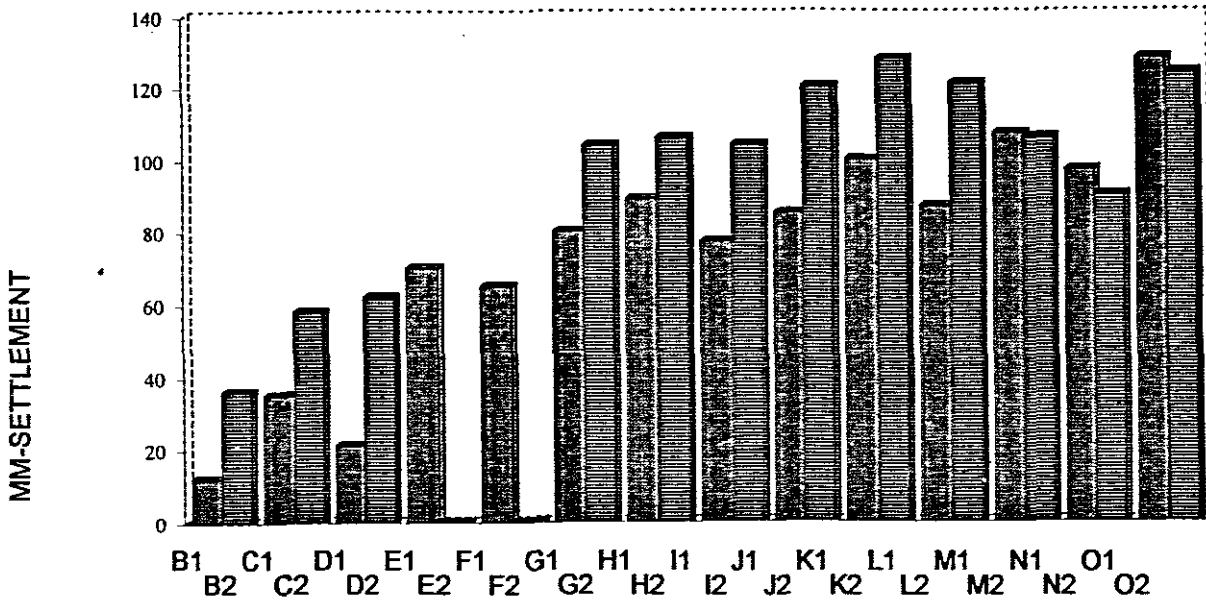
Fig 2.11

Caisson Settlement-June 1993 & Oct 1993

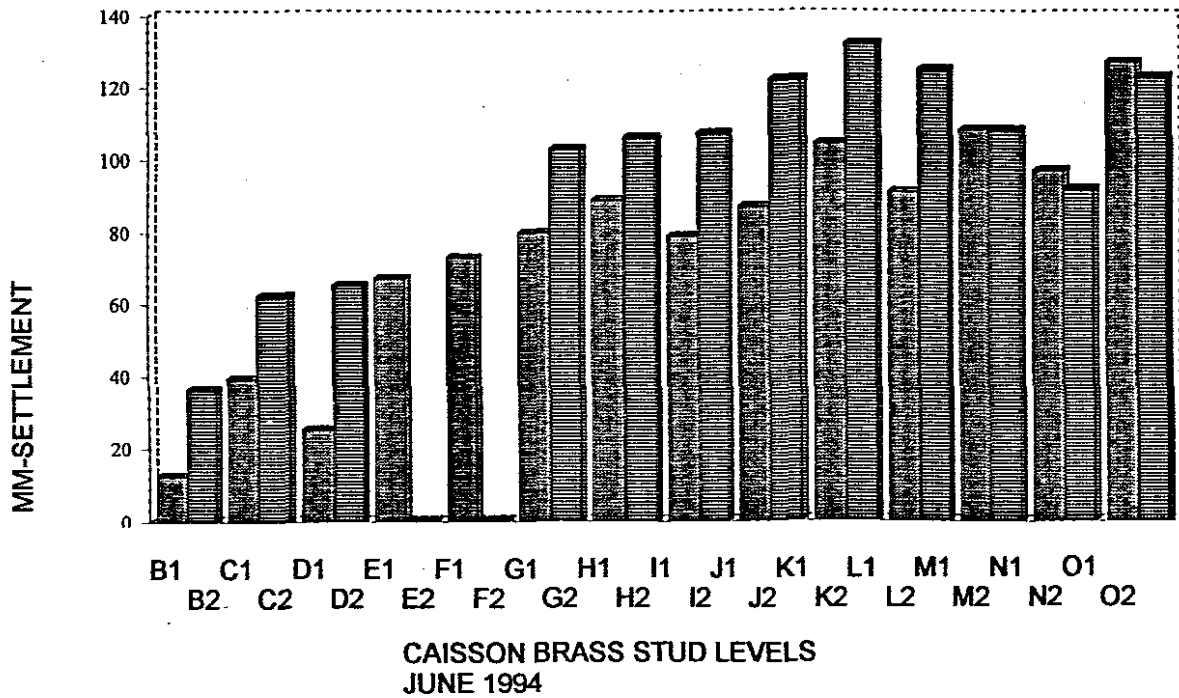
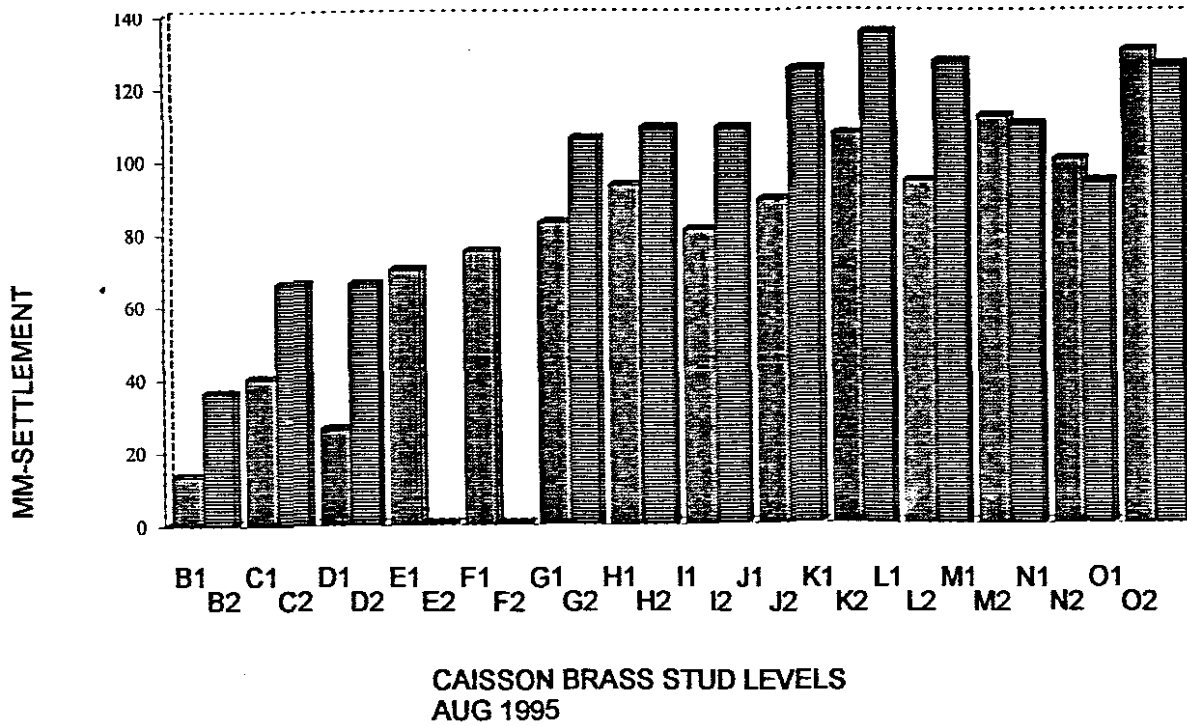
Fig 2.12

Caisson Settlement-June 1994 & Aug 1995

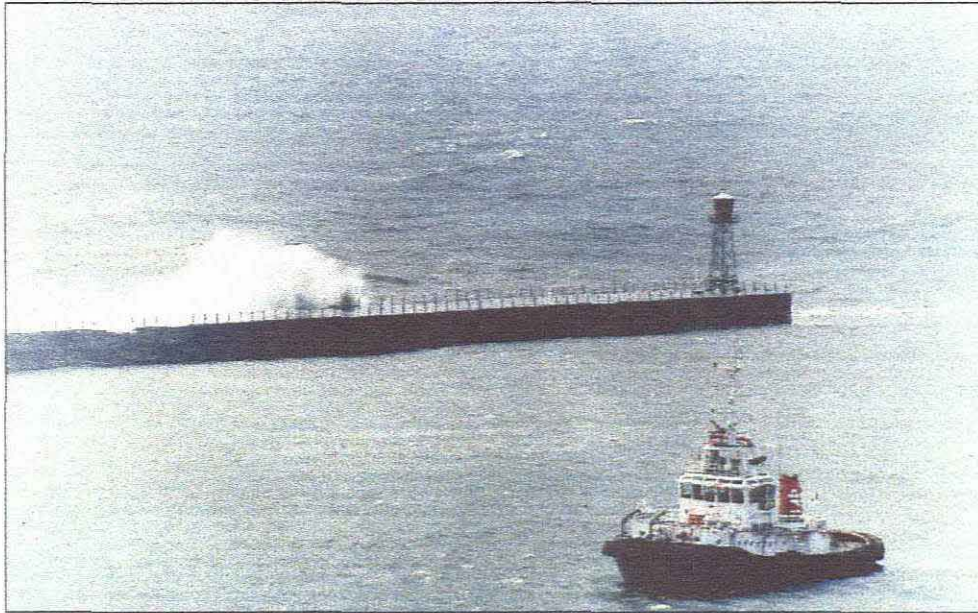
An approaching wave,  
South West direction,  
overtopping at  
caisson M3.

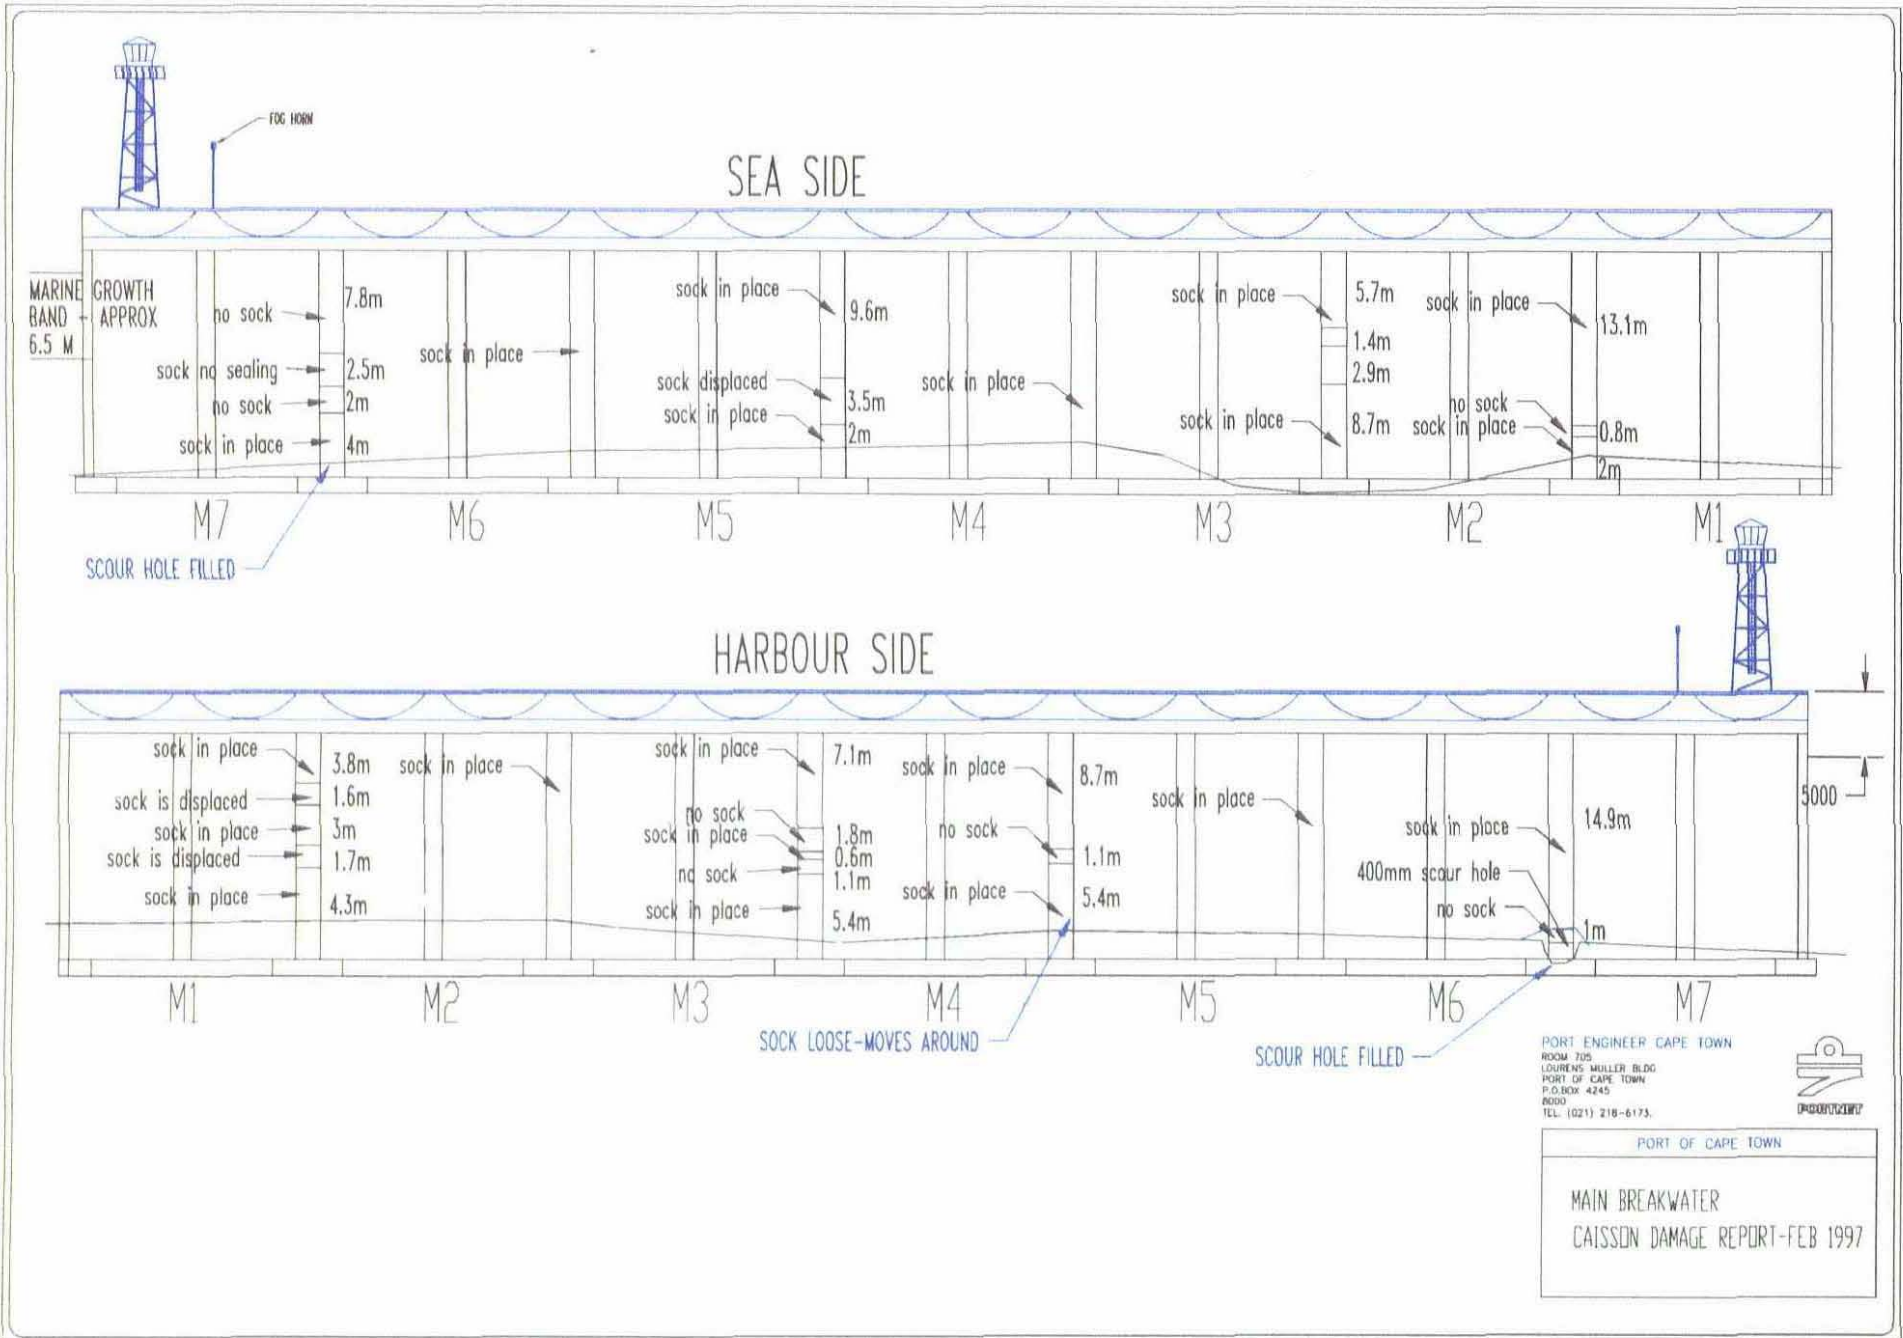
*Joint M5 - M4:* Grout sock in joint loose and moves inside the groove with the current.

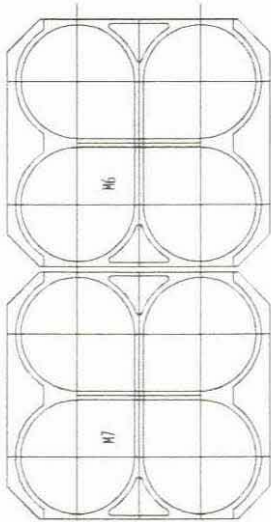
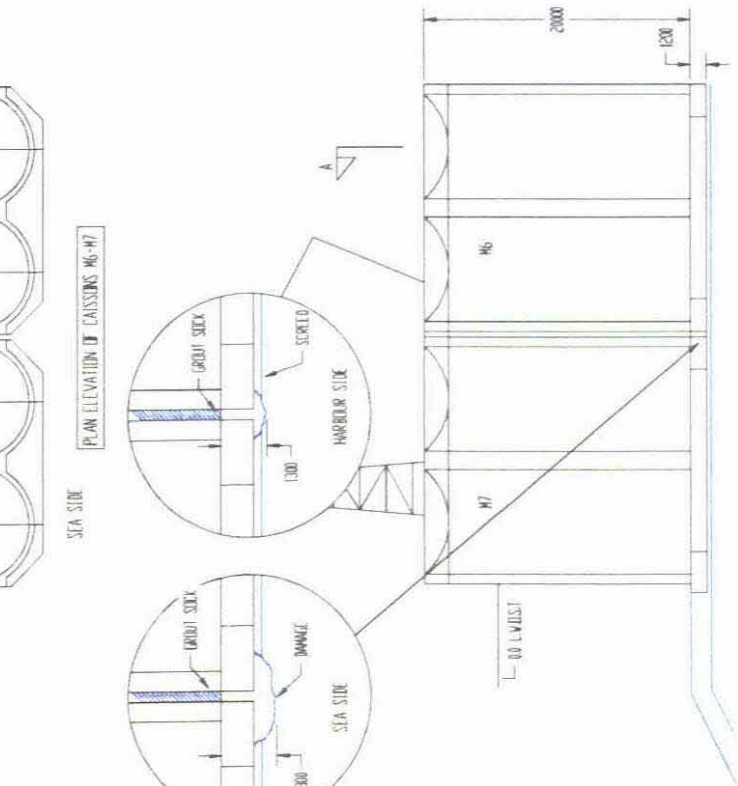
PLAN ELEVATION OF CAISSONS M6-M7

A FLOW UNDERNEATH CAISSON JOINTS HAVE CAUSED DAMAGE TO THE SCREED LAYER UNDERNEATH THE CAISSON STRUCTURE. THIS SITUATION WAS CAUSED BY THE GROUT SICKS NOT SEALING THE TWO CAISSON BLOCKS TOGETHER. THE GROUT SICKS ONLY HAVE A NEGATIVE EFFECT SINCE A BREACH ON BOTH SIDES OF THE CAISSONS HAVE TAKEN PLACE.  
 THIS CURRENT HAS TO BE STOPPED TO PREVENT SCOURING OF THE FOUNDATION LAYERS.

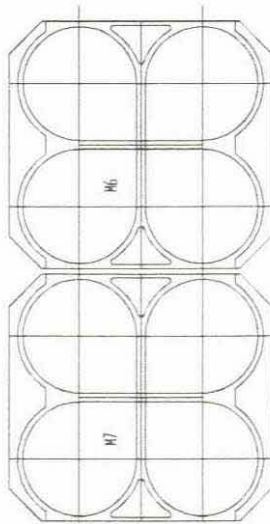
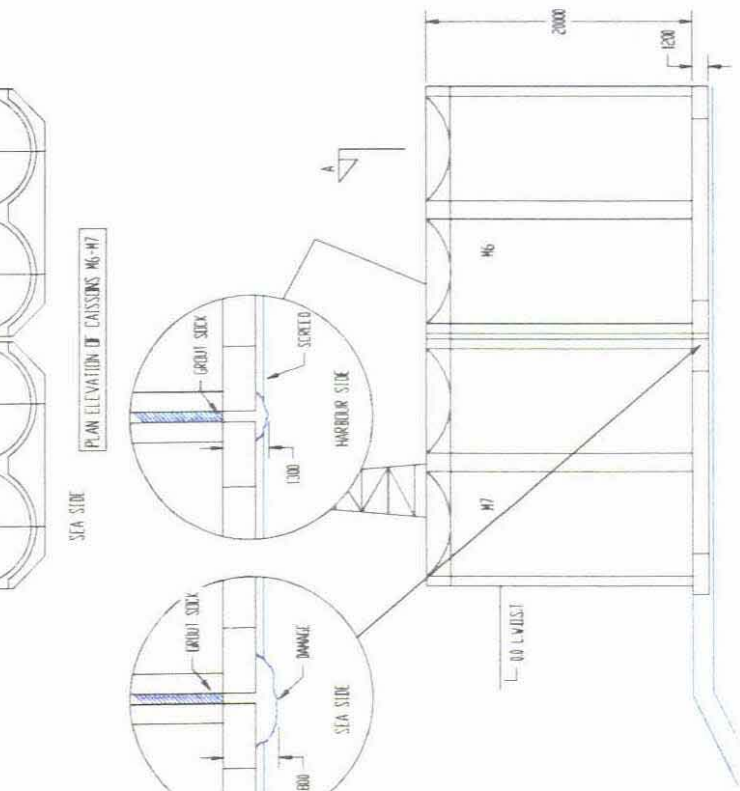
PLAN ELEVATION OF CAISSONS M6-M7

A FLOW UNDERNEATH CAISSON JOINTS HAVE CAUSED DAMAGE TO THE SCREED LAYER UNDERNEATH THE CAISSON STRUCTURE. THIS SITUATION WAS CAUSED BY THE GROUT SICKS NOT SEALING THE TWO CAISSON BLOCKS TOGETHER. THE GROUT SICKS ONLY HAVE A NEGATIVE EFFECT SINCE A BREACH ON BOTH SIDES OF THE CAISSONS HAVE TAKEN PLACE.  
THIS CURRENT HAS TO BE STOPPED TO PREVENT SCOURING OF THE FOUNDATION LAYERS.
