APPENDIX 2: EXAMPLES OF THE SHARED BASIC SANITATION TECHNOLOGY OPTIONS AVAILABLE TO RESIDENTS OF INFORMAL SETTLEMENTS WITHIN THE CITY OF CAPE TOWN

Appendix 2 Examples of shared basic sanitation technology options available to the residents of informal settlements within the COCT

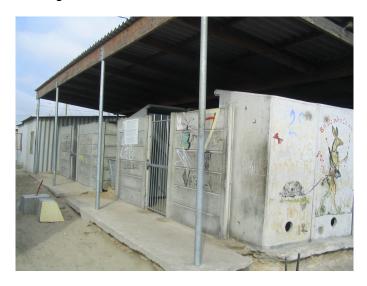
Shared ablution block at the Delft TRA.

The TRA shared ablution blocks comprise 6 flush toilets and 6 shower units. The shower units are not operational. The TRA ablution blocks are maintained by a contractor who has appointed locally-based cleaners. The municipality is responsible for repairs and unblocking blockages.

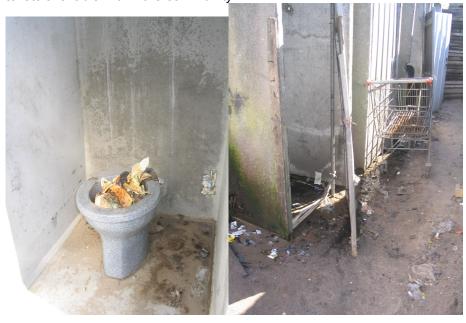
Blocked pour flush toilet and an example of a vandalized block of toilets

The pour flush technology requires end users to flush the toilet by pouring a bucket of water into the pan. The pour flush toilets are susceptible to blockages due to the use of newspaper; users not having a bucket accessible to fetch water to flush the toilet; and the intermittent supply of water to the toilet blocks. Residents have no option but to empty their buckets into the already blocked toilet as there are no alternatives for the safe disposal of the nightsoil. Vandalism is common and puts increased pressure on the limited operational toilets available within the community.

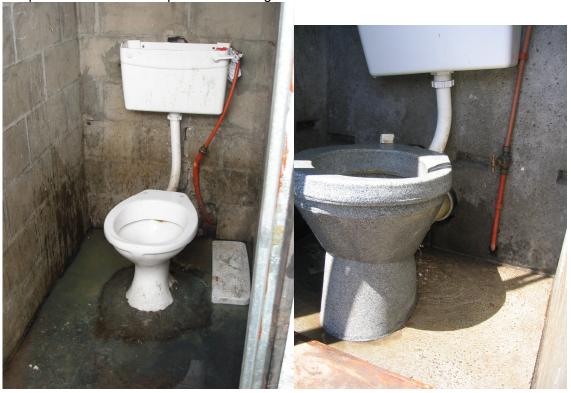
Leaking flush toilet

An example of a leaking flush toilet as a result of a damaged seal around the outlet pipe(below left) and inlet pipe (below right). The high incidence of the theft of metal components has resulted in the municipality having to replace them with less durable plastic components that are more prone to breakages.

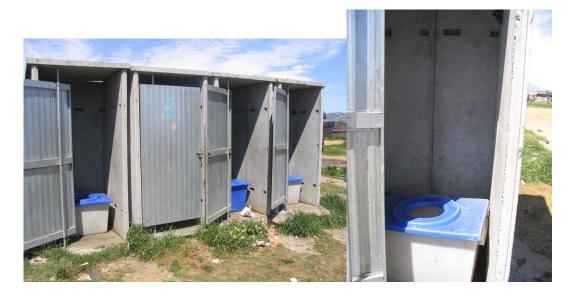
Container toilets at Wallacedene

A container toilet is a large bucket. These container toilets had been emptied and cleaned the morning of the site visit. All the containers were empty and the inside of the toilets were clean and safe to use.

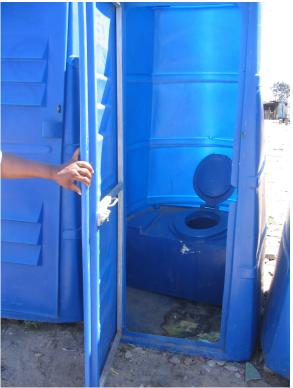
Chemical toilet at Wallacedene

The chemical toilet consists of a bucket containing a disinfectant solution. The containers are emptied by a vacuum pump. This chemical toilet had been emptied and cleaned the morning of the visit. Some spillage of chemical solution at bottom right hand corner.
