# **Aspects of Thermography for Non-Destructive Testing in Mechanical Maintenance**

Bandile Jama

*Masters of Engineering: Mechanical Engineering*

2017-11-07

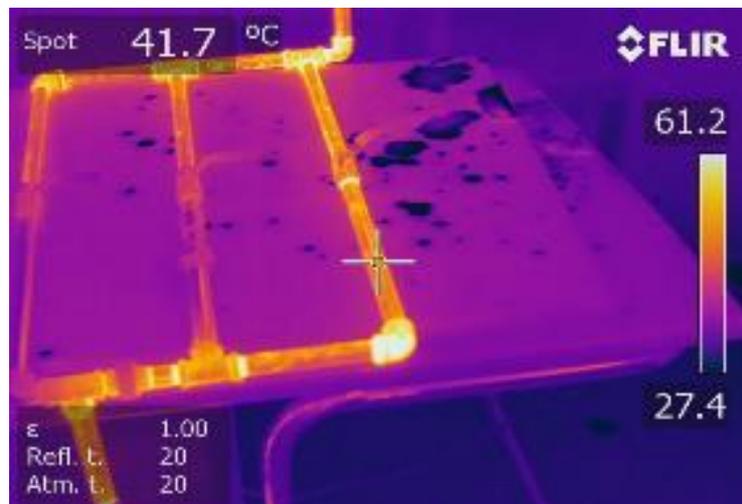
**Figure 3-7. Demonstration of internal leak through valve A**

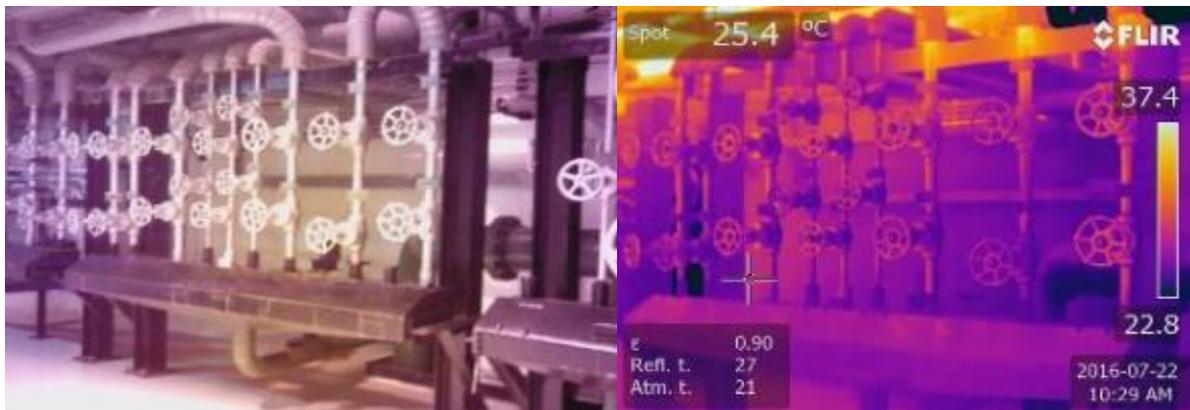
Figure 3-8. Drain system without internal leaks

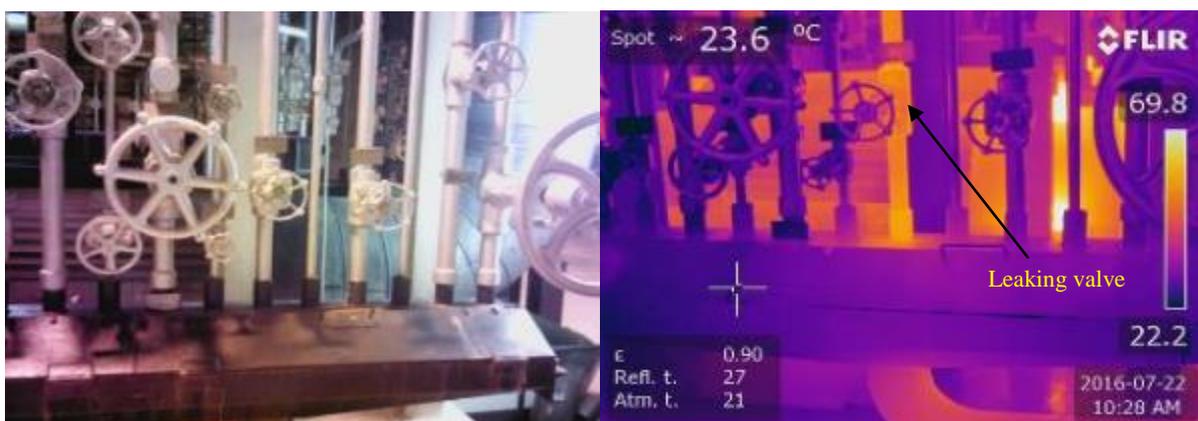
Figure 3-9. Drain system A with internal leak

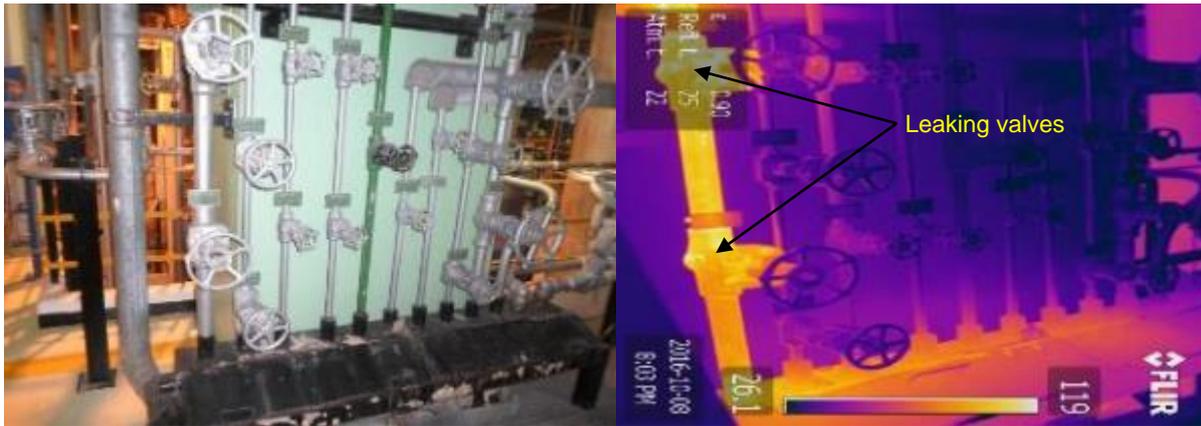
**Figure 3-10. Drain system B with double isolation leaking**

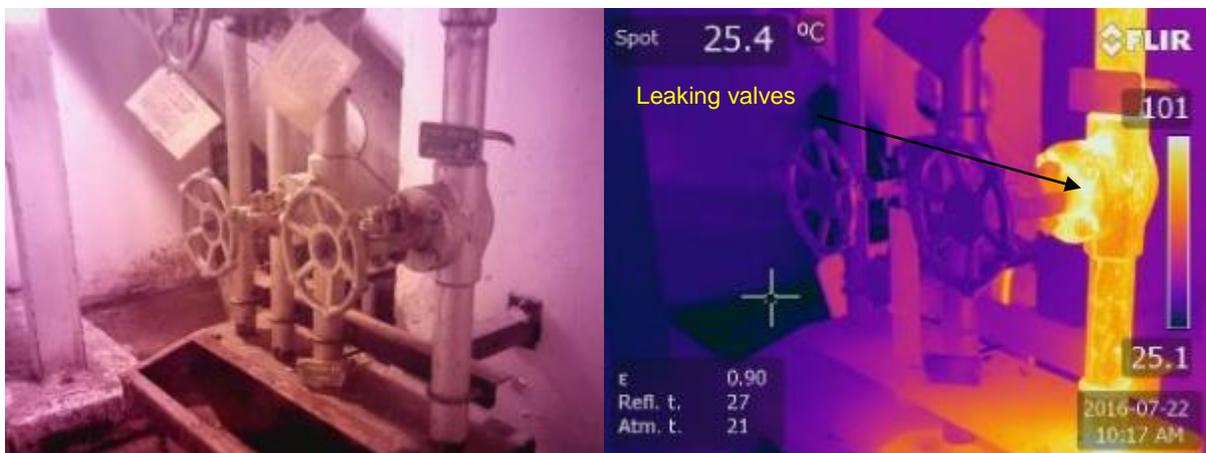
**Figure 3-11. Drain system B with internal leak**

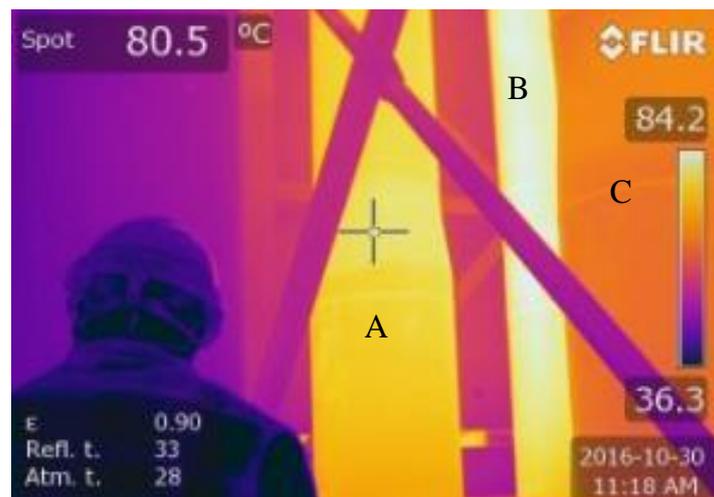
Figures 3-12, 3-13 and 3-14 demonstrate the results obtained during leak detection across safety valves. The results indicate that discharge pipes A and B are likely to have fluid (steam) passing through them when compared to C, and B seems to be worse than A.

Figure 3-12. Discharge pipe A results

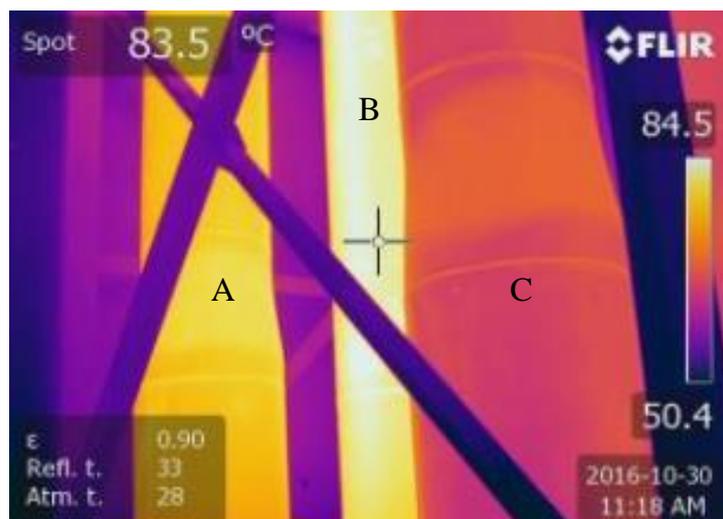
Figure 3-13. Discharge pipe B results

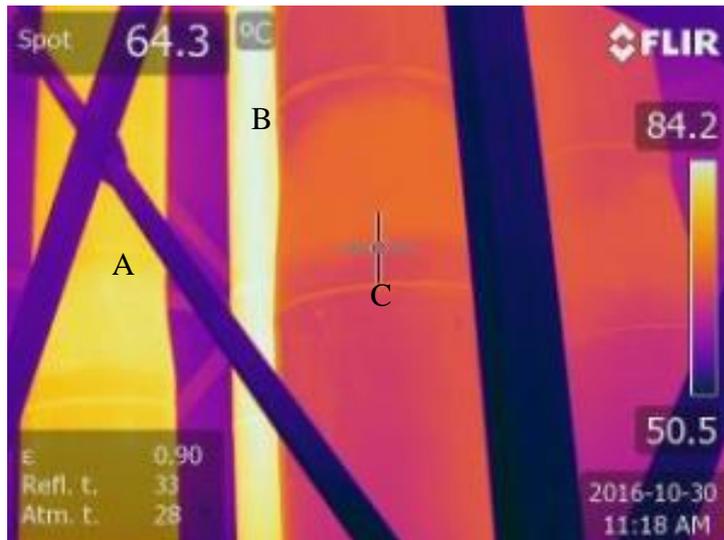
**Figure 3-14. Discharge pipe C results**

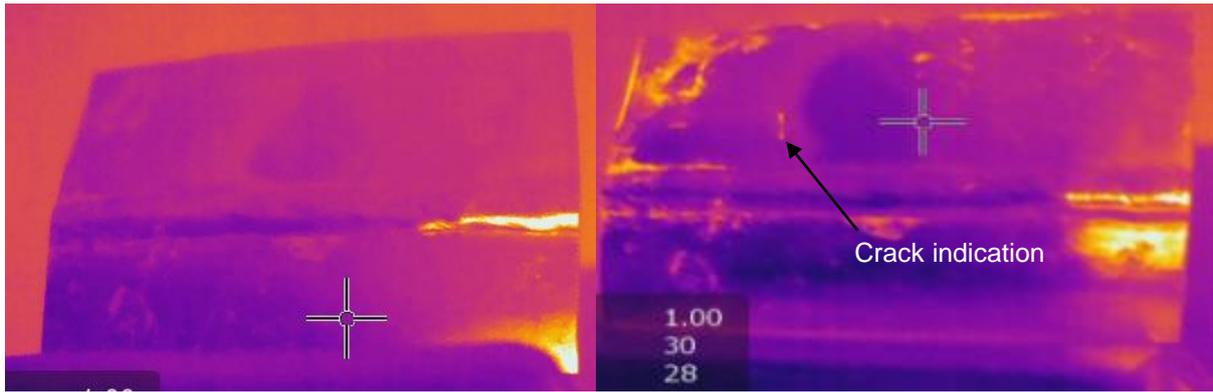
**Figure 3-34. 304L stainless steel after excitation**

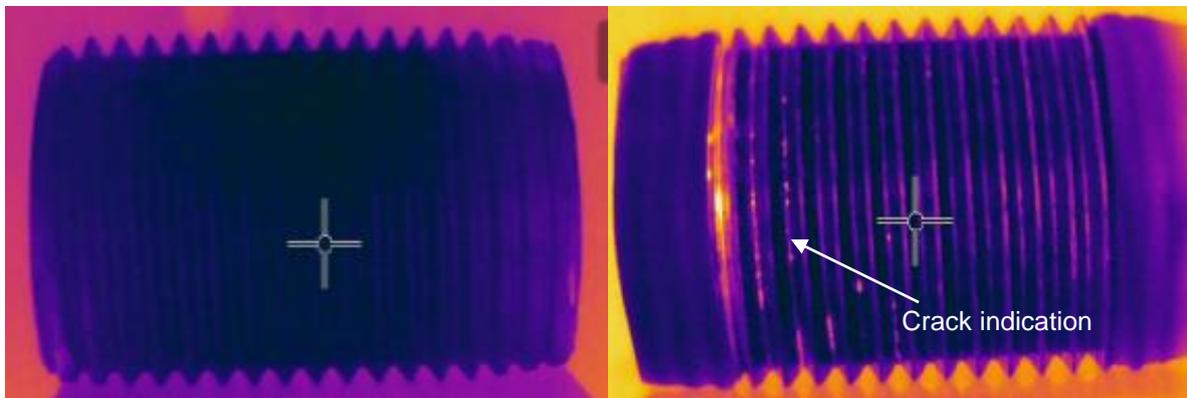
**Figure 3-35. Results of M80 HP turbine's studs after excitation**

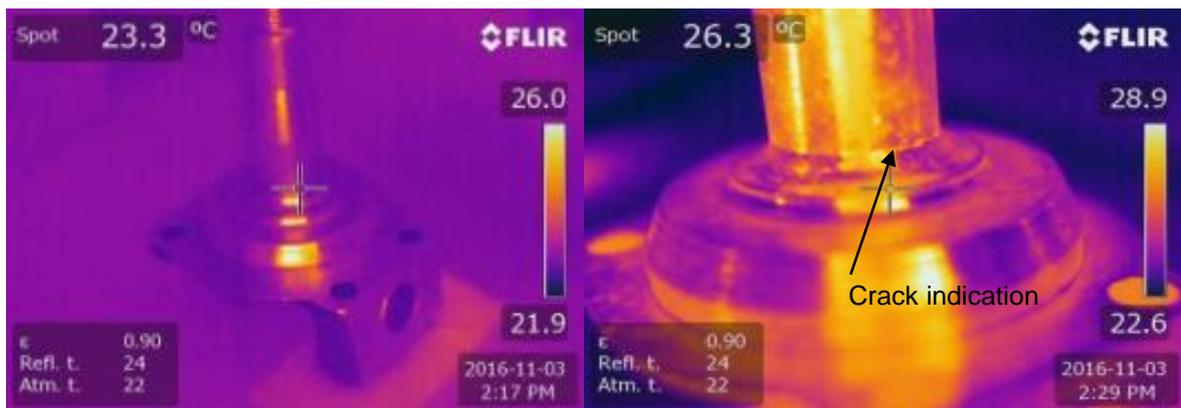
**Figure 3-36. Results of CV-joint after excitation**

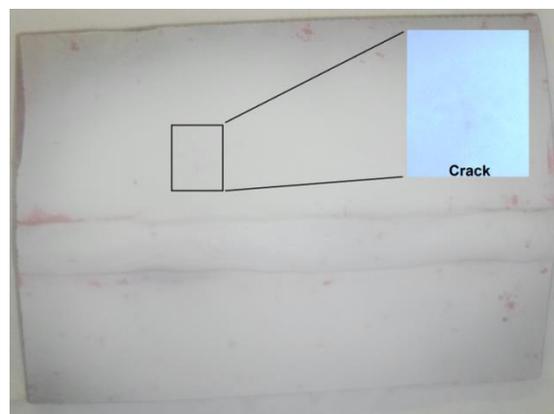
**Figure 3-40. DPI results from the 304L stainless steel test piece**

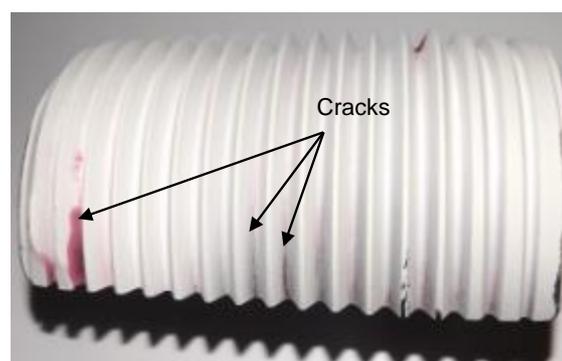
**Figure 3-41. DPI results from the HP-turbine's stud specimen**

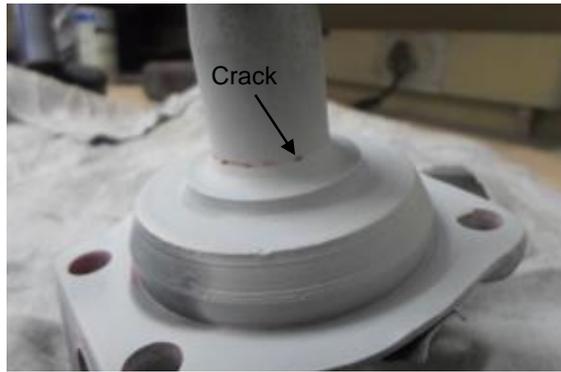
**Figure 3-42. DPI results from the CV-joint**
