## Kirstenbosch Gardens

Kirstenbosch Gardens sees a plethora of visitors on a daily basis, which include school tours, the elderly, and foreign tourists. The gardens seem to represent a universal approach in their efforts to cater for this vast spectrum of individuals.

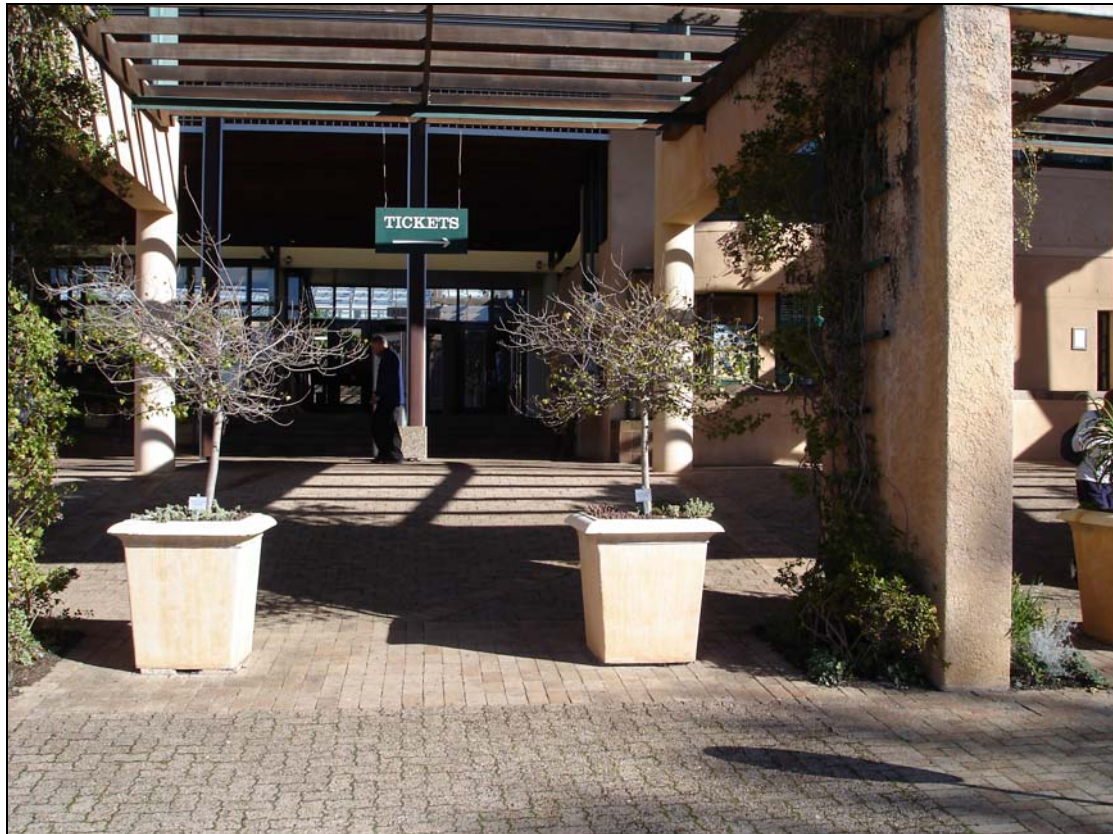
After arriving at the entrance from the parking lot, one is greeted by several large and clearly legible signs directing one to the ticket booths. They show only the English word 'tickets'. A low gradient ramp serves as entrance to the building.

Perceptible information:	Signage is large and clear.
Equitable use:	The ramp leading into the buildings serves both able bodied and disabled people alike.
Low physical effort:	The ramp serves this principle in much the same fashion.

Perceptible information:	Signage appears only in English, makes no use of universal symbols.
--------------------------	---

Symbol for ticket counter as specified by AIGA. Available from: <http://www.aiga.org/content.cfm/symbol-signs>

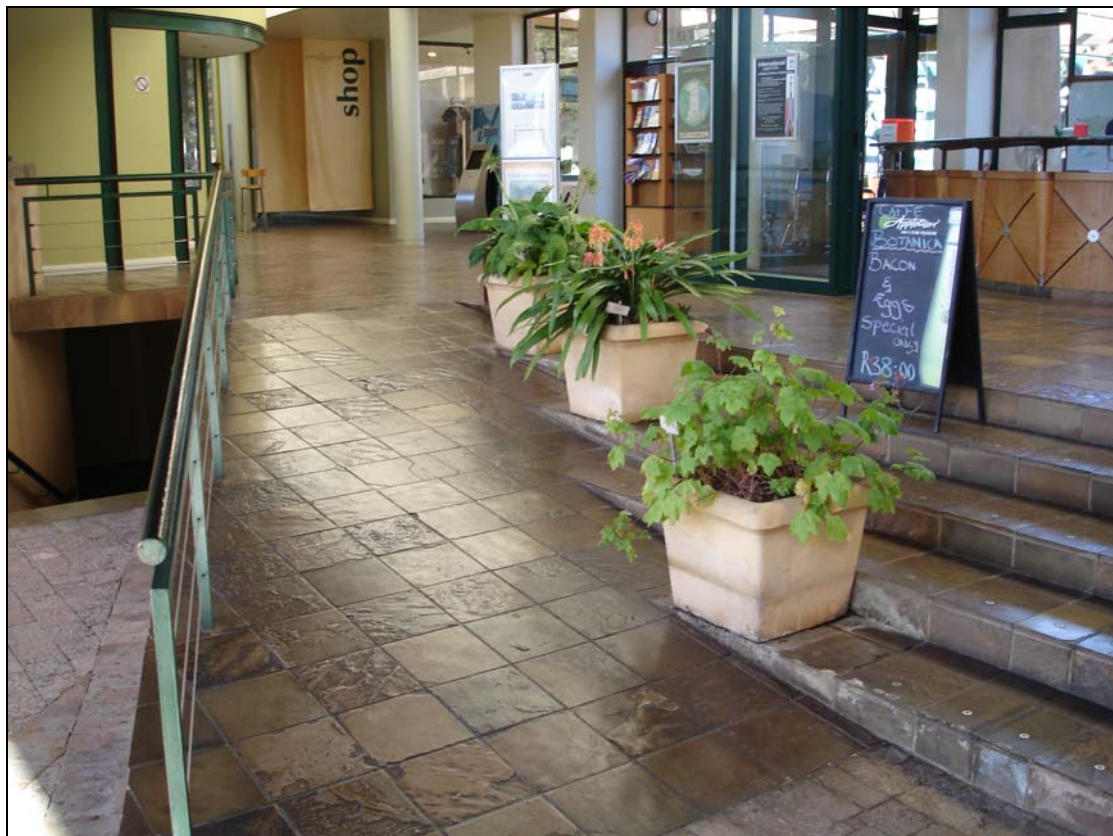
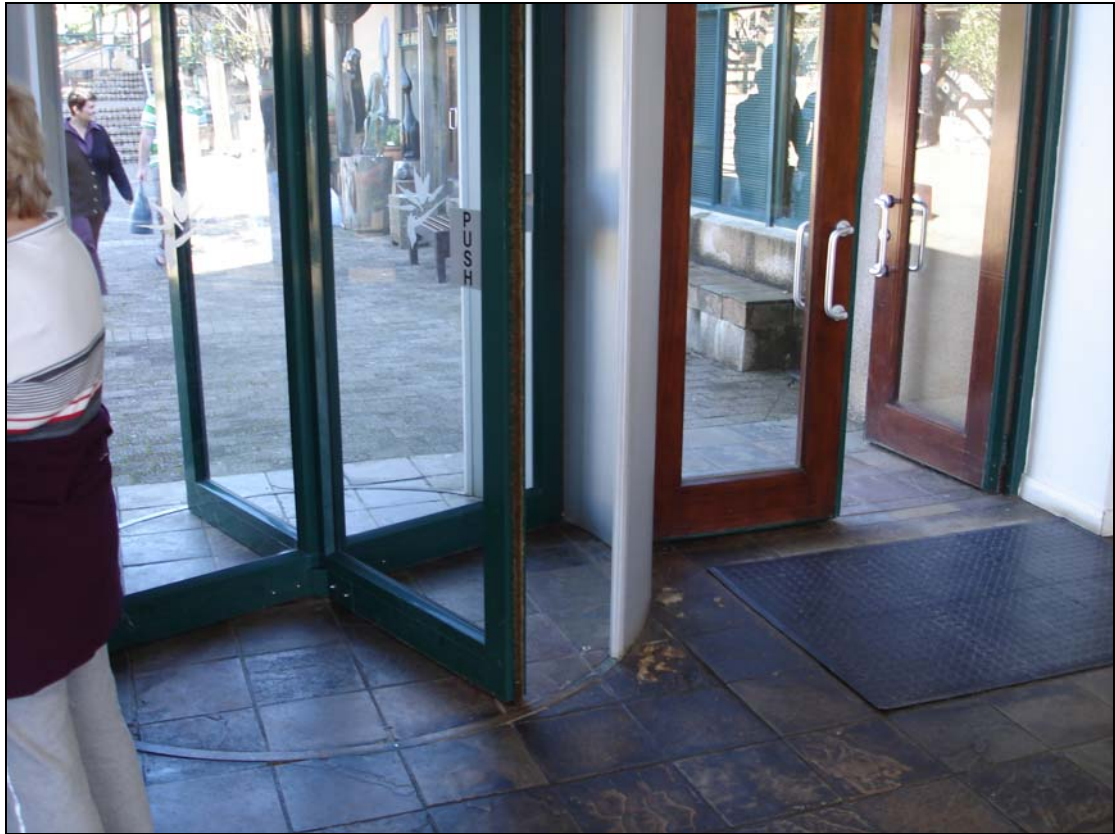
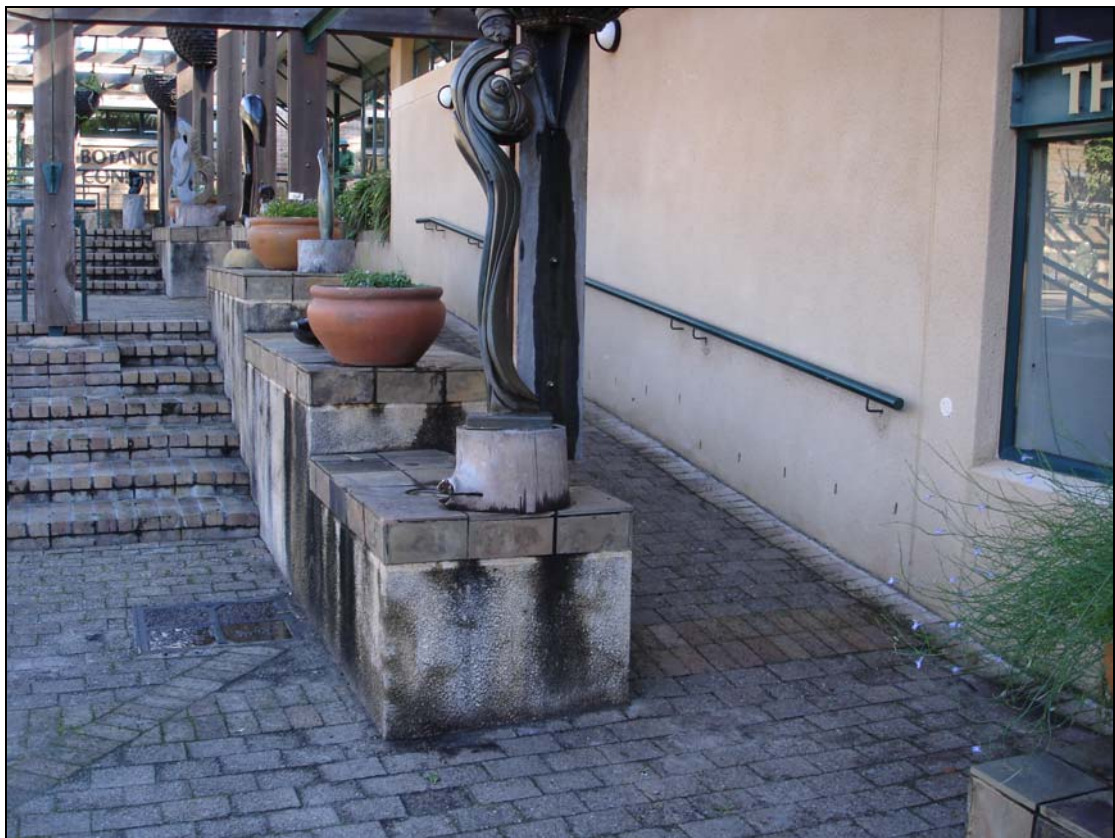
The preceding three images show where ramps accompany flights of stairs in order to accommodate individuals with mobility orientated disabilities, the elderly, prams, or for that matter anyone who would choose to use them. They are used throughout Kirstenbosch Gardens where it is possible, or where their construction is not limited by topography.

Flexibility in use: Ramps are useful for mothers with prams, goods delivery, wheelchairs, etc.

Equitable use: Ramps serve both able bodied and disabled people alike.

Low physical effort: Ramps serve this principle in much the same fashion.

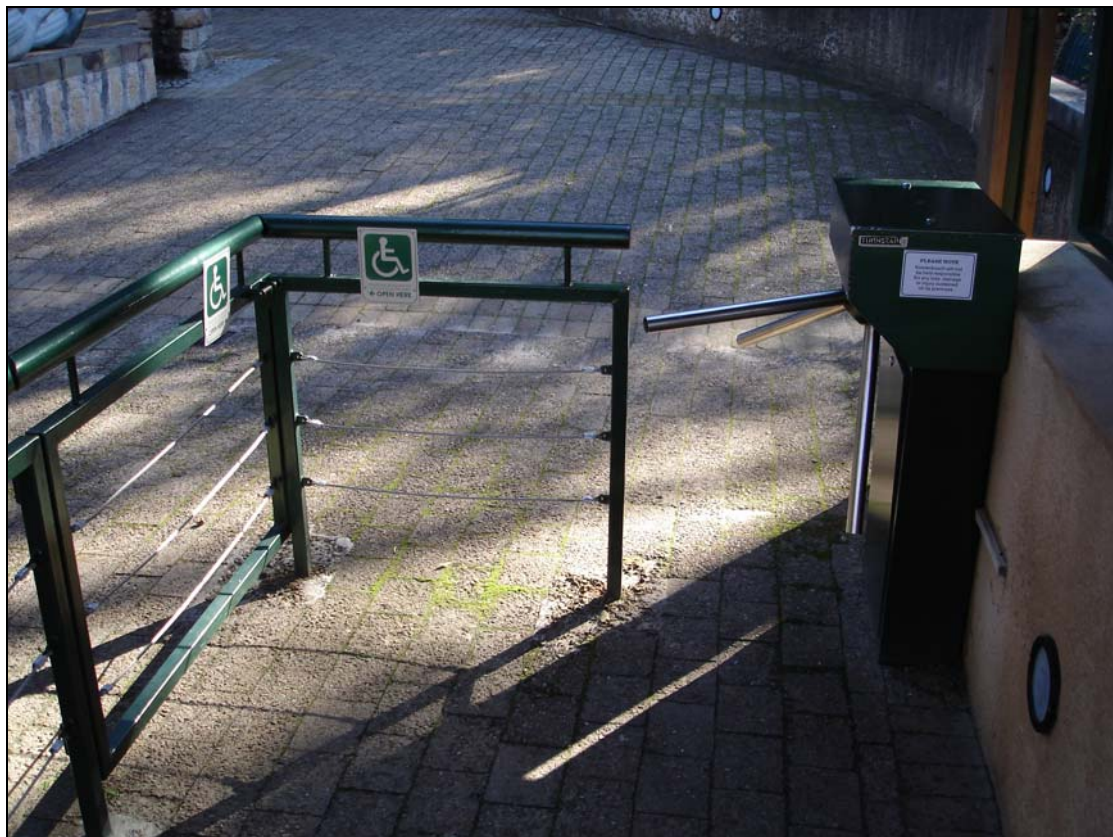
Wheelchair access into the gardens is afforded by the moveable gate, which has a somewhat difficult to notice sign stating this. A point mentioned by the ticket collector at the gate was that individuals with prams often do not recognize the sign and realize that one can gain access by moving the gate, and subsequently try to force their way through one of the turnstiles.

Flexibility in use: Despite the shortcomings of the gate with regards to visibility, it can serve multiple purposes (wheelchairs and prams).

Size and space for approach: There seems to be adequate room to manoeuvre a wheelchair in this area.

Perceptible information: Signage is too small, blends into the background, at a height difficult to read for a standing individual, and is not recognized by many individuals.

Tolerance for error: By not making this feature readily apparent, the incorrect method of access is chosen, perhaps forcing the turnstile.

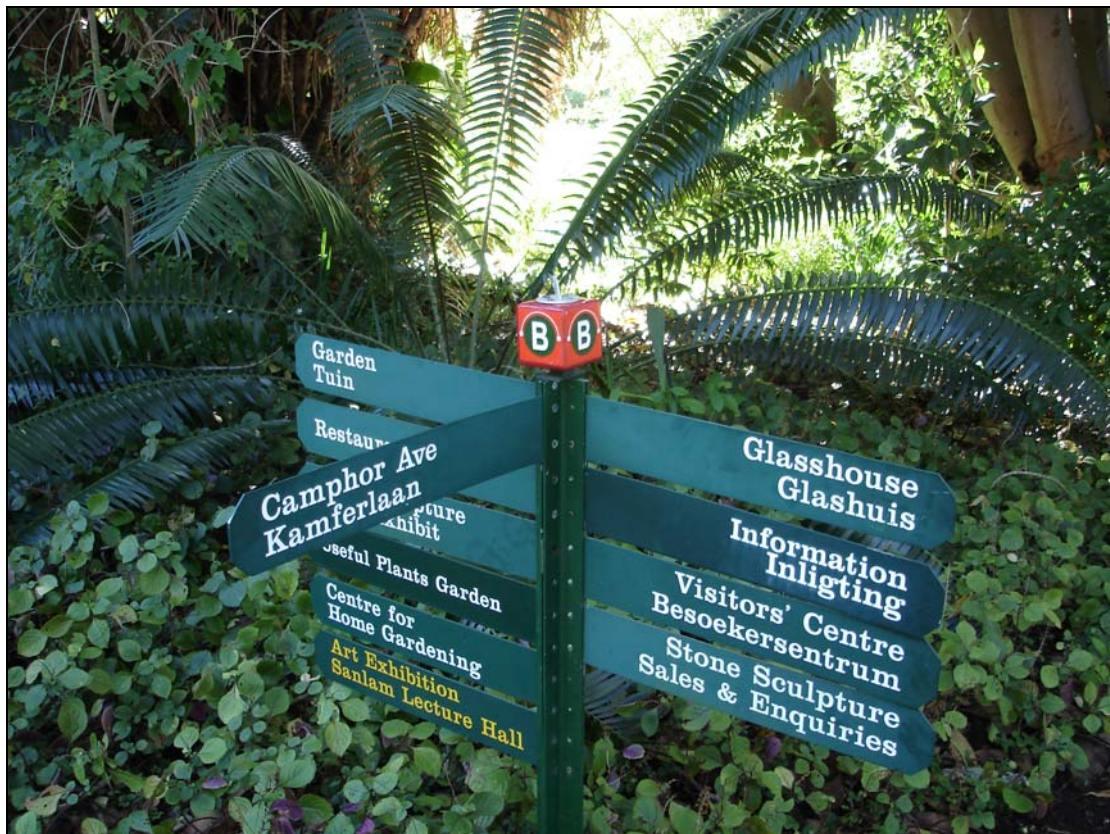
Signage appears more than adequate throughout Kirstenbosch Gardens. The proceeding example illustrates this, and was positioned at a major junction. Note the red block on the top with the letter 'B' surrounded by a pair of headphones. This forms part of the 'Braille Trail', which is a 'short self-guided tour that passes through a patch of wetland and natural forest'. Audio devices can be rented from the information desk.

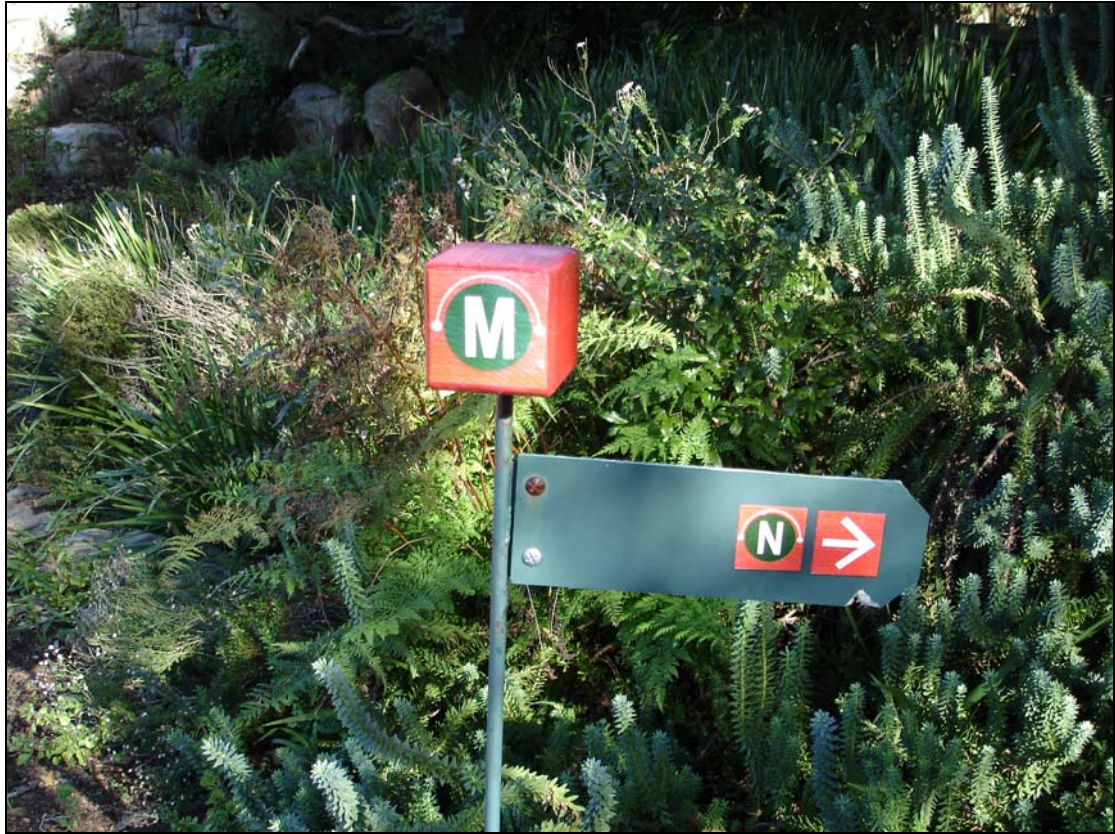
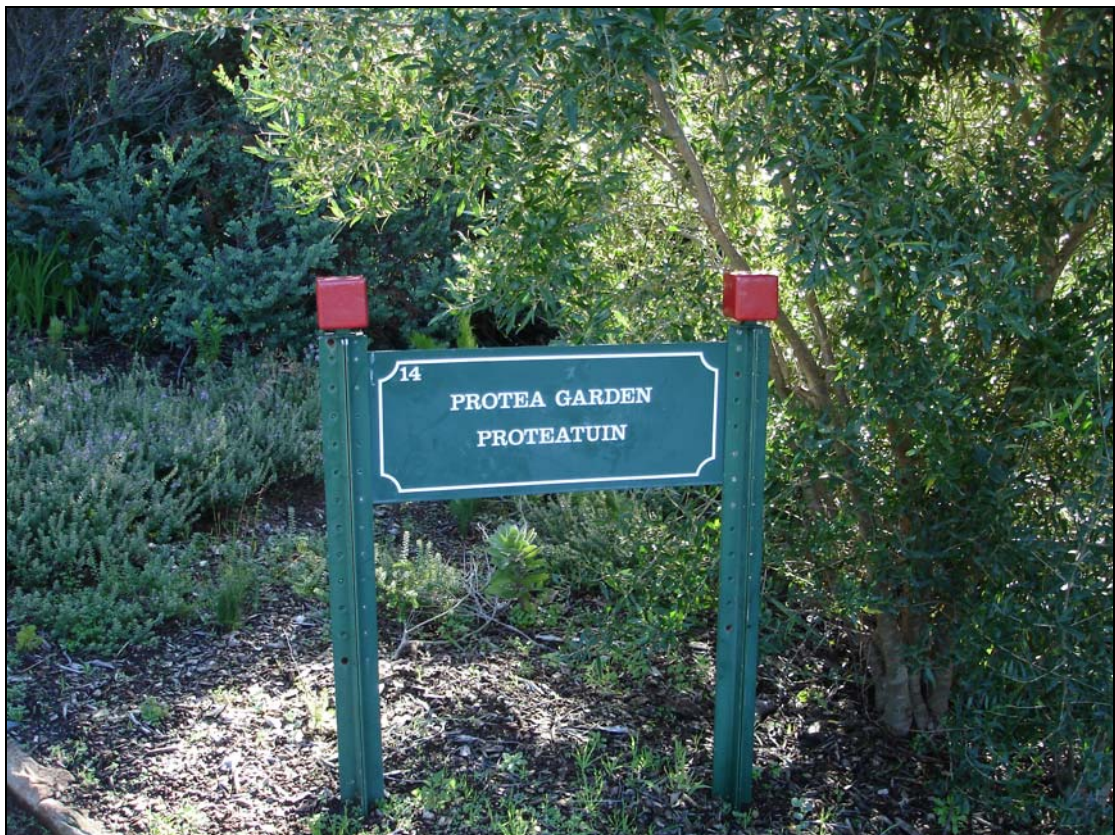
Pictured above is a sign of one of the various sections of the garden. Note the number in the top left, for reference with a guide map available at the information desk.

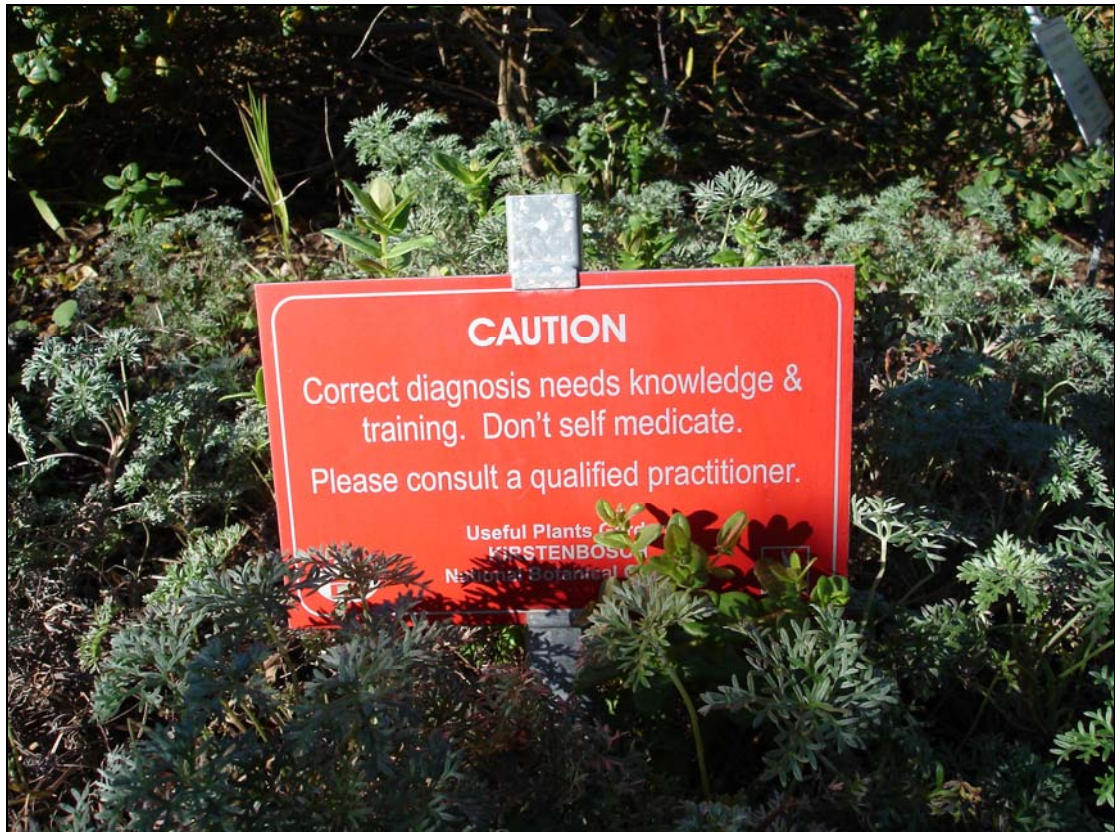
This caution sign differs from the other signage in the area, being bright red. This serves to help it stand out from the foliage, as well as being representative of danger.

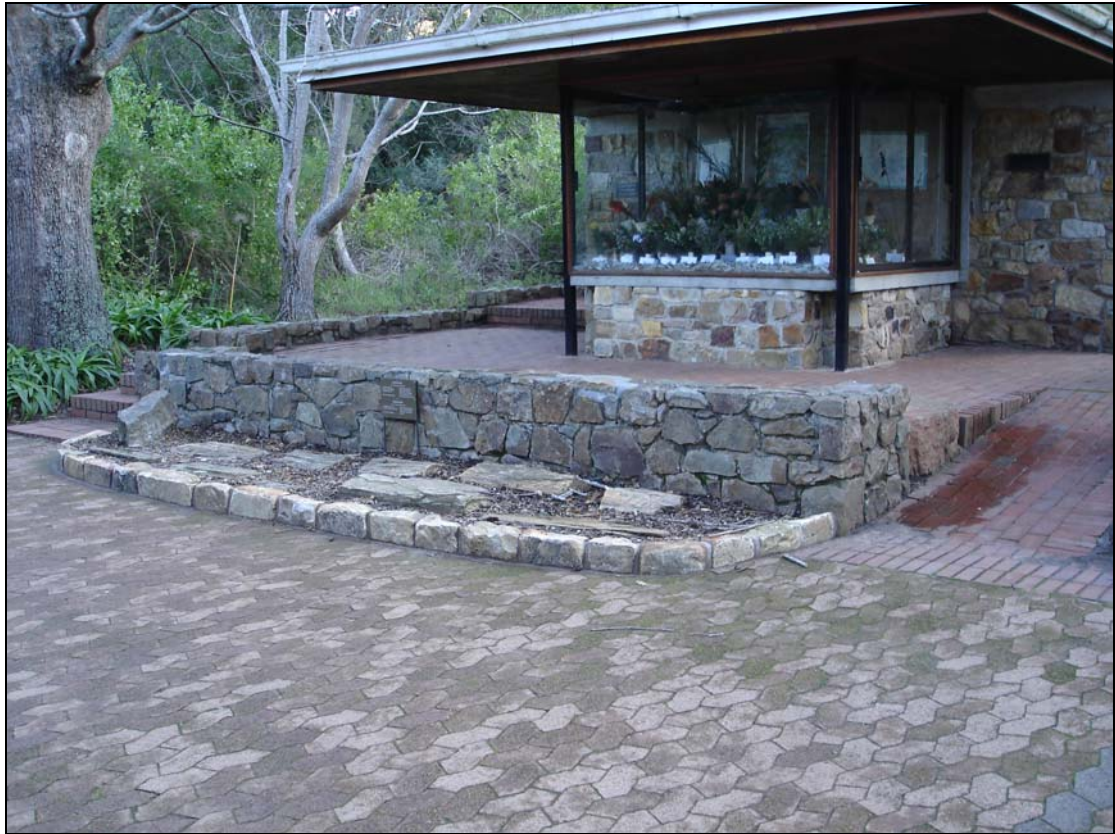
Even a display of the various types of proteas situated on a raised platform has both ramp and stairs.

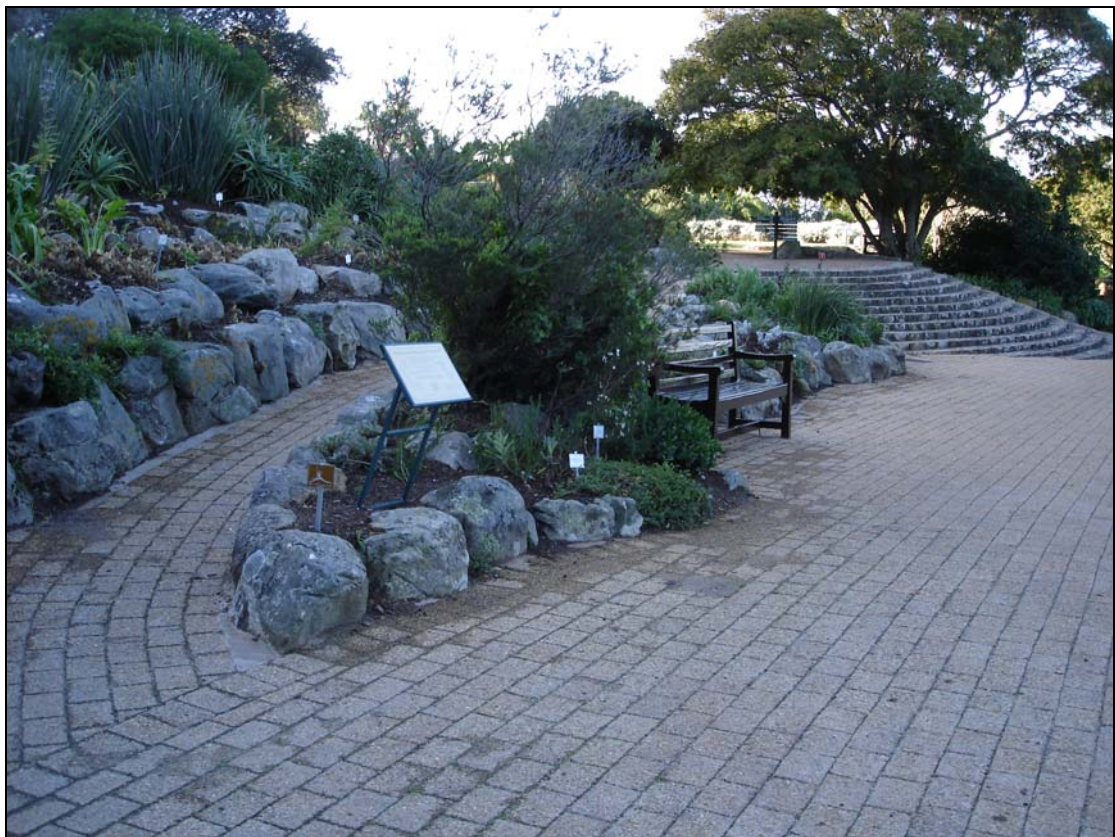
Here again at one of the main entrances ramps are provided at various levels to accommodate people with various abilities or prams.

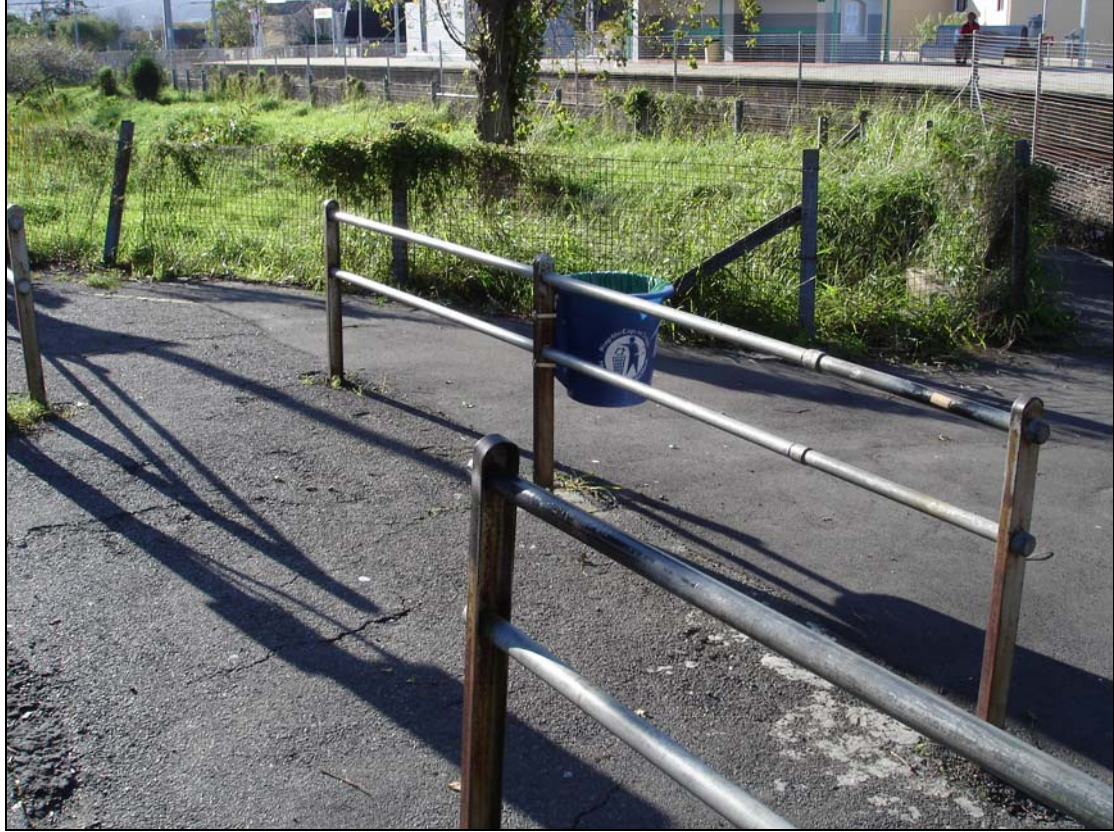
Upon approach one encounters this railing, the purpose of which is difficult to decide upon. It could be to keep cars out, or for ticket collection in days past. It is however a barrier that would impede access to the stairs.

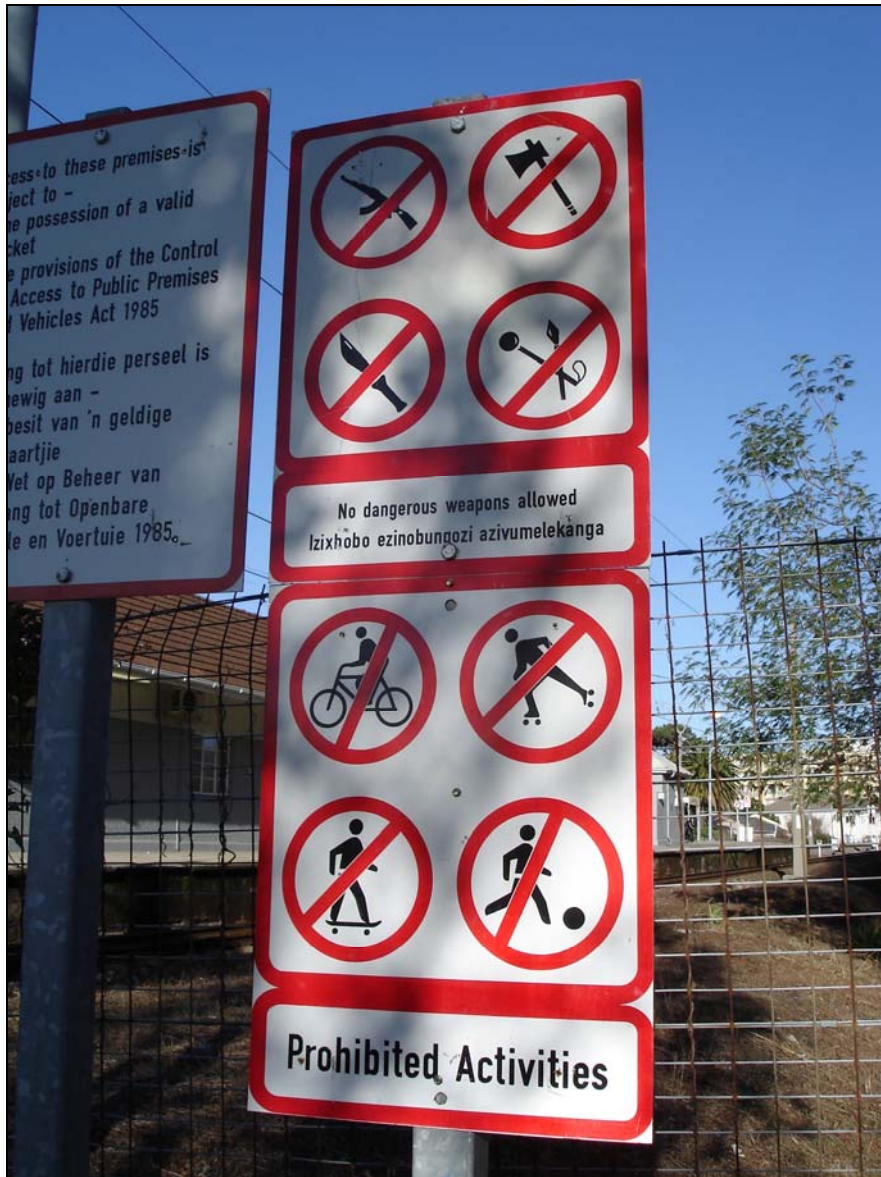
Take note of the fact that there is no symbol representing 'no photography' on this sign of prohibited activities. As it was kindly pointed out by an official, photography is not permitted on the station. It does do a fairly good job of inspiring a sense of fear, with 4 symbols representing exactly what weapons one is not allowed to bring onto the platform.

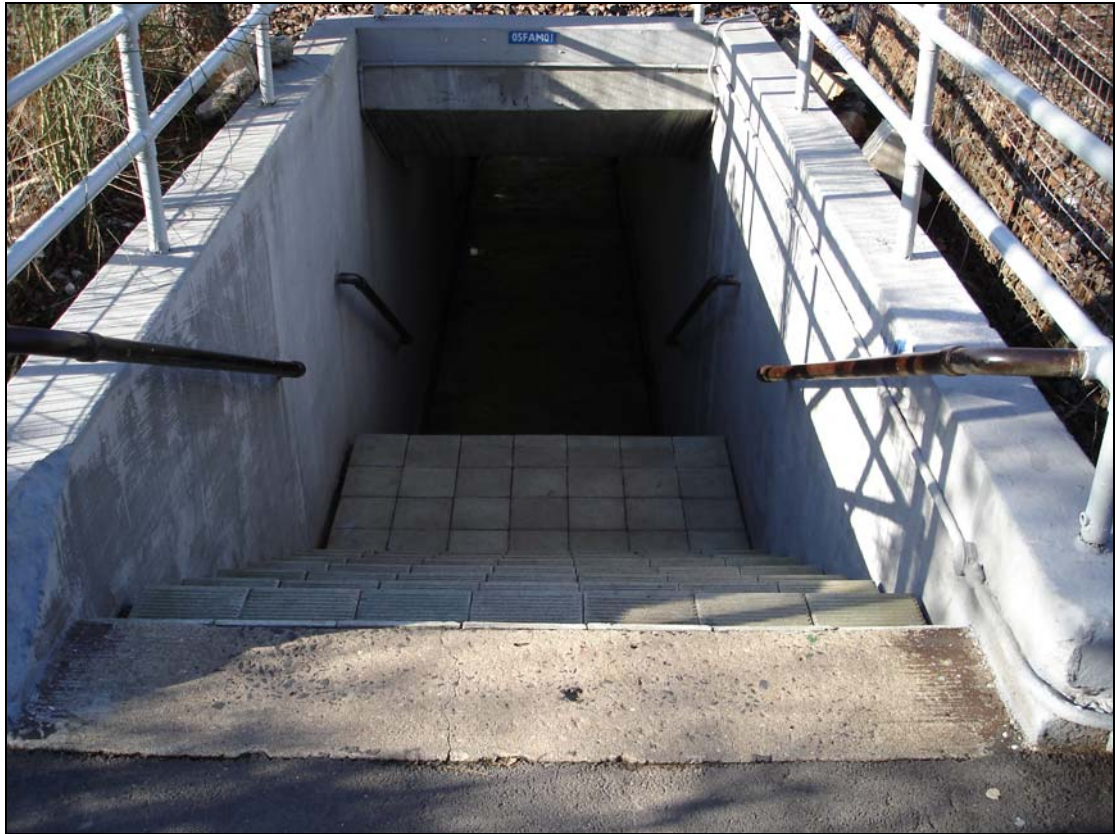
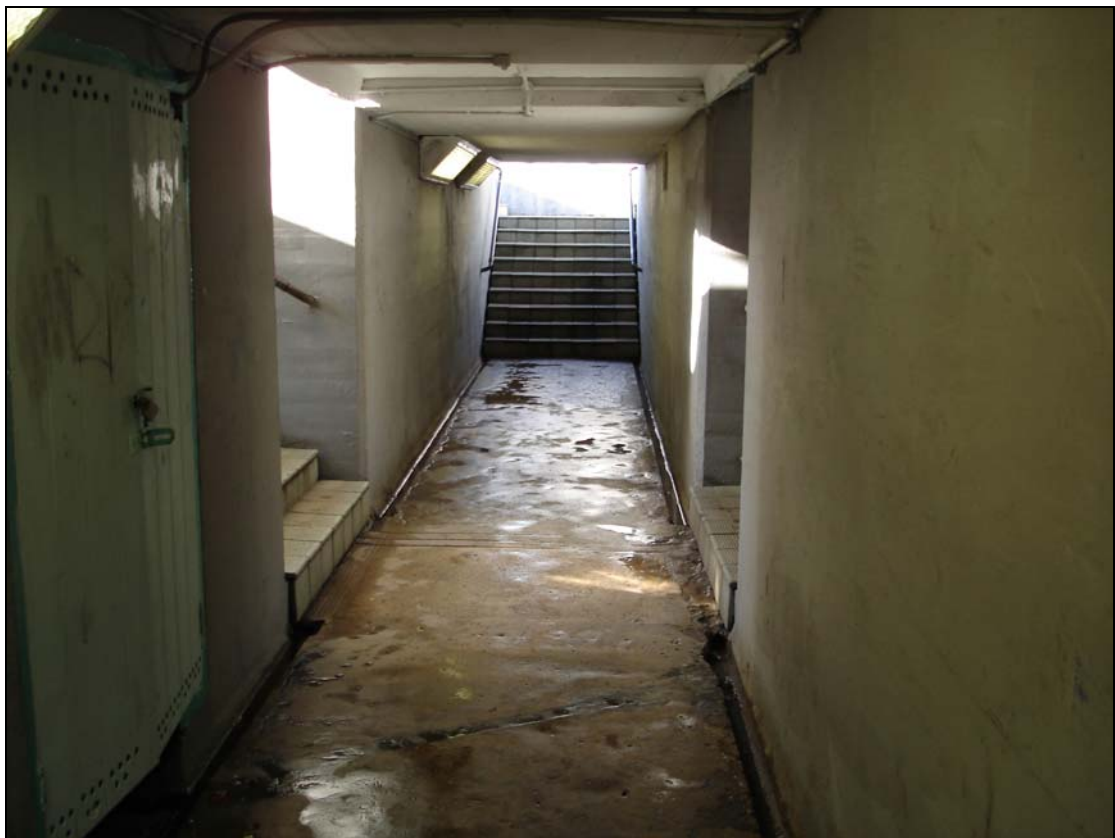
The previous two photographs show the only access to the platform. One first has to descend a flight of stairs then cross through a dimly lit subway, followed by ascending another flight of stairs. This represents a major problem for the elderly or people with mobility orientated disabilities. It actually is a danger to just about anyone, as the stairs are often wet and slimy, and I have slipped and fallen on more than one occasion when in a hurry.

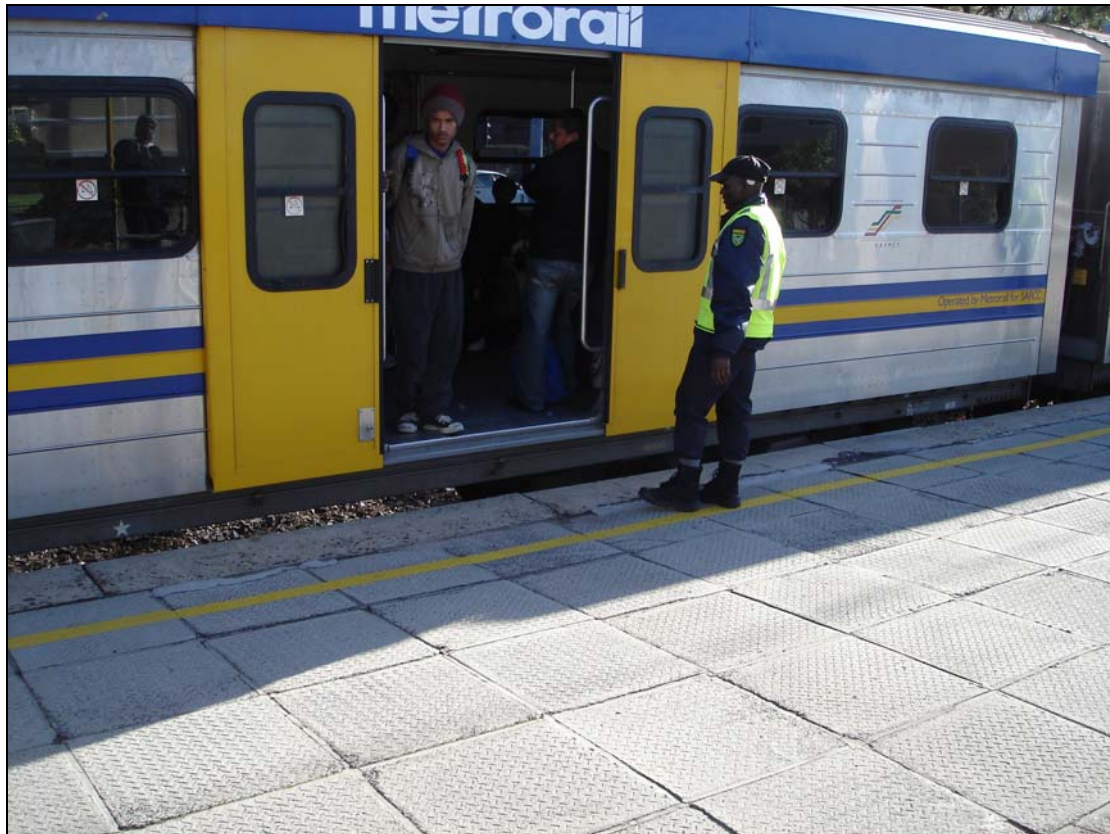
Upon arriving at the station a train arrived, preceded by an audio message that said something along the lines of stay away from the tracks and exit through the doors. The security guard pictured was helping a person with a visual disability onto the train, perhaps to guide him over the large gap and rise between the platform and train. This presents a problem not only for this particular individual but also people with mobility disabilities.

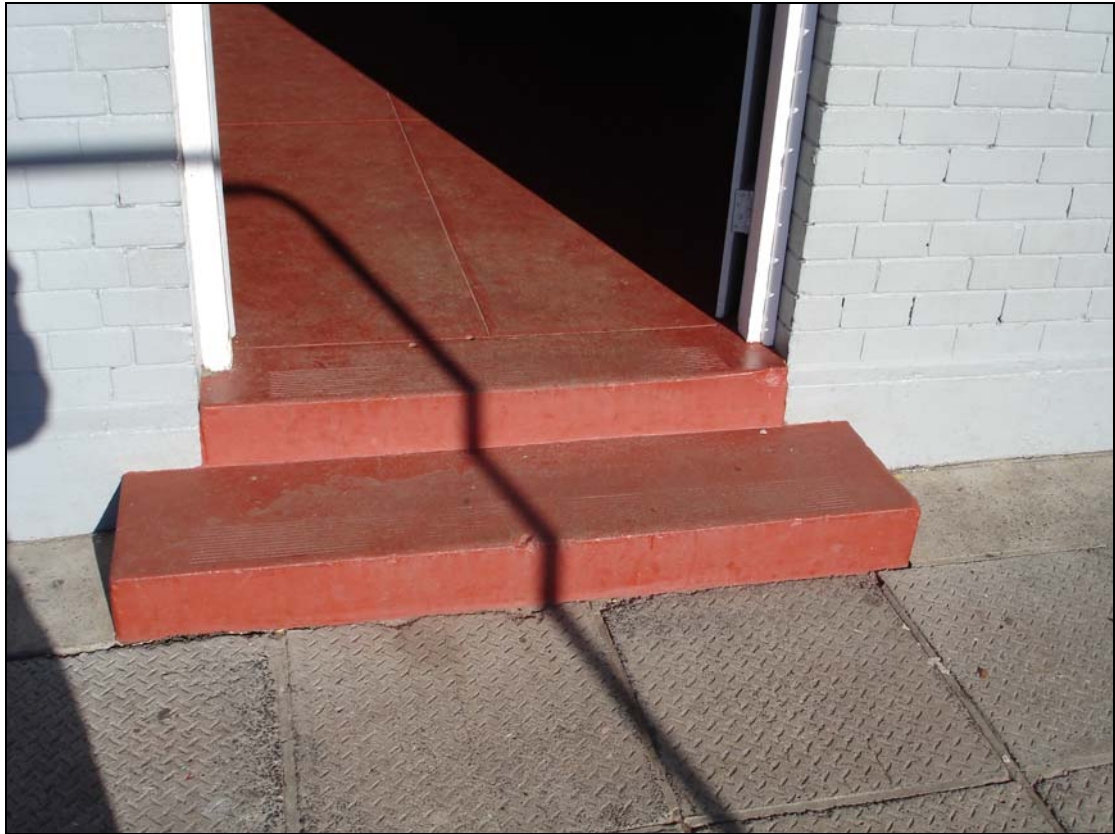
These steps of unequal height hamper entry to the ticket office.

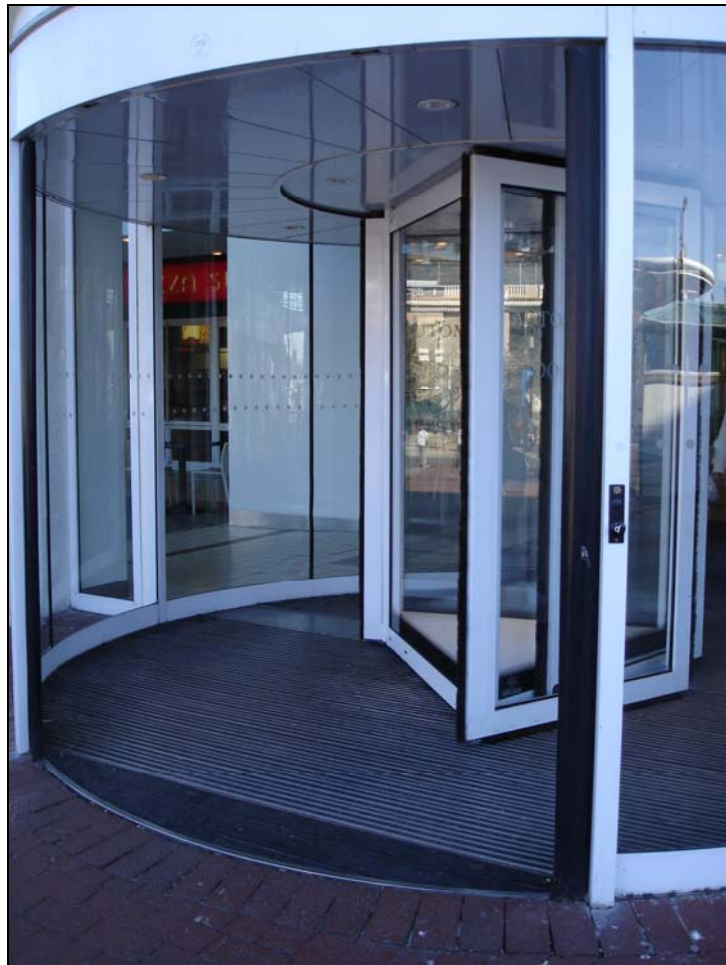
The revolving door at one of the main entrances can be seen as inclusive, despite the fact that it was not operational at the time of the photograph. There is enough room within the door to manoeuvre a wheelchair and when operational does not require the use of ones hands to open, as in the case of many side doors in buildings that provide for wheelchair access. The textured material on the floor not only serves as a mat, but also as a tactile stimulus to confirm the transition of the doorway. Surfaces are level throughout with no raised sections that might cause one to trip.

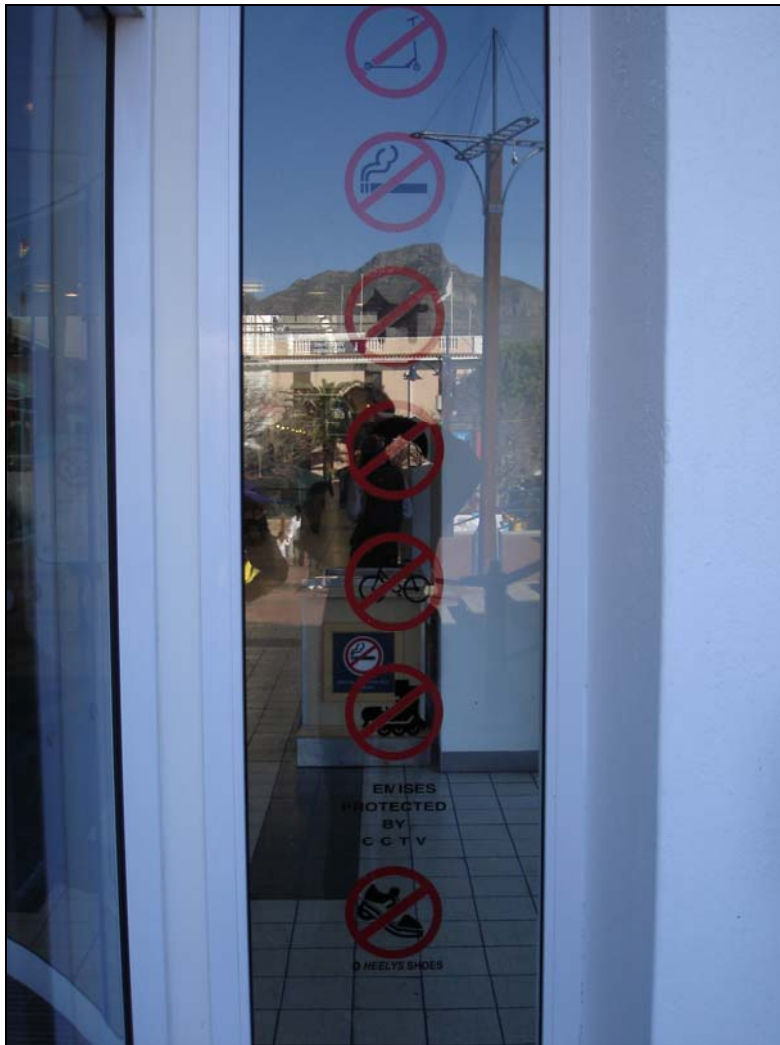
The signage on the door at one of the main entrances at first went completely unnoticed due to its placement on the glass on the far side of the door and the use of partially transparent stickers.

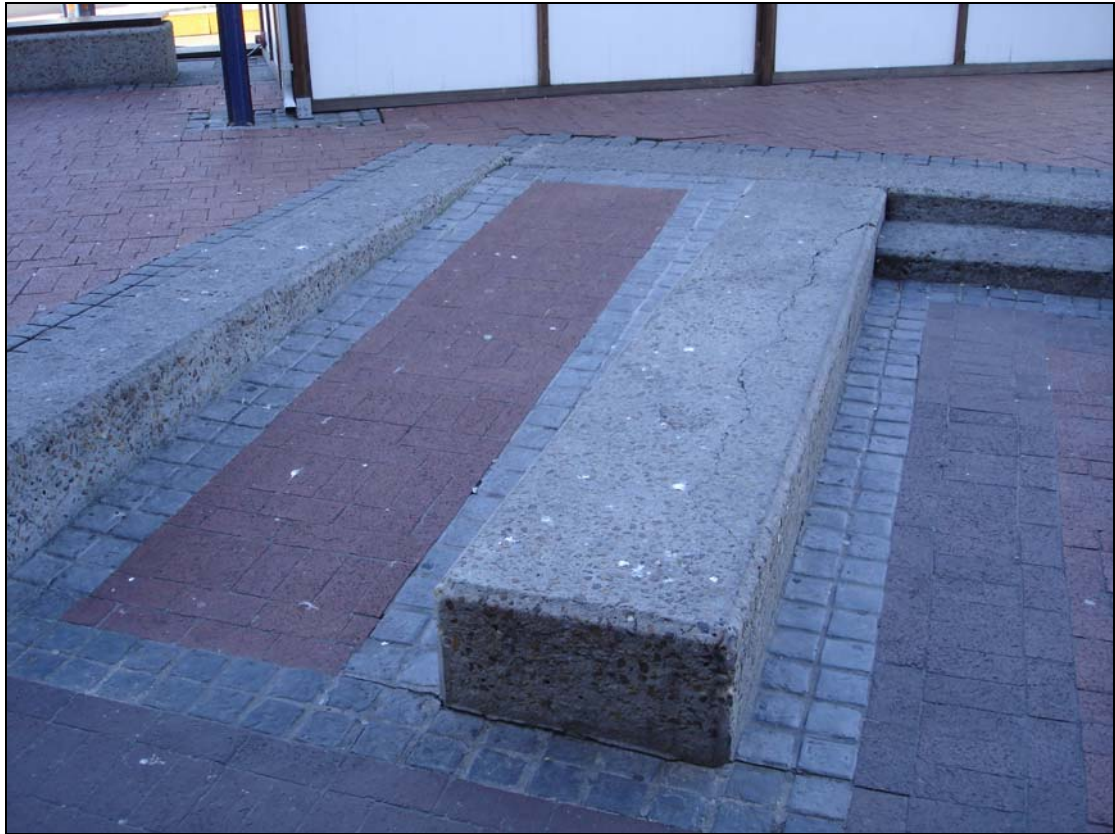
Pictured here is a ramp to afford access to a raised section of ground in the area surrounding the shopping mall.

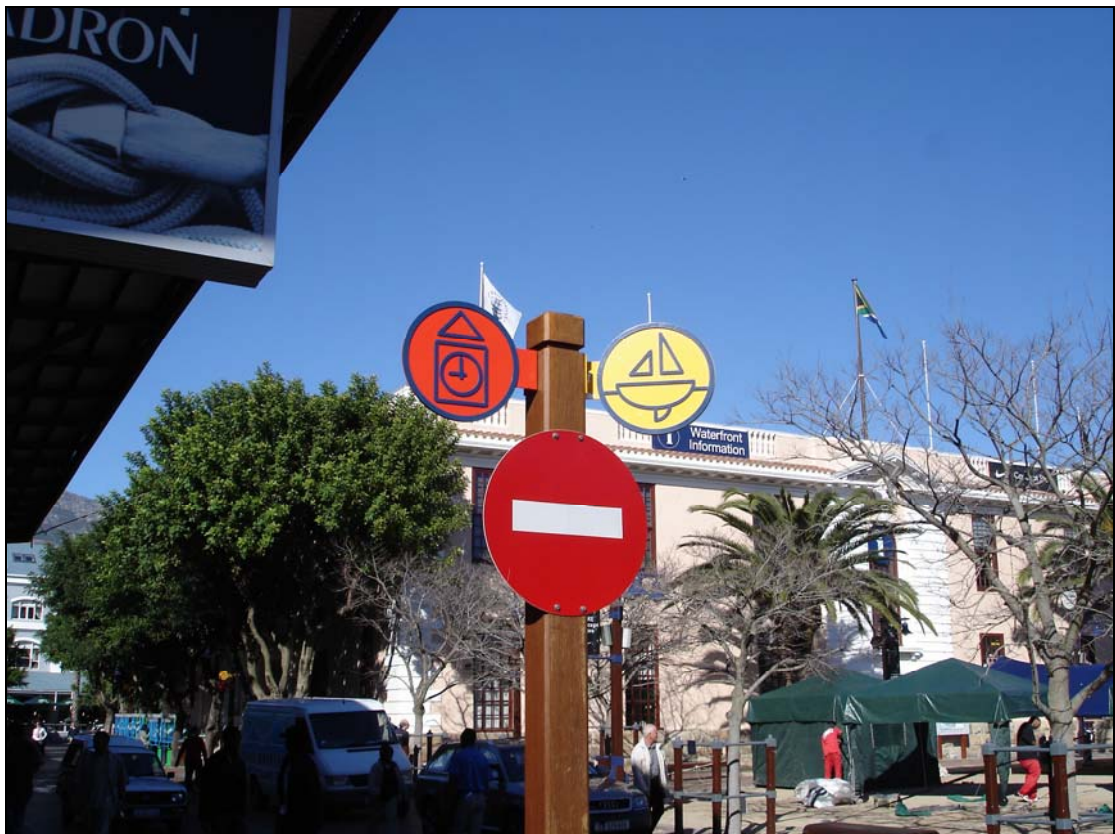
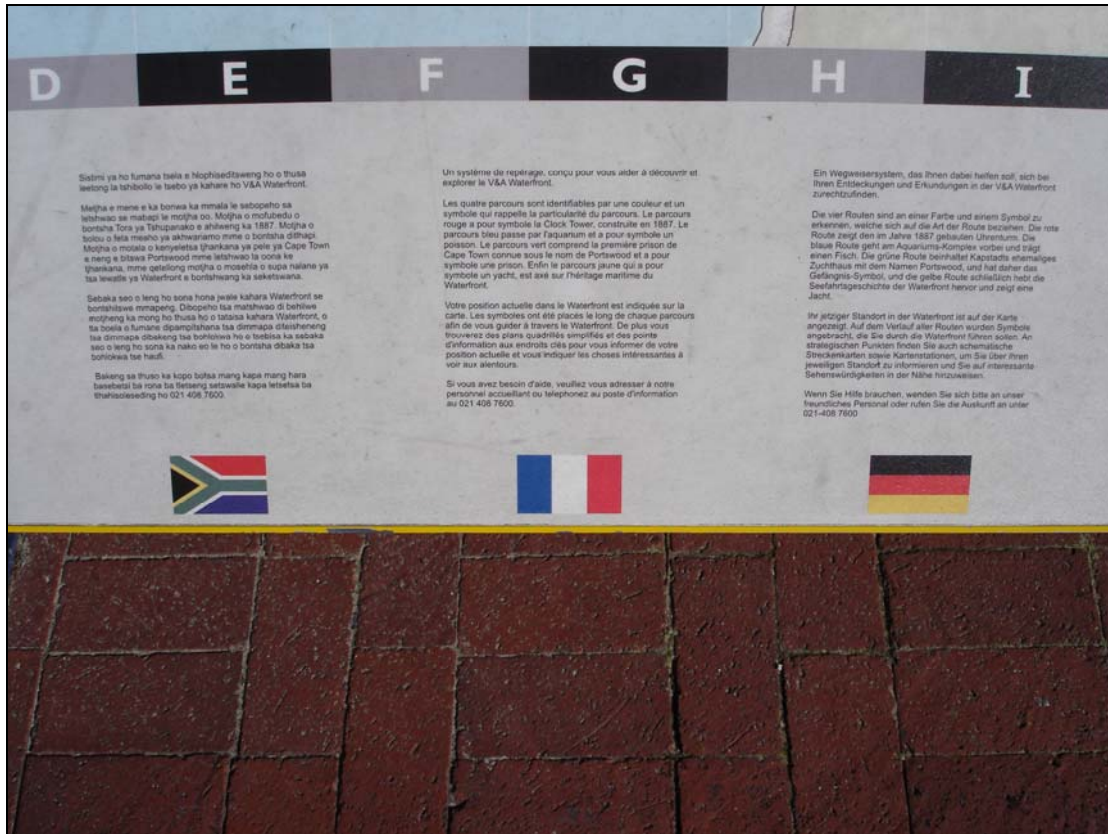
The preceding three photographs show a signage system employed to help individuals navigate around the waterfront, following one a few predefined routes. Each route has its own icon of differing colour and is easily identifiable.

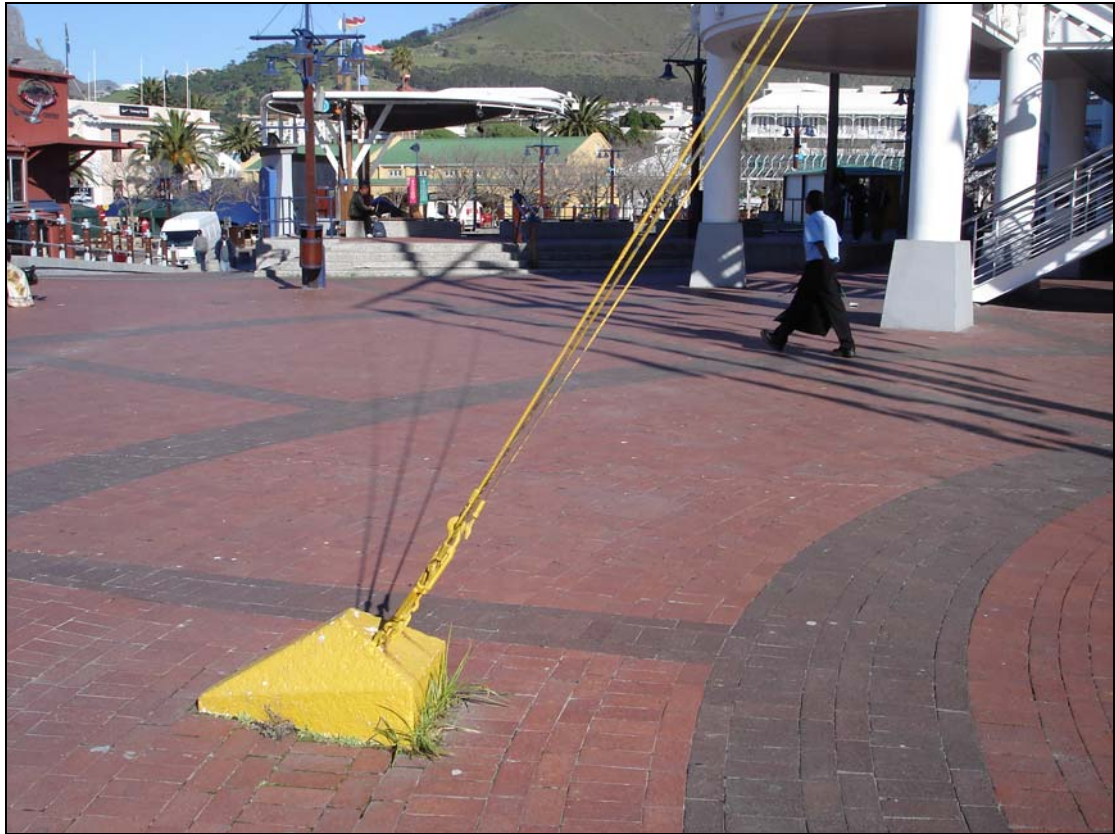
This obstacle, the support of a structure reminiscent of a ships mast, no doubt has seen many head collisions as people walk by.
