## Kirstenbosch Gardens

Kirstenbosch Gardens sees a plethora of visitors on a daily basis, which include school tours, the elderly, and foreign tourists. The gardens seem to represent a universal approach in their efforts to cater for this vast spectrum of individuals.

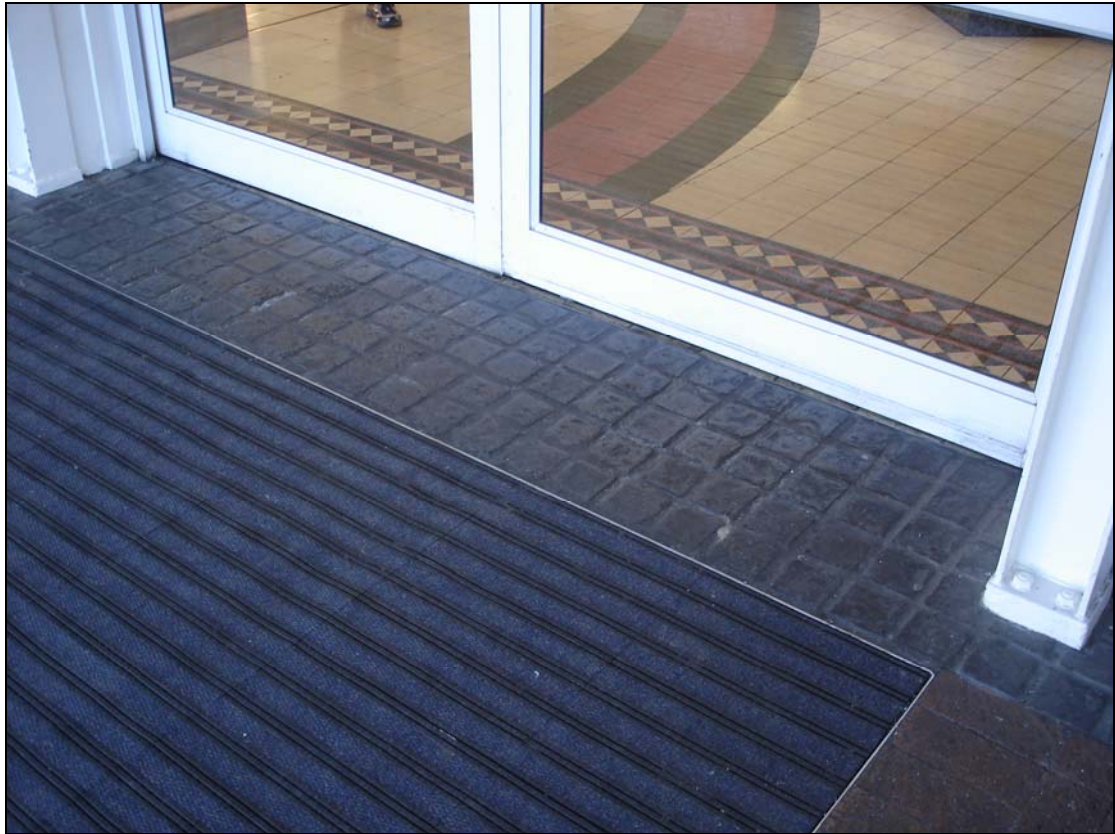
Much the same as the previous entrance pictured, this one has varying surface textures that afford some kind of tactile feedback as to the transition between indoors and outdoors.

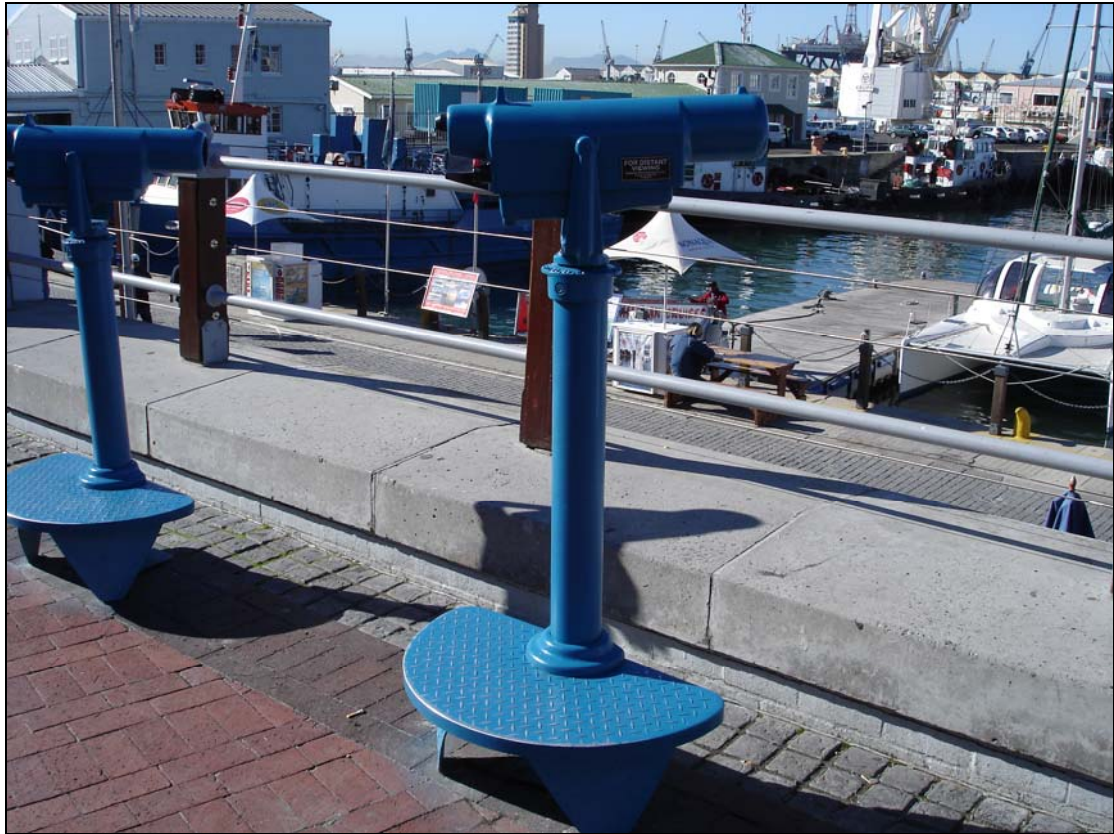
While these viewing telescopes have a small raised platform, either for children or to lean against (both of which I have my doubts as to functionality), it may actually impede certain individuals. Some form of height adjustment mechanism would seem a more appropriate solution.
