**ANALYSIS OF DEFECTS OCCURING ON RAIL TRACKS  
By**

**Thesis submitted in partial fulfilment of the requirements for the degree**

**Master of Engineering: Mechanical Engineering in the Faculty of Engineering**

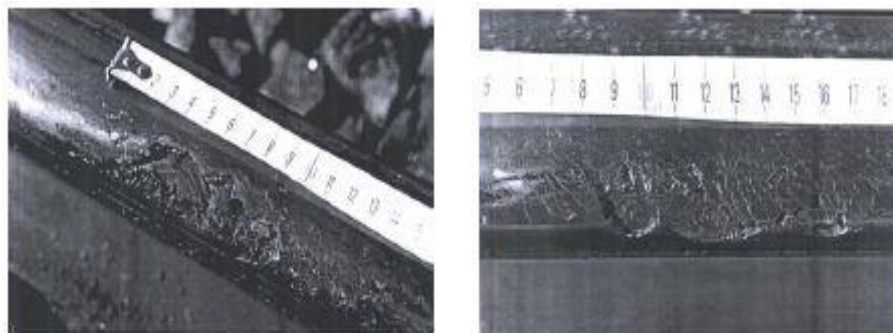
Figure 2.2: Gauge corner shelling in rails [Rhen and Larsson, LTU]

Shelling defect is a direct cause by material loss created by subsurface fatigue, which normally takes place at the gauge corner of high rails in bends [Nielsen and Stensson,1999]. An elliptical shell-like crack spreads in the subsurface comparable to the rail surface. When these cracks occur on the surface, they cause the metal to arise from the crack area. These cracks move in downward direction which might possibly lead to a transverse fracture of rail [Kumar, 2006]. As this is subsurface created deficiency, steel metallurgy plays a significant role in its creation. Traces of oxide inclusion and residual stress development during manufacturing donate in shelling [Esveld, 2001]. Figure 2.2 shows gauge corner shelling which is usually removed by grating.

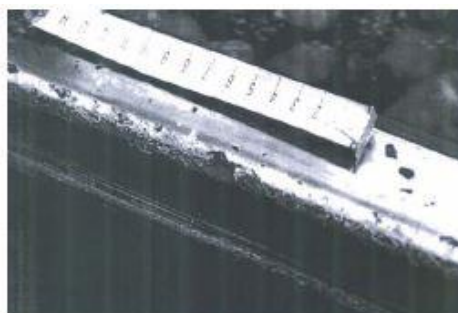
Figure 2.4: Spalling in rails [Rhen and Larsson, LTU]

Spalling is defined as shallow chip of rail material which falls out when the surface-created crack development path is traversed by other comparable surface cracks on the rail head area (see figure 2.4). Uninspected spalling occurs at a much later stage of crack propagation phase. Spalling is occurring mostly on cold climates due to an increased in material stiffness [Nielsen and Stensson, 1999].

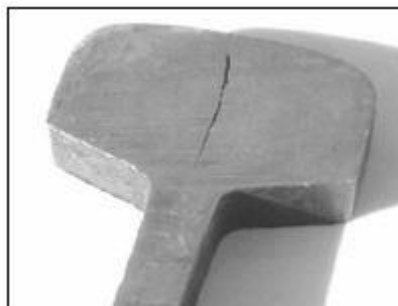
Figure 2.7: Longitudinal vertical crack [Granstrom, LTU]

This is an engineering deficiency, which generally acts in the rail web and may spread into the rail head. If interconnected by some additional crack, it might lead to a premature fracture or rail break. The danger of sudden breakage due to this type of crack is elevated in cold climates. Figure 2.7 shows a longitudinal vertical crack.

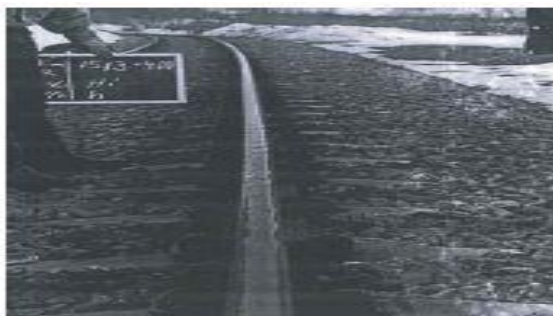
Figure 2.9: Corrugation in rails [Rhen and Larsson, LTU]

Corrugation remains a rail flaw in a wave-like form wearing displaying a periodic unevenness of the rail surface [IHHA, 2001], see Figure 2.9. Rail corrugation exists as the result of a damage mechanism, such as wear, fatigue or plastic flow functioning at about characteristic frequency which does not pose any instantaneous derailment risks but they might be accountable for loosening of rail fasteners, ballast worsening, upsurge in noise and vibration level leading to customer anxiety. [Magel and Kalousek,2002]. Numerous reasons may be the reason for corrugations but it is challenging to connect these causes of corrugation at diverse rail sections.

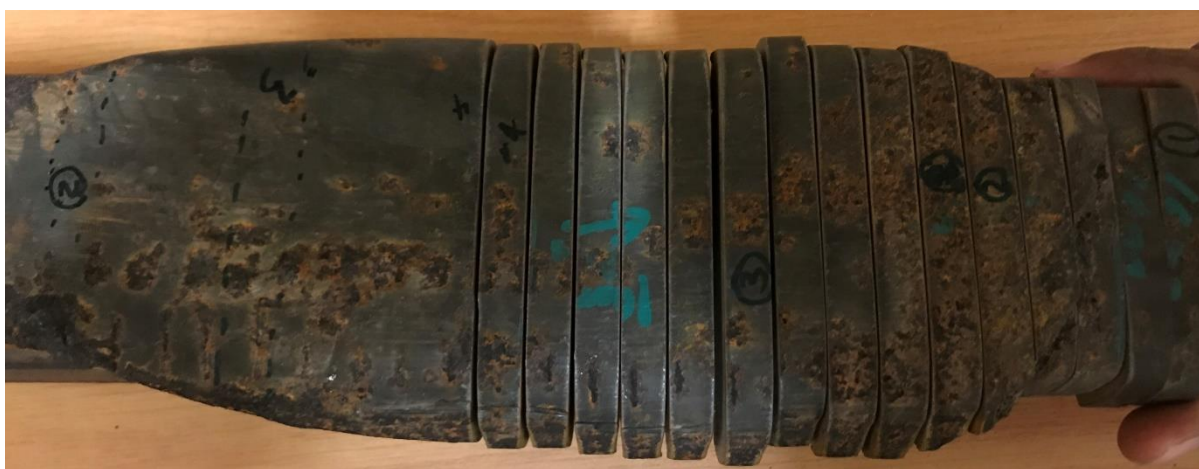
Figure 3.1: Damage Rail Track

A water-jet cutter was used to cut the damage rail track into 10mm pieces of which four pieces was chosen to be analysed. These four pieces were labelled as specimen 1, 2, 3 and 4 (see figure 3.1). The four 10mm pieces were than hot mounted into a conventional hot mounting press. Lastly, the specimens were grinded, polished and etched to finally get these specimens ready for characterization. These test samples analysis and preparation were done at the Mechanical Engineering laboratory of Cape Peninsula University of Technology, Bellville Campus. Details on the processing with the apparatus that were followed during the experimental procedure are discussed below.

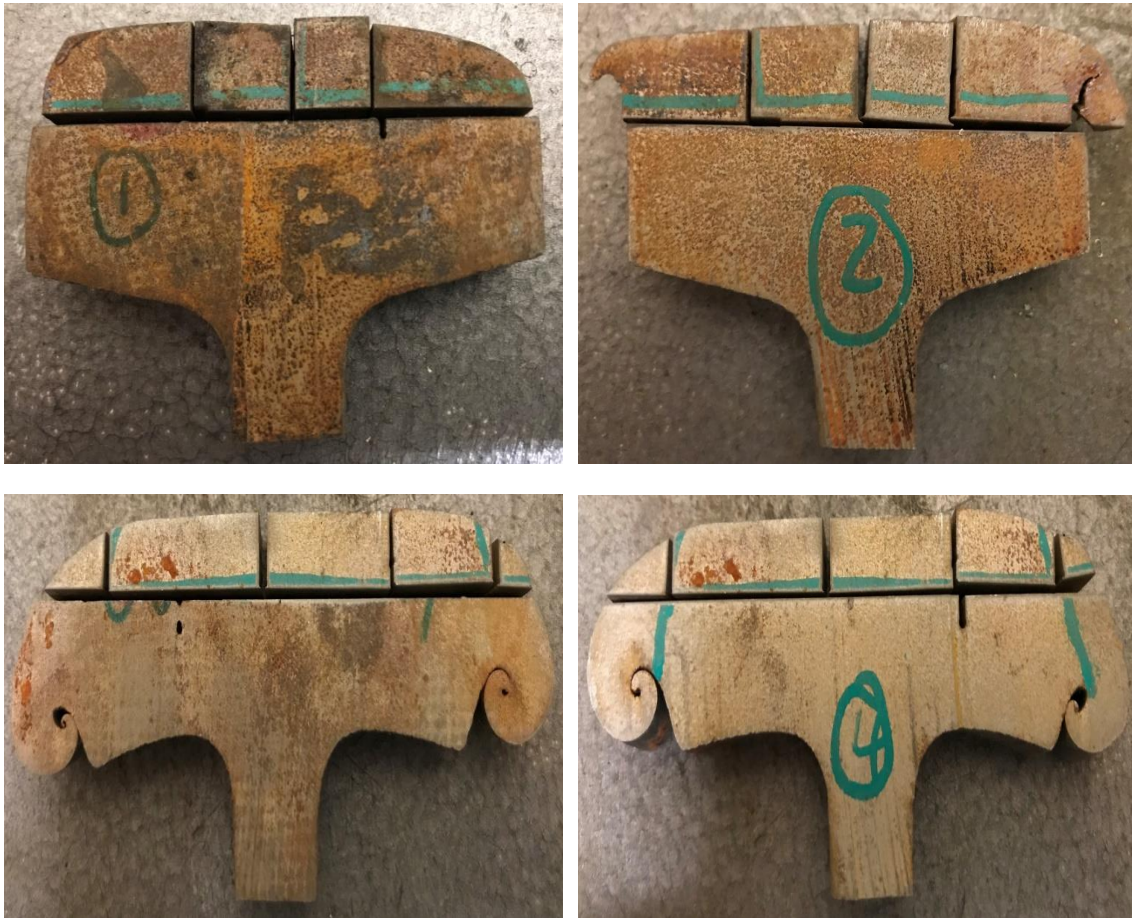
This is an industrial tool capable of cutting a wide range of materials by means of a very high-pressure jet of water or a combination of water and an abrasive material. Due to the minimum heat transfer to the microstructure during the cutting process,

Figure 3.2: Steel rail sample cut into four 10mm pieces

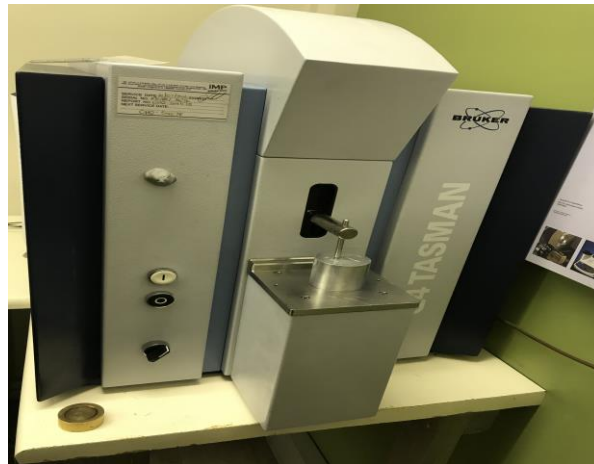
This X-ray has the energy which is characteristic of the energy difference between these two shells. It depends on the atomic number, which is a unique property of every element. In this way, X-rays identify the type of each element that exists in this sample.

Figure 3.5: Q4 Tasman scanning electron microscope (SEM) coupled with electron dispersion X-ray spectroscopy (EDX)

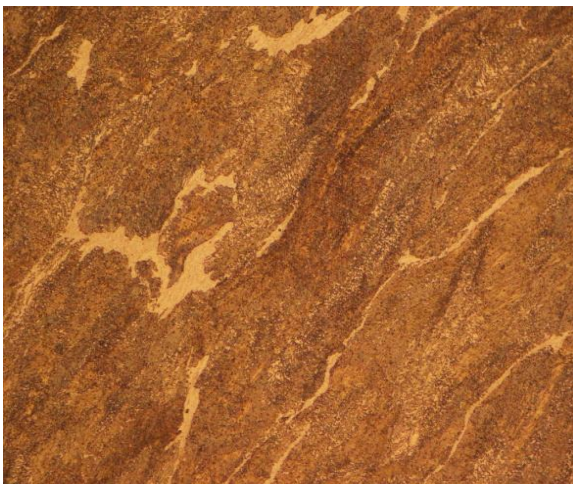
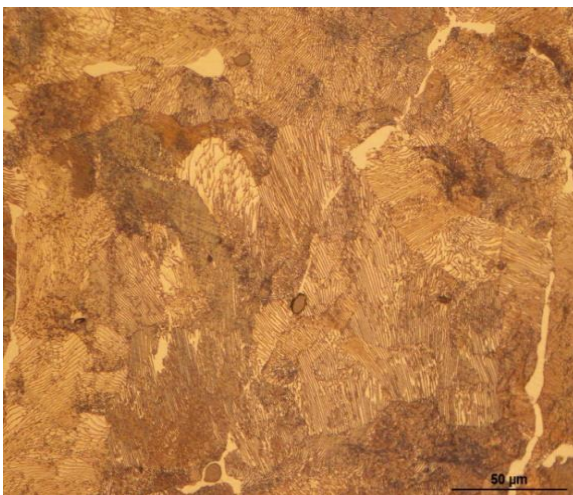
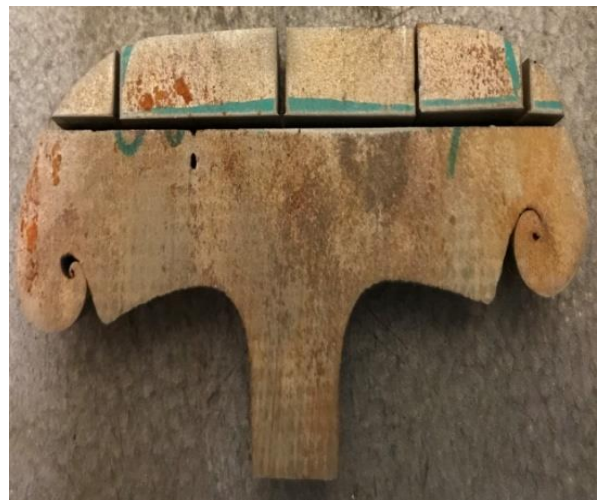
A steel specimen was examined under an optical microscope as presented below.

Looking at the top surface of specimens, it is evident that decarburization occurs to a certain depth per specimen. Decarburization is the process opposite to carburization, namely the reduction of carbon content. Decarburization occurs when carbon atoms at the steel surface interact with the atmosphere and are removed from the steel as a gaseous phase. Carbon from the interior diffusion towards the surface, moving from high to low concentration and continues until above the upper critical temperature,  $AC_3$ . From temperatures in the two-phase region, between lower critical temperature,  $AC_1$ , and, upper critical temperature,  $AC_3$ , the process is more complex. Carbon diffusion rates in ferrite and austenite are different and are influenced by both temperature and composition.
