STANDARD PROTOCOLS FOR RESTORING HERITAGE CEMENTING MATERIALS

A thesis submitted to the Faculty of Engineering and the Built Environment
Department of Civil Engineering and Surveying
in fulfilment of the requirements for the degree of
Master of Engineering: Civil Engineering at

Cape Peninsula University of Technology

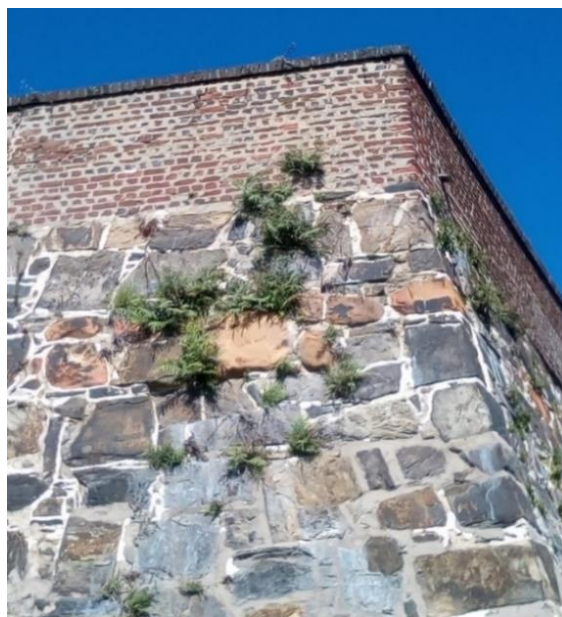
Figure 2.3 Biological colonisation: Castle of Good Hope, South Africa

According to Ngoma (2009), microorganisms such as algae, lichens and fungi generally cause minor damage to masonry when compared to other factors such as air pollution or soluble salts. In addition to microorganisms, plants tend to grow in between masonry joints as depicted in Figure 2.3. This could lead to mortar chipping off as the plants are de-rooted, thereby affecting the structure's integrity.

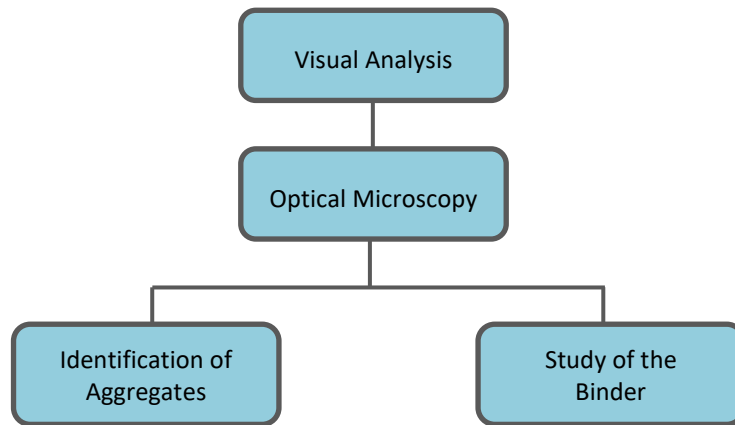
Figure 2.4 Mortar analysis procedure (Van Balen *et al.*, 1999; Palomo *et al.*, 2014)

The reverse engineering process provides an answer to the question: What cementing material (type of binder, aggregates and additives) was originally used for the construction of the heritage building? The process is presented in Figure 2.4. Additionally, a study by Hauková *et al.* (2013) highlights the importance of characterising not only historic building materials but also the modern materials prior to restoration.

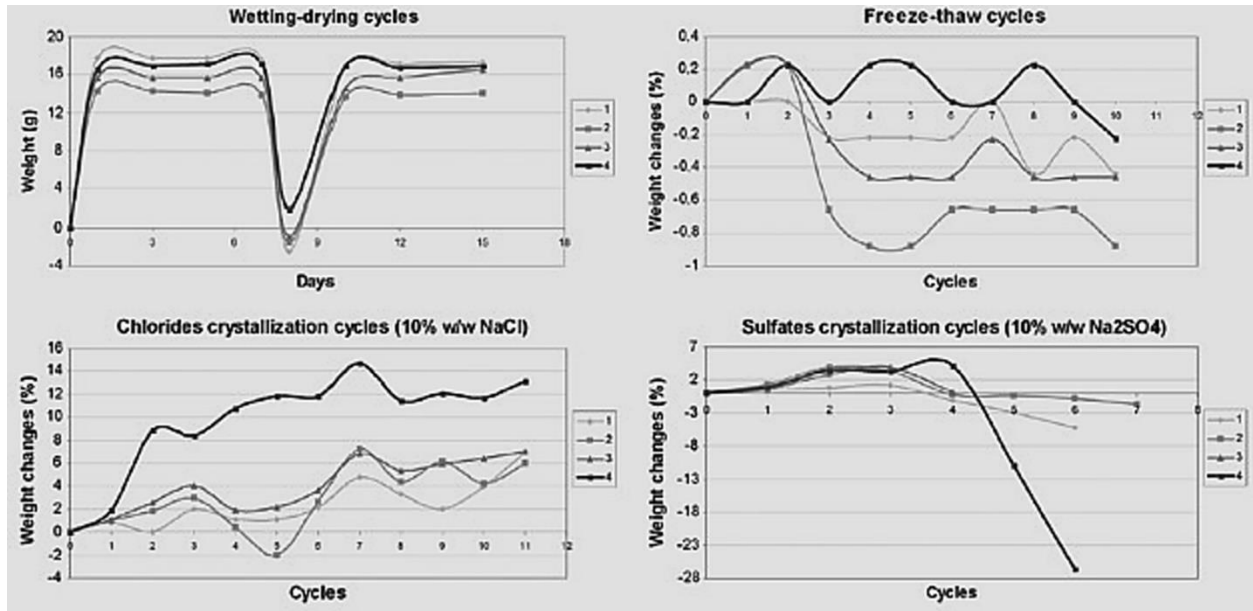
Figure 2.8 Ageing tests of repair mortars (Papayianni *et al.*, 2013)

The results obtainable from the physical ageing tests are presented in Figure 2.8, showing the cycles for each test.

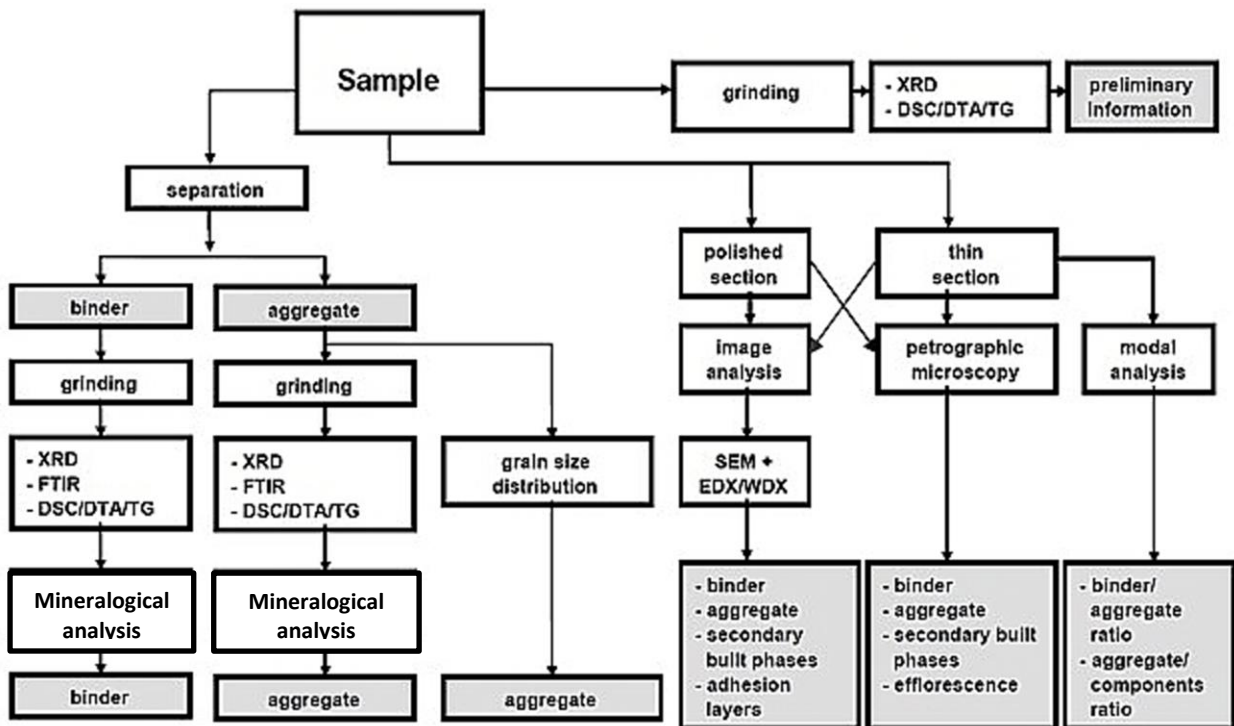
Figure 2.9 Flow chart for mineralogical characterisation (Middendorf *et al.*, 2005a)

To assess the degree of hydration and present quantities of calcium hydroxide/slaked lime ($\text{Ca}(\text{OH})_2$) and calcium carbonate/limestone (CaCO_3), thermogravimetric analysis (TGA) and Fourier transform infrared spectrometry (FTIR) are among other methods used. All these tests provide details of the minerals present and their quantities in a mortar sample, while FTIR gives the ratio between the CaCO_3 and SiO_2 content. These two tests require less than 2 mg of samples to conduct. The process of mineralogical and petrographic characterisation of historic mortars is illustrated in Figure 2.9.

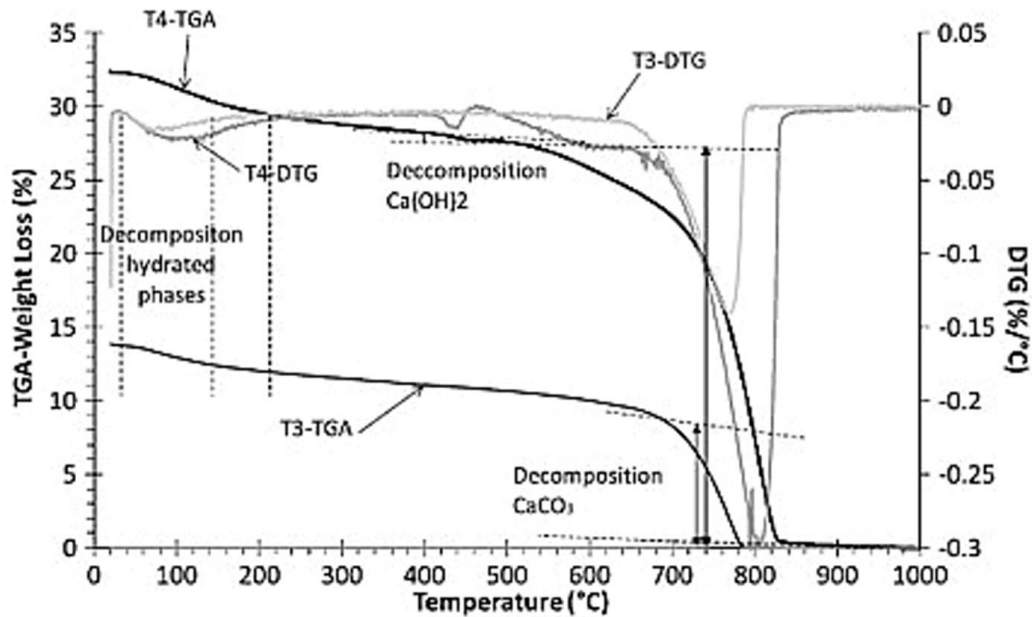
Figure 2.11 TGA/DTG (Schueremans *et al.*, 2011)

On the other hand, DTA deals with exposing the sample to heat for the loss of chemically bound components in a mortar sample. These could be water from gypsum or carbon dioxide from calcite and dolomite. DTA is further used to identify endothermic or exothermic transitions of particular minerals. Figure 2.11 shows an example of the results obtained from a TGA/DTG analysis.

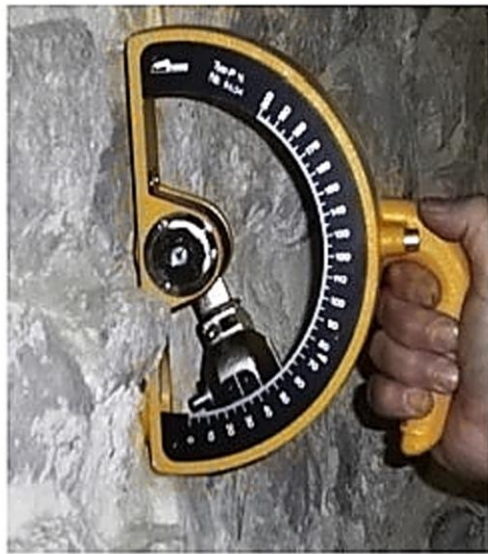
Figure 2.13 Pendulum Schmidt hammer (Schueremans *et al.*, 2011)

(UPV) tests to mention but a few. In addition, Benedetti and Pelà (2012) provided an example of obtaining mechanical properties using an in-situ penetrometer technique. This method is carried out to measure the energy required to penetrate a masonry structure by means of drilling resistance. Due to scattered results, this technique requires caution when combining and analysing results.

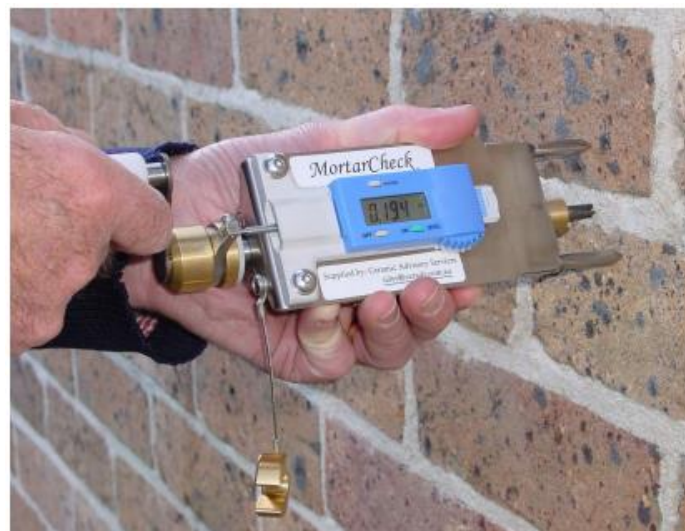
Figure 2.14 Mortar Scratch test (Lawrence *et al.*, 2004)

In addition to the testing techniques outlined by Schueremans *et al.* (2011), a field test (scratch test), shown in Figure 2.14, was suggested. This is an NDT method which formulates a relationship between the scratch index and cement content in historic mortars. The test sensitivity could be altered by changing the form of the probe, the spring force and/or changing the number of turns used to make a measurement. It is to be noted that there is a possible difference in surface and inner mortar hardness due to the susceptibility of surface areas to attack by environmental factors.

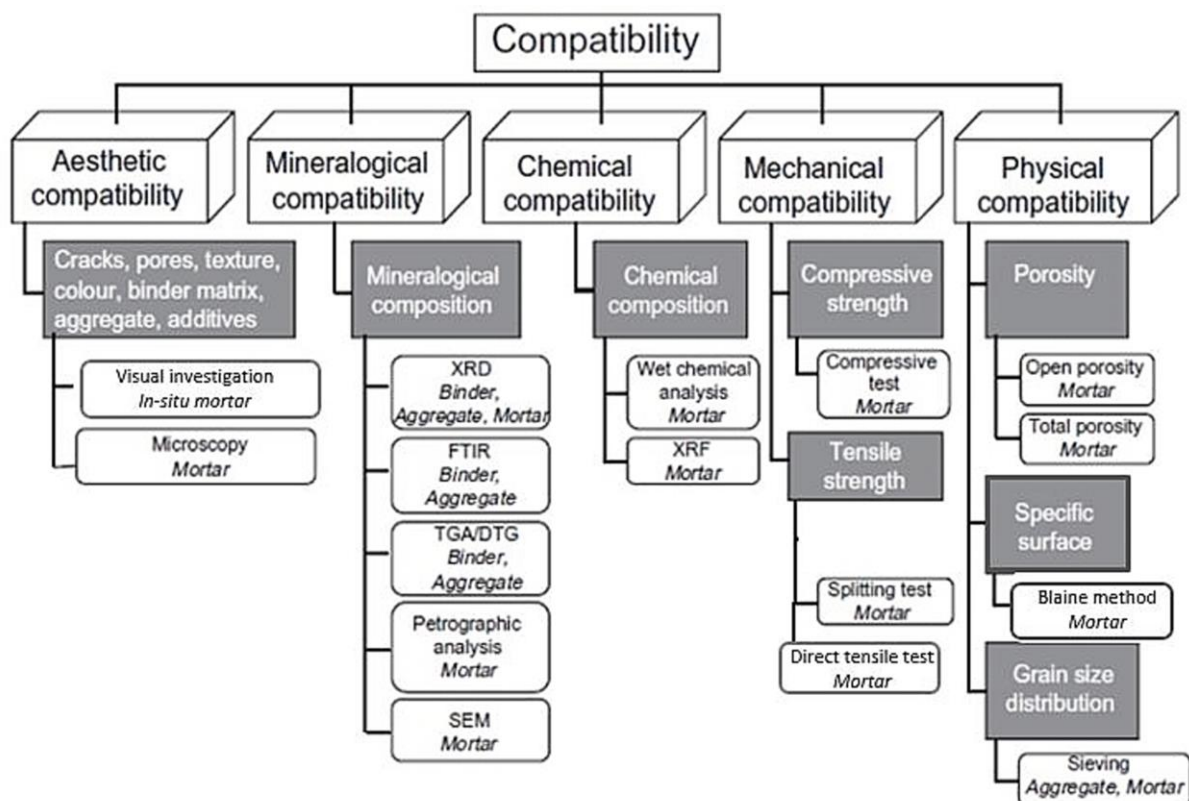
Figure 2.15 Compatibility assessment (Schueremans *et al.*, 2011)

It is vital to carefully select a number of tests to study the properties of the original mortar to ensure compatibility with the repair mortar. Figure 2.15 summarises the overall conventional characterisation techniques for achieving compatibility on historic mortars. The knowledge of original material properties makes it possible to foresee how the historic structure will react with restoration materials applied to it. Such critical information can only be achieved through original material characterisation.

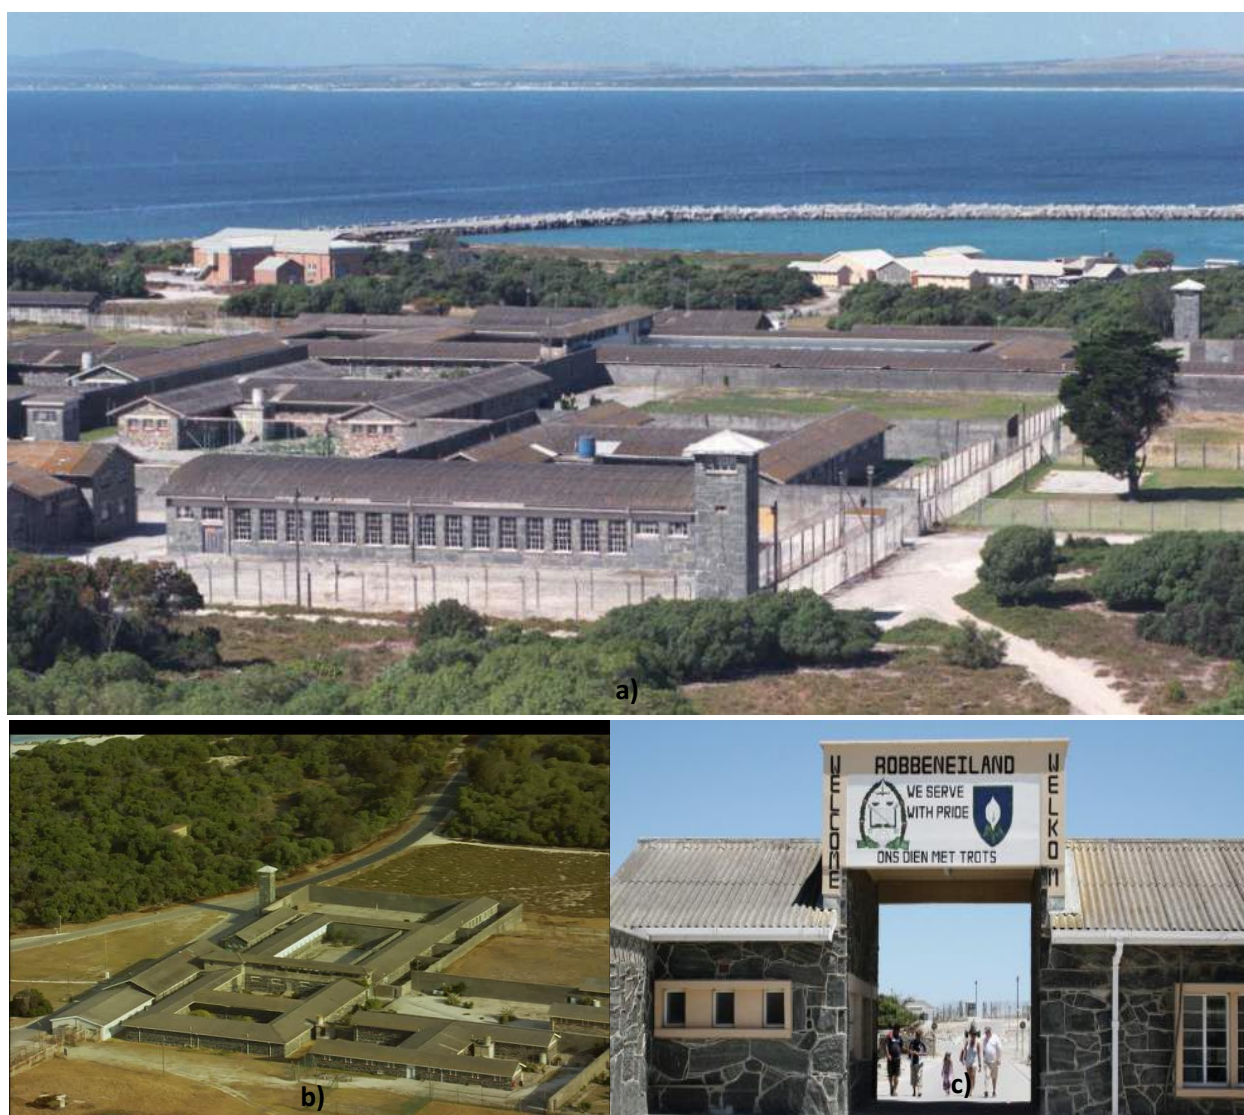
Figure 3.4 a) Robben Island elevation b) Plan c) Entrance side view (Robben Island, 2018)

This world heritage site is located in Table Bay. It was used as a maximum-security prison, with some additions made during the 19th century, and is now a museum. Like the castle, Robben Island was constructed with stone masonry, as depicted in Figure 3.4. The different material eras were collected for analysis and comparison from the structure.

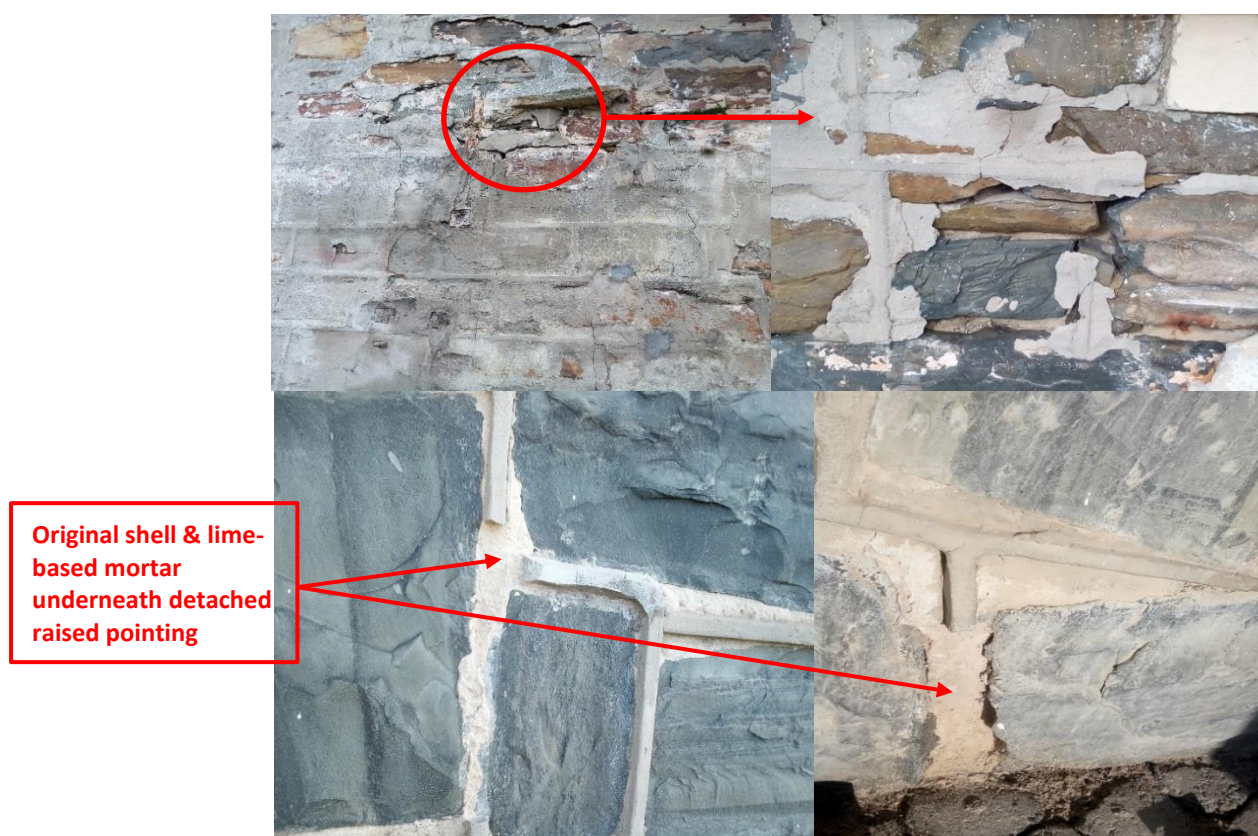
Figure 3.5 Recent failing repairs – Robben Island

It was evident from visual inspections and the contents of the Conditional Assessment of Buildings on Robben Island (2018) by Charles Consult Consortium that the island has undergone maintenance and repair works in recent years (1999 onwards). In this assessment report, it was stated that the repairs on the wall pointing did not consider how air circulates through wall sections and how condensation and dampness were to be treated. It has been concluded that the repair work caused further damages to wall sections of the island. The need for material analysis prior to restoration of heritage structures is emphasised further in the assessment report. SAHRA has proposed maintenance work to rectify the previous restoration mistakes on the island. The deterioration seen on some of the oldest buildings on the island is shown in Figure 3.5. Regrettably, the material used for repair proved to be incompatible with both the original mortar and the masonry surface itself, and thus are seen to be detaching from the original surface on both the maximum-security prison (1700s) and the pre-primary school building (1800's). The original material underneath the repair material was lime-based while the repair materials are Portland cement which are impermeable. This has caused the moisture movement problems on the wall structure and repair materials peeling off.

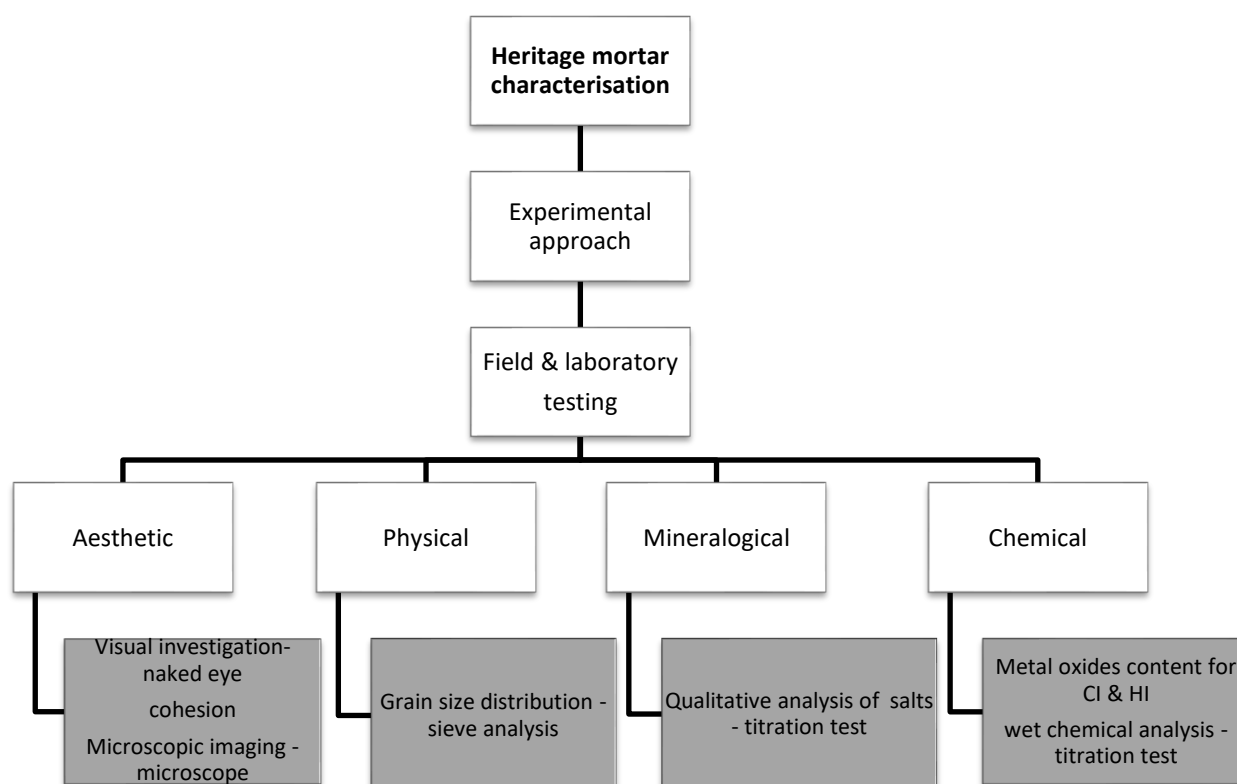
Figure 3.6 Experimental flow chart

According to the literature (Table 2.6), there are several techniques available for the analysis of historic mortars that many researchers have used in the past. However, it was concluded that not all could be considered economically viable. Thus, in order to achieve the objectives of this study, the experiments conducted were identified as the affordable (cost, time and expertise-wise) using the selection criteria in Table 3.2. The first phase of the research involved an experimental characterisation using the preliminary techniques, followed by the final optimisation of the optimum methods.

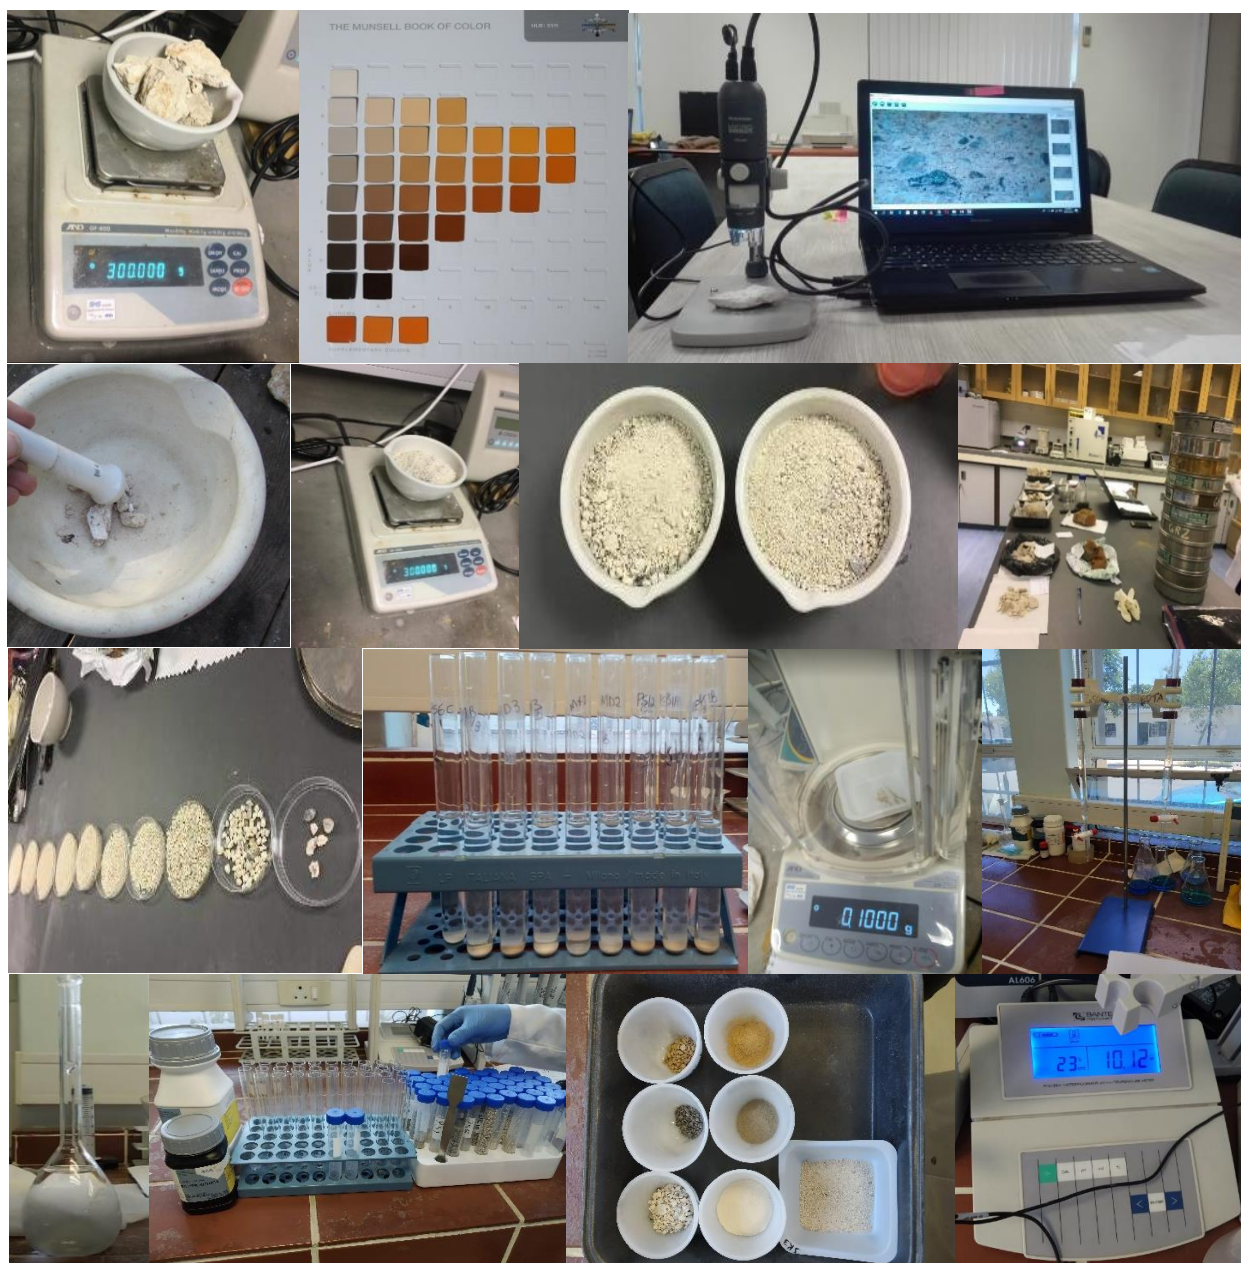
Figure 3.11 Testing equipment

The laboratory instruments used in this research are depicted in Figure 3.12

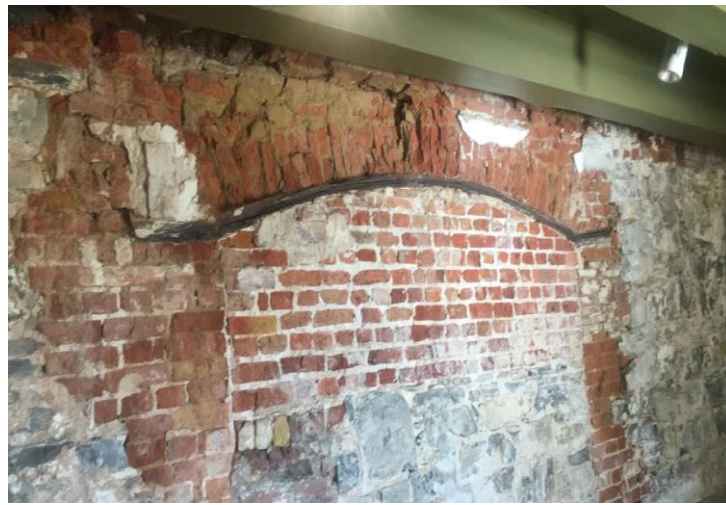
Figure 4.5 The investigated section, Castle of Good- Hope-South Africa

Table 4.2 shows the values for the coefficients of uniformity and curvature and it can be concluded that the mortars from the kitchen wall section (see Figure 4.5) at the Castle were made of uniform soils except for sample 8, which showed a well-graded soil as per the C_u and C_c criteria.

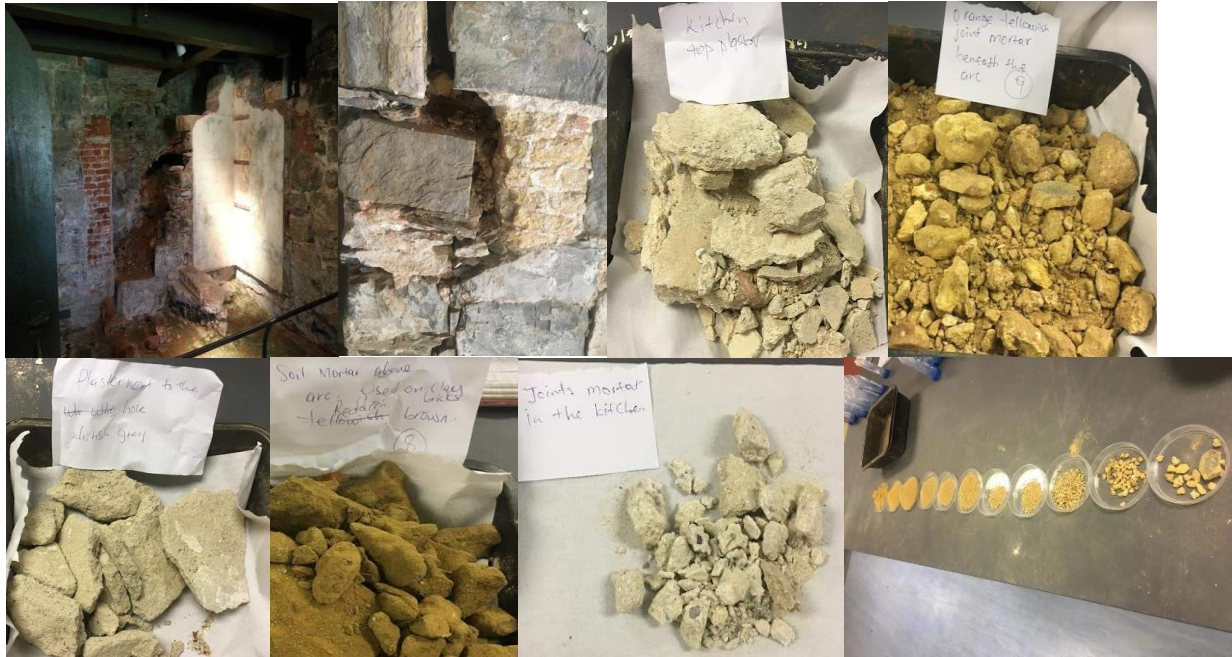
Figure A.1 Castle of Good Hope samples

This section shows the samples collected from the Castle of Good Hope and the Robben Island using the manual hammer-and-chisel method.

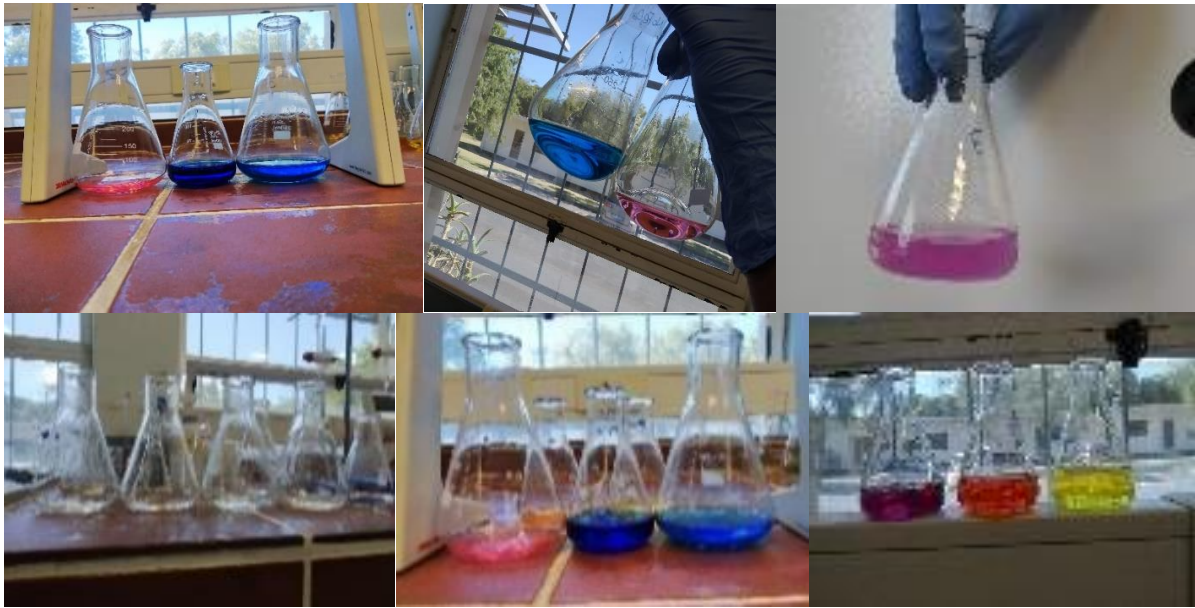
Figure F.1 Colour observations during titration
