Cape Peninsula
University of Technology

**IN-SITU CHARACTERISATION OF THE INSULATOR LEAKAGE CURRENT OF HIGH
VOLTAGE DIRECT CURRENT TRANSMISSION LINES**

Thesis submitted in fulfilment of the requirements for the degree

Doctor of Engineering: ELECTRICAL ENGINEERING

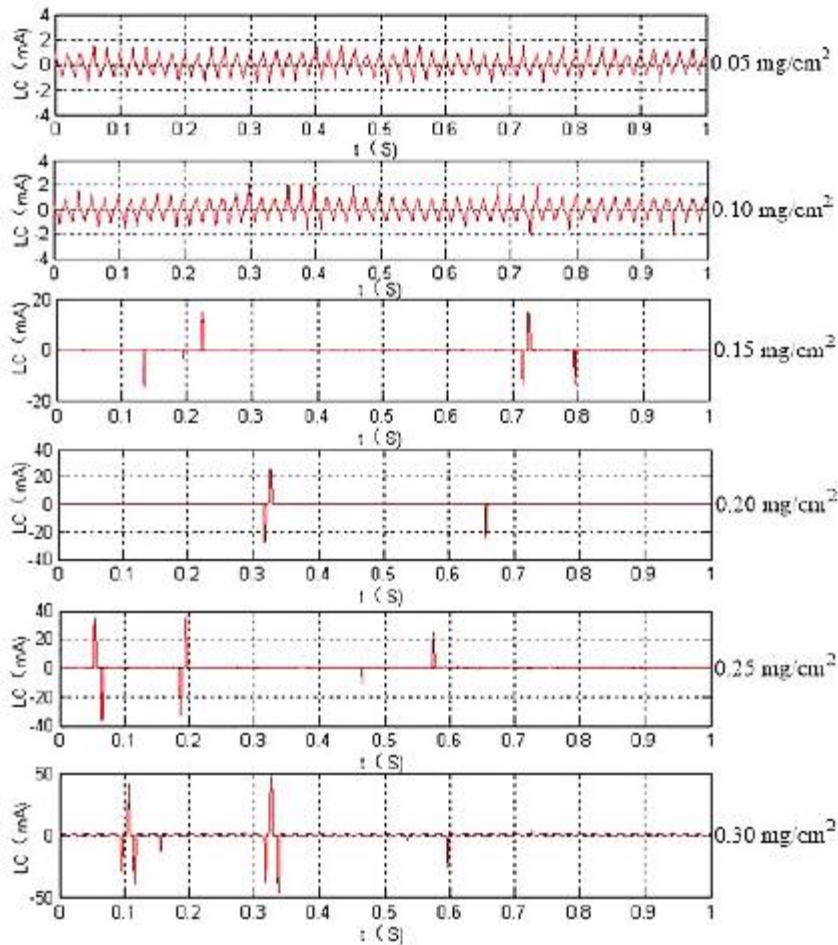
Figure 2.24: Composite insulator LC waveform for different ESDDs (From Zhengfa *et al.*, 2018)

Zhengfa *et al.* (2018) studied LC characteristics and what influences them on a 110 kV ac composite insulator. Figure 2.24 shows the LC waveforms obtained for various ESDDs. It was observed that the LC amplitude increased and the waveform became more distorted as the ESDD increased. Polluted ac insulator tests by studying LC variation have also been performed by Banik *et al.* (2014) and similar results were reported.

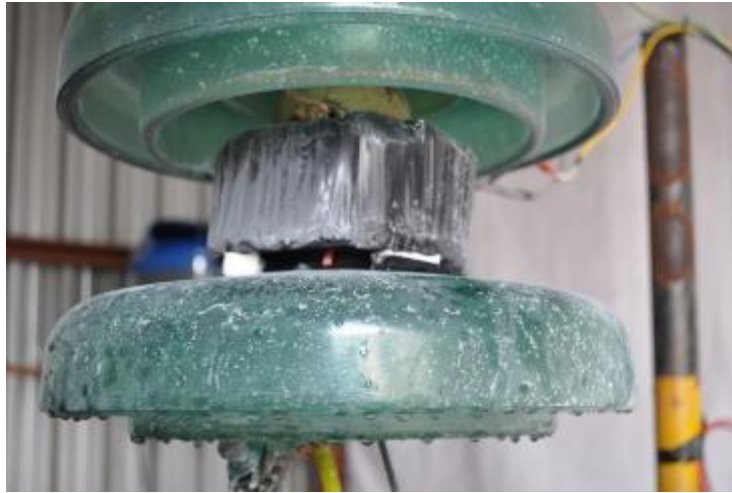
Figure 5.10: Leakage current test setup showing the pollution on the outside of the LCPR1 sensor and insulators (with two stand-off insulators) after testing

Figure 5.10 shows that the insulation tape, which forms part of the LCPR1 sensor’s enclosure, was covered with salt pollution after the tests. This induced salt pollution is a phenomenon that was not anticipated, and that may have affected the results as LC could have flowed on the outside of the LCPR1 sensor. This may have attributed to the LCPR1 sensor having a wider spread in current values compared to that of the shunt as observed in the scatter plot of Figure 5.6 (b).

The contamination of the clean stand-off insulator is also noted. However, as explained in Section 5.2.1, this will not influence the measurements.
