**Evaluation of the Leakage Current Performance of
RTV Silicone Rubber-Coated Glass Samples,
energized under AC, DC+, and DC- in a Controlled
Local Laboratory**

**A thesis submitted in fulfilment of the requirements
for the degree**

Master of Engineering: Electrical Engineering

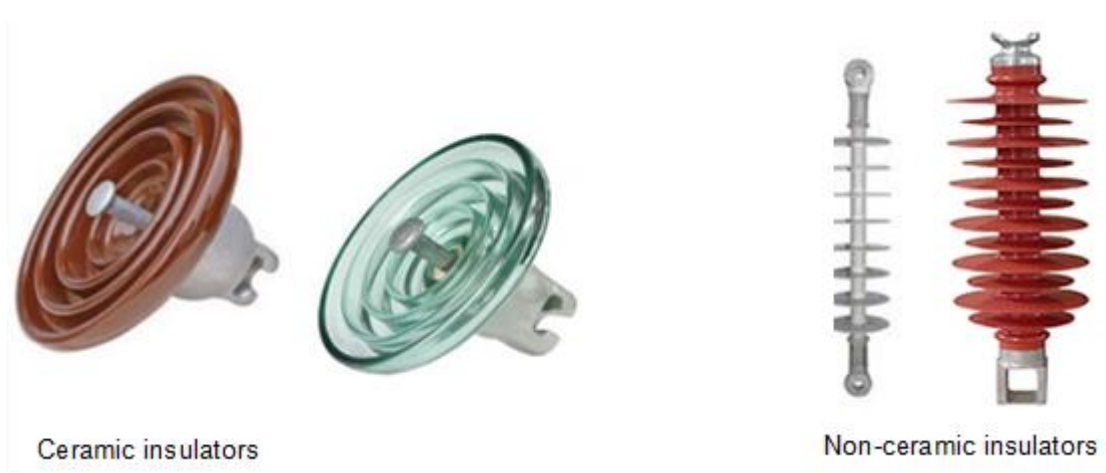
Figure 1-1: Ceramic and non-ceramic insulators

Because polymeric insulators can work efficiently in varied climatic conditions, they have gained popularity as high-voltage transmission insulators (Darwison *et al.* 2019). The superior material used in manufacturing polymeric insulators allows for easy handling during installation and maintenance by washing (Izadi *et al.* 2017). Figure 1-1 shows the different types of insulators (i.e. ceramic and non-ceramic).

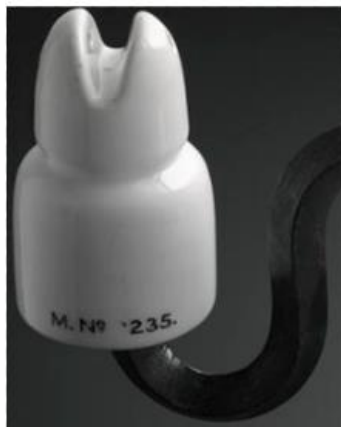
Figure 2-1: Porcelain insulators for aerial lines (1820-1877)

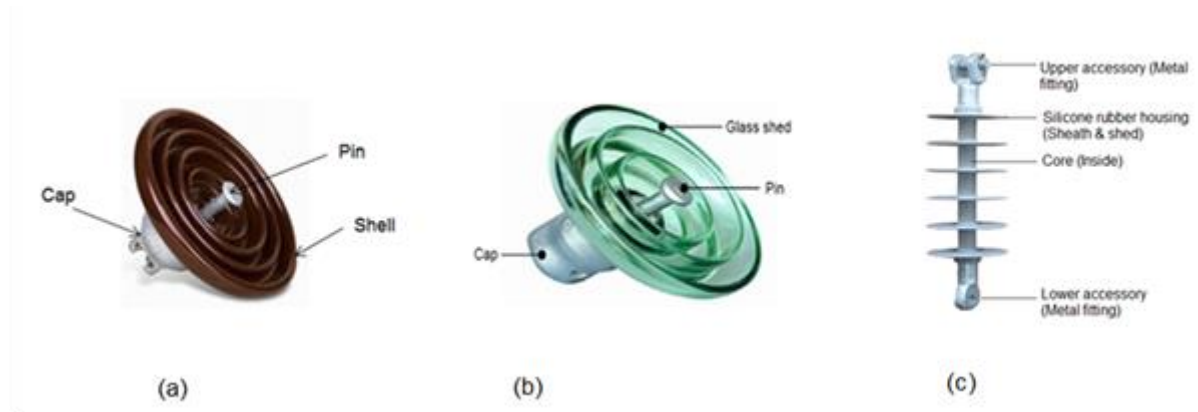
Figure 2-2: High-voltage insulators (a) porcelain (b) glass (c) polymeric

In distribution and transmission overhead lines, there are three main types of outdoor insulators: porcelain, glass, and polymeric insulators (Lan & Gorur, 2008). Figure 2-2 illustrates the different types of insulators.

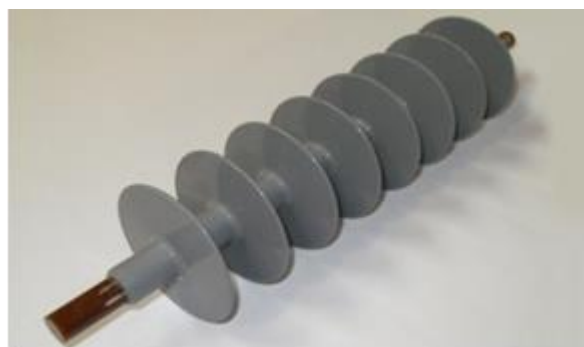
Figure 2-3: HTV silicone rubber insulator

It has been more than 30 years since high temperature vulcanised (HTV) silicone rubber (SR) was used as housing for high-voltage insulators in power transmission and distribution systems, according to Haddad *et al.* (2014). HTV-SR insulators, as shown in Figure 2-3, are widely used as outdoor insulation in power transmission and distribution systems (Chakraborty & Reddy, 2017).

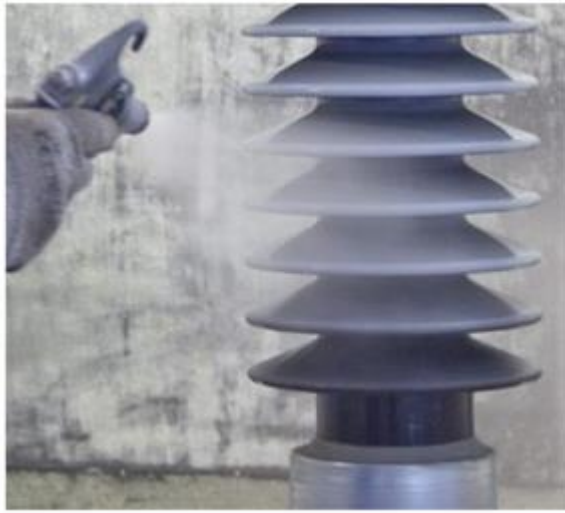
Figure 2-5: Spray painting of high-voltage insulator with RTV-SR coating

Silicone rubber is available in two forms: high temperature, vulcanised (HTV) elastomer for weather sheds, or room temperature spray for porcelain or glass insulators (Theodoridis *et al.* 2001). RTV-SR coatings are available in a liquid state and, when applied to the surface of the insulator, form a hard rubber-like layer (Siderakis *et al.* 2011). Their adhesion to ceramic insulators, their permeability to tracking or erosion, and their ability to prevent leakage currents are important characteristics of RTV-SR coating systems (Ilhan & Aslan, 2020). The application of RTV-SR coating is demonstrated in Figure 2-5 below.

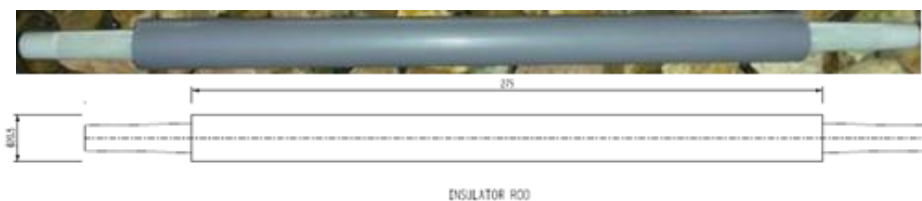
Figure 3-1: HTV-SR extruded onto glass fibre test samples (6x)

To achieve the objectives of this study, as stated in § 1.5, a set of two RTV-SR coated borosilicate glass test samples and two HTV-SR extruded onto glass fibre test samples were chosen accordingly (see Figure 3-1 and Figure 3-2).

The test samples displayed were manufactured by GlassChem in Stellenbosch. The important insulator dimensions of the HTV-SR and RTV-SR test samples are summarised in Table 3-1 below.

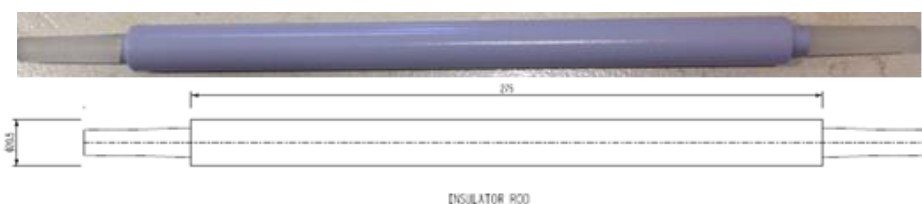
Figure 3-2: RTV-SR coated borosilicate glass test samples (6x)

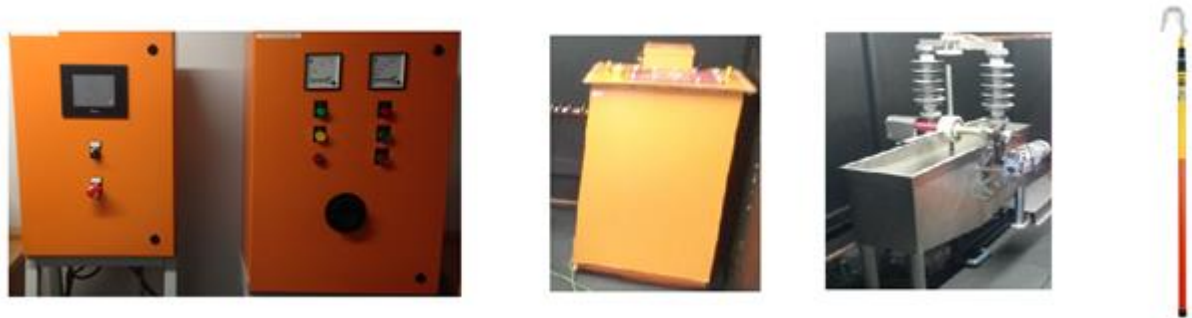
Figure 4-2: Overview of the test apparatus inside insulated shipping container:
(a) control panels (b) 30 kV transformer and DC rectifier (c) RWDT and (d) HV earth stick

Figure 4-2 illustrates the control panels, the transformer and DC rectifier, the rotating wheel dip test and the high-voltage earth stick. These devices are instrumental for the performance of the tests (AC, DC+, and DC-) in this study.

Figure 4-2 below shows the test devices secured in a white insulated shipping container of approximately 5 m in length in the test facility. According to the Research, Testing and Development technical staff, this container was procured to address the pollution performance of high-voltage insulators in various pollution conditions and other related insulator issues in the industry.

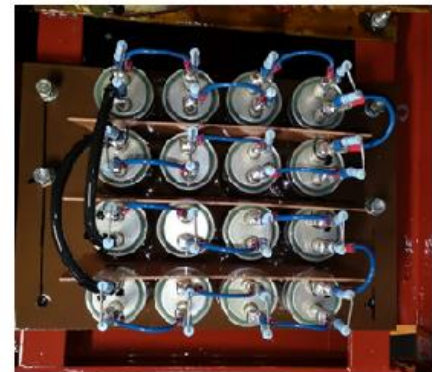
Figure 4-5: Capacitor bank

The capacitor consisted of sixteen smaller 0.47 μF electrolytic capacitors, 4200 VDC / 2500 VAC, stacked in series (see Figure 4-5 above). To ensure that the voltage across the capacitors remains balanced, 1.5 MΩ resistors have been shunted with each capacitor.

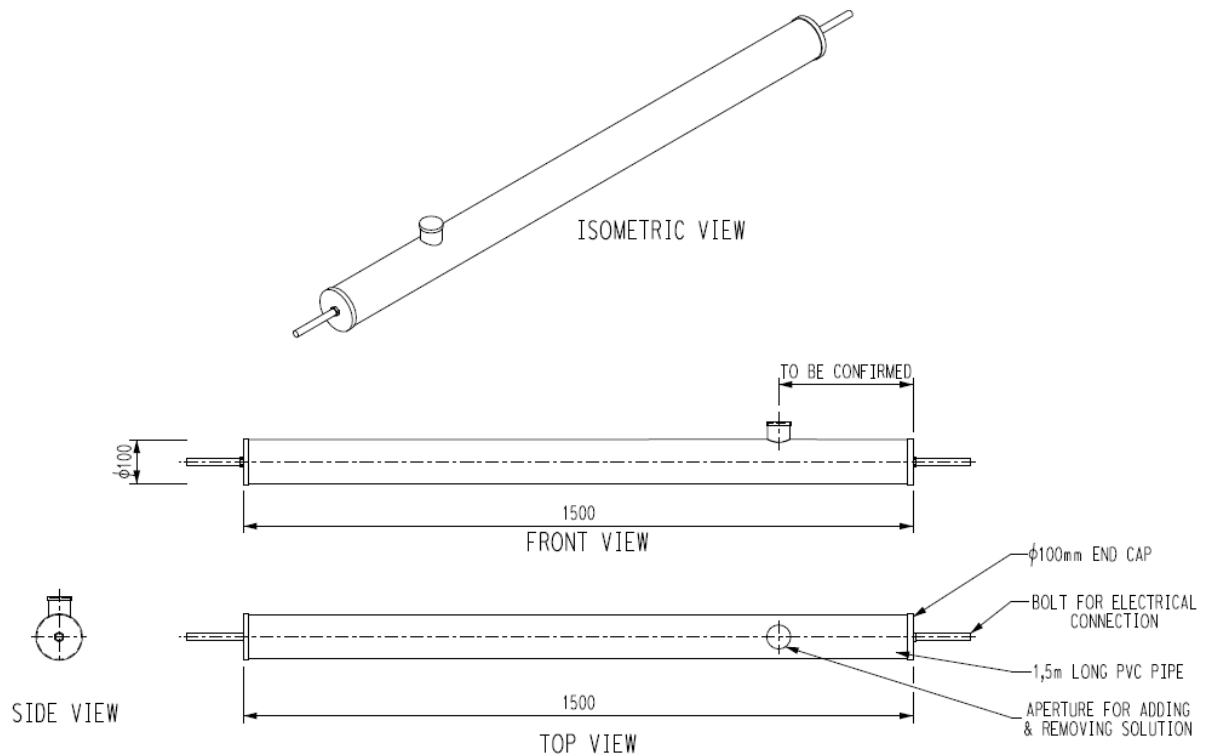
Figure 4-6: Basic design drawing of a sodium chloride (NaCl) water resistor

The water resistor was expected to perform acceptably under normal and fault conditions (as might happen in those conditions). This was verified by means of numerous high-voltage tests. Figure 4-6 shows a basic design drawing of a water resistor, and Figure 4-7 shows a fully constructed water resistor using a PVC pipe.

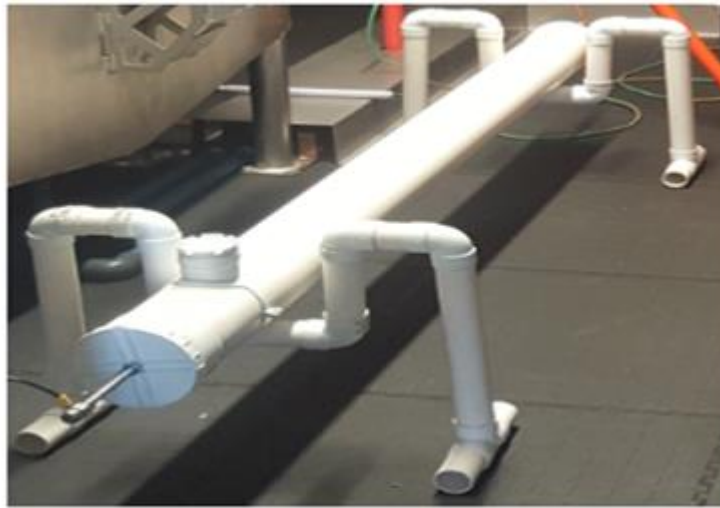
Figure 4-7: Fully constructed sodium chloride (NaCl) water resistor

For the setup, the following components were required: a sodium chloride (NaCl) water resistor with two copper electrodes fixed at the ends (see Figure 4-7), distilled water, a supply of 10 kV, a digital multimeter and a current clamp. Figure 4-8 depicts the load test schematic diagram.

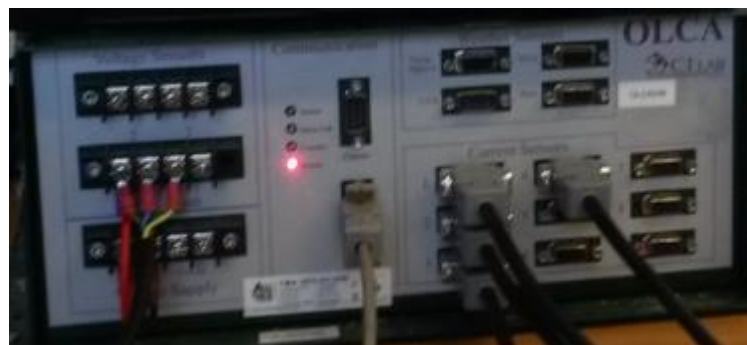
Figure 4-9: Front view of the OLCA used as a leakage current data logging device

The data logging device (see Figure 4-9) was used to record data in the current study. It is called an online leakage current analyser (OLCA). OLCA is a microprocessor-based data acquisition system developed by a South African company, CT Lab (Pty) Ltd, to record leakage current data and specific weather data. Nine channels are available for leakage current measurements, three for voltage measurements, and four more to record weather data (Bogias, 2012; Mouton, 2012; Heger, 2009; Vosloo, 2002; Elombo, 2012; Swinny, 2021).

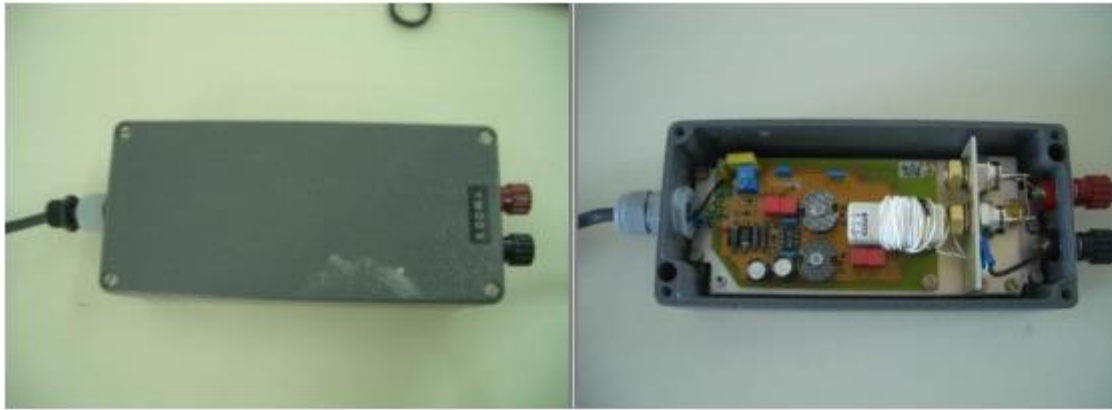
Figure 4-11: Photo of the Hall sensor

Figure 4-11 depicts the Hall sensor with and without its exterior housing. The inner circuit consists of a Hall coil and many integrated circuits, capacitors, and resistors to amplify and transfer the signal from the input (current) to the analogue output (voltage).

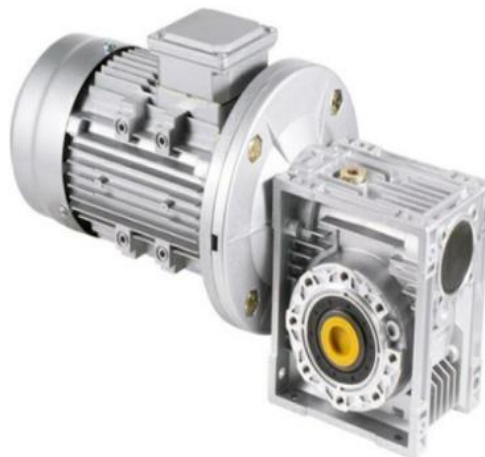
The motor provides simple speed control and responds fast to starting and stopping the wheel (see Figure 4-17).

Figure 4-17: Worm-gearred drive motor

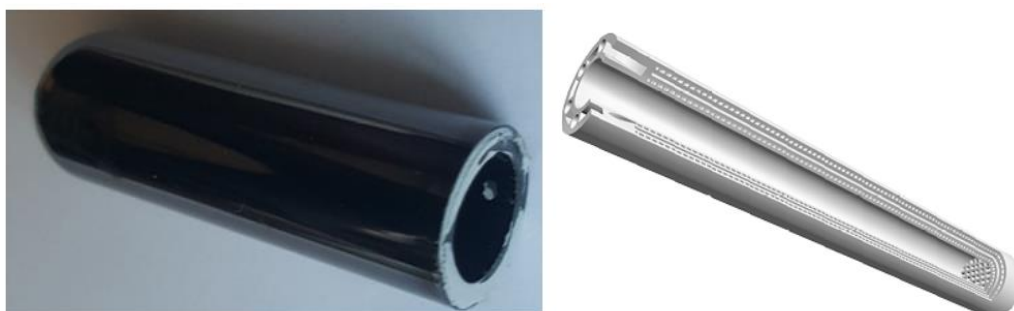
Glassy carbon is a form of carbon that cannot be graphitised, meaning that even at extreme temperatures, it cannot become crystalline graphite. Glassy carbon possesses both ceramic and glassy properties. As a result of its unique properties, glassy carbon is suitable for many applications. The most popular application is electrochemistry in glassy carbon electrodes (GCEs), used as sensors. Glassy carbon has a wider electrochemical activity window than gold when immersed in water. According to Dekanski *et al.* (2001) and Abdel-Aziz *et al.* (2020), glassy carbon has become an interesting and widely used electrode due to its physical and chemical properties. It exhibits a rather low oxidation rate and a very high chemical inertness. Glassy carbon is a convenient inert electrode with very small pores and low gas and liquid permeability (see Figure 4-21 below).

Figure 4-21: Overview of the glassy carbon electrode

Its most important properties are high-temperature resistance, extreme chemical resistance, and impermeability to gases and liquids. Glassy carbon electrodes were used on the test sample's end tips. The manufacturer did not provide the actual specifications of the glassy carbon electrode. Table 4-5 shows typical values for the glassy carbon electrode use on HTV-SR and RTV-SR test samples used in the test.

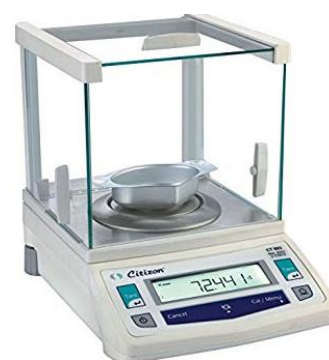
An accurate scale with sufficient resolution was necessary to measure the weight of salt content. The CG 4102 is an electronic scale suitable for accurate weight measurement under laboratory conditions, with zero adjustments in all measurement ranges. When deionised water is filled in the water tank, it was measured using the Citizen scale (refer to Figure 4-23).

Figure 4-23: Citizen scale CG 4102 for weighing of salt content

This scale is a high-precision weighing instrument for measuring mass ranging from 0.01 mg to 100 kg. The technical specification of the scale is given in Table 4-7.

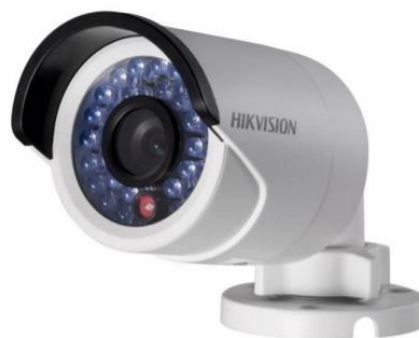
It was crucial that comprehensive visual observations regarding changes, damage and degradation on test samples be accurately documented and recorded. To achieve this, a Hikvision IR Network Camera was used. Hikvision is a data acquisition system that captures motion picture data from live environments, encoding the data into statistics that may be decoded or transcoded into digital video media. Video recordings were made for all the tests (AC, DC+, and DC-) using high-quality video cameras with infrared capability – Hikvision IR network camera, Model DS-2CD2042WD-I (Figure 4-24).

Figure 4-24: Hikvision IR network camera

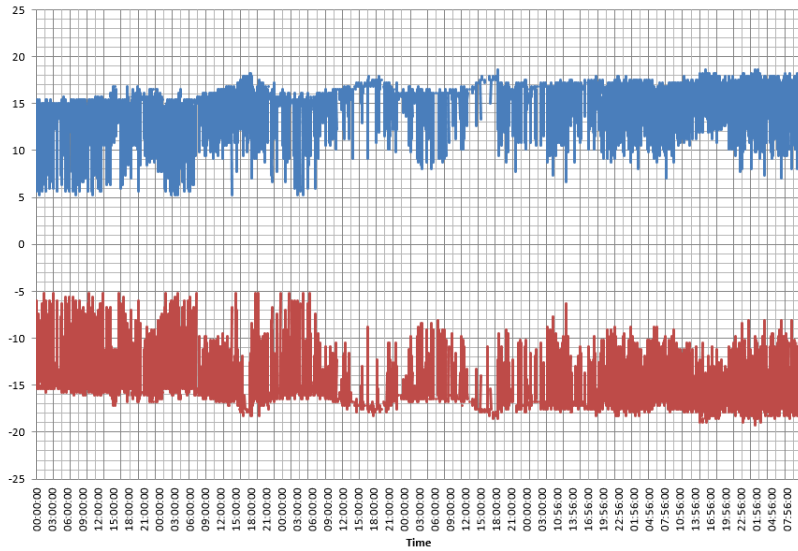
Figure 5-1: Maximum or highest leakage current captured by OLCA

The OLCA device samples continuously at 2 kHz and captures peak currents in a 60-second period. During this study, however, the test rods were only energised for 40 seconds, and during the energization period, the OLCA captured the minimum and maximum peak currents. The online leakage current analyser (OLCA) is designed to capture and record the Maximum and minimum peak currents in a 60-second period. Figure 5-1 shows the maximum and minimum peak currents captured by the OLCA.

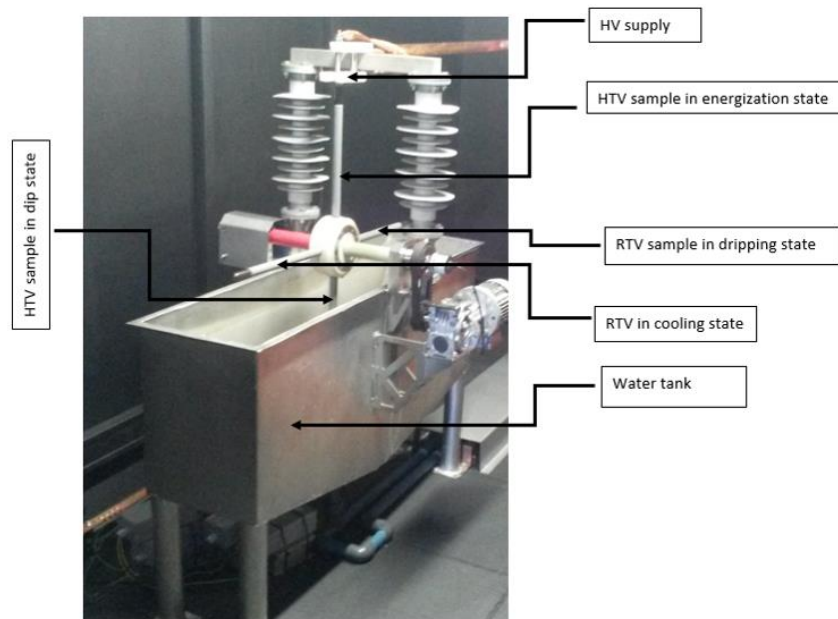
Figure 5-4: Schematic diagram of the RWDT (IEC / TR 62730:2012)

The tests were carried out according to the procedure specified in the IEC / TR 62730:2012 standard, as mentioned in Chapter 3.0. In the standard, the test specimens are mounted on the wheel (refer to Figure 5-4) and move through four positions in one cycle. Each test sample remains stationary for about 40 seconds in each of the four positions. The 90°-rotation from one position to the next takes about eight seconds. In the first part of the cycle, which is vertical (upside down), the insulator is dipped into a saline solution (NaCl content).

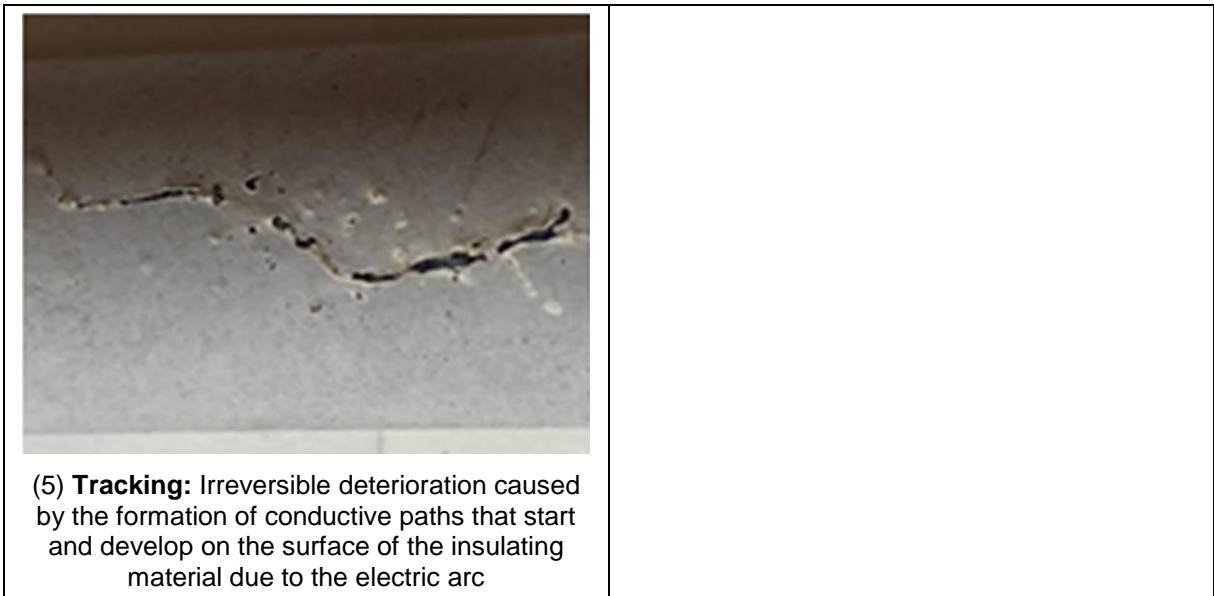
Figure 5-5: Test sample material ageing modes

Ageing modes, discolouration, crazing (which is a form of deformation that occurs on the surface of a material as a precursor to cracking), dry-bands, tracking and erosion (Ferreira *et al.* 2010; Fraçz *et al.* 2016; Madi *et al.* 2016; Roman *et al.* 2014; Zhu *et al.* 2017) are some of the key failure indicators on the surface of the insulators which this study sought to identify and analyse. Figure 5-5 below shows indications of the surfaces of the test samples. The photographs illustrate the failure indicators in test samples from the least severe to the most severe. Photos 1 to 3 of Figure 5-5 show the least severe modes, whereas, in photos 4 and 5, this effect can be interpreted as the most severe mode and as a warning sign of insulator surface deterioration.

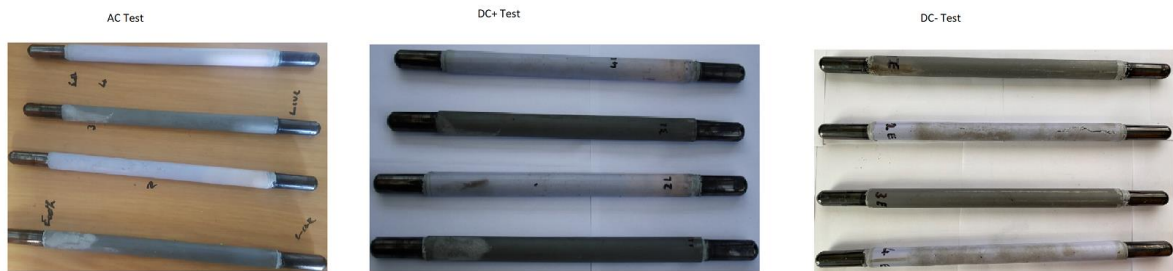
The photos in Figure 5-6 below summarise the observations made with the Hikvision IR network camera for each set of test samples in different excitation voltages (AC, DC+, and DC-) with the same creepage length. Each test was observed for a total of six days. In Chapter 3.0, the observations are discussed in more detail.

Figure 5-6: Overview of visual observations made (on RTV-SR and HTV-SR test samples) under AC, DC+, and DC- excitation voltages after the 6-day testing period

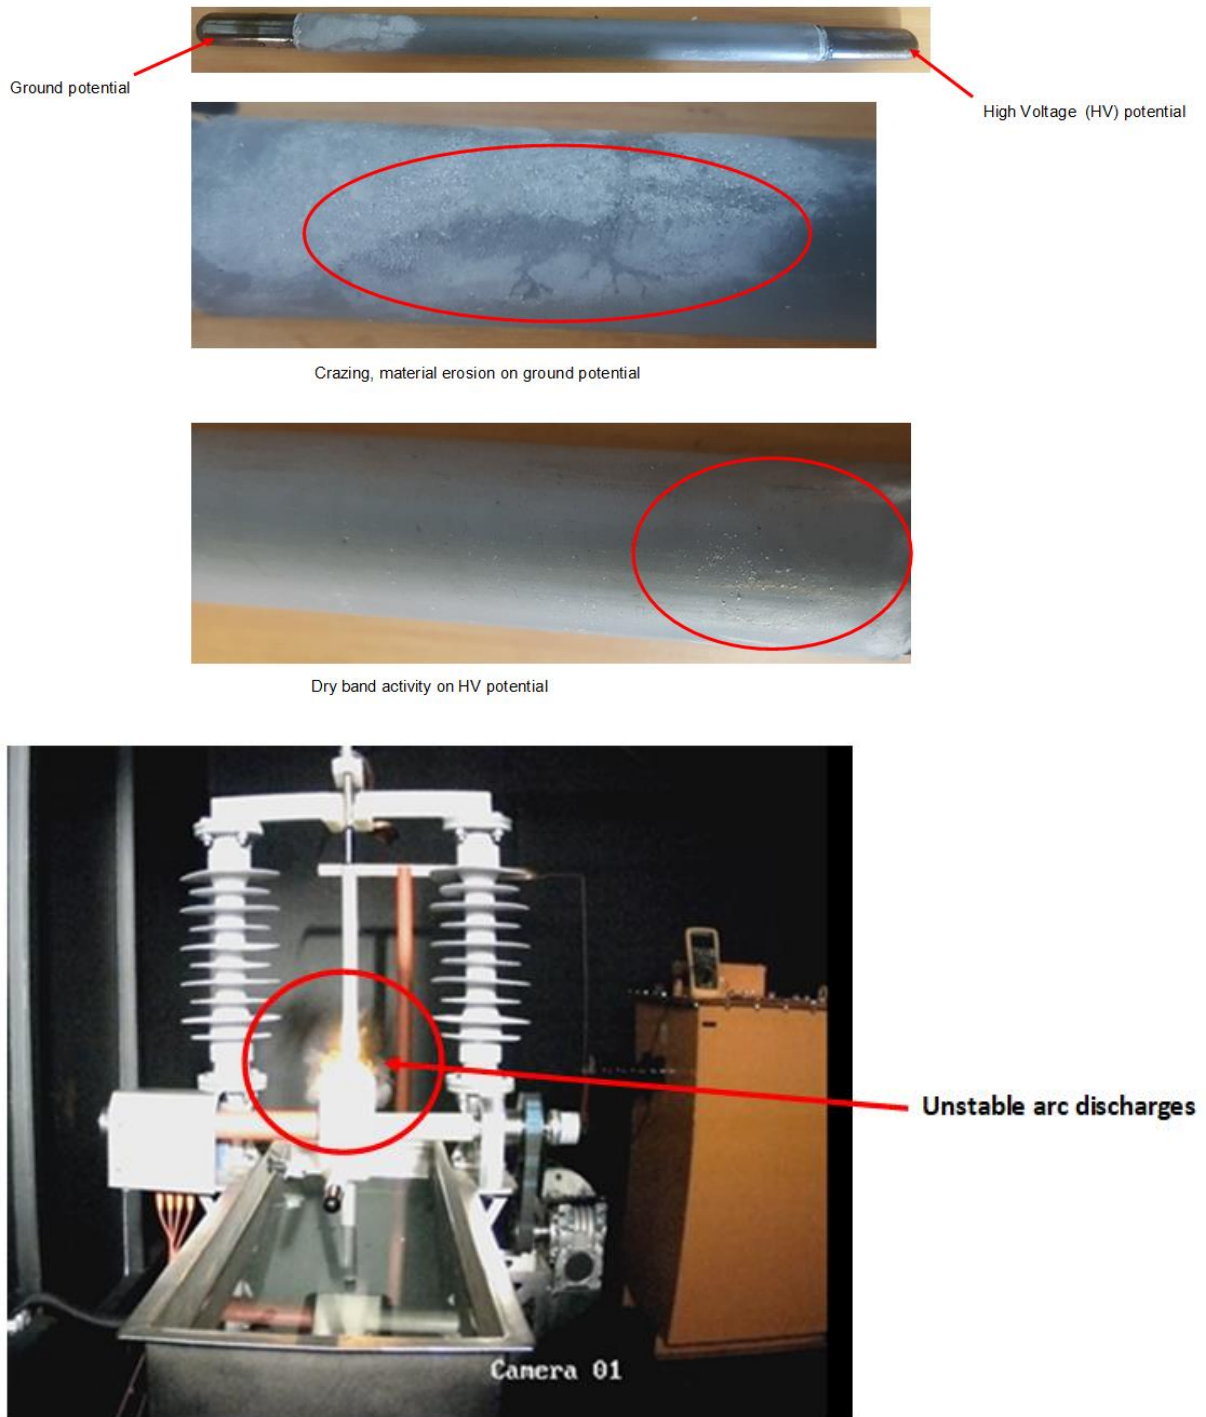
Figure 5-10: Material erosion, crazing, dry band activities, and unstable arc discharges observed on the HTV-SR test sample

Dry band formation on the HTV-SR test sample 1 indicates discharge activities on the ground potential side of the test sample. According to Zhou *et al.* (2010), the formation of the dry band greatly influences the distribution of the electric field along the insulator, which leads to partial arcing and flash-over. According to Roman *et al.* (2019), light rain and high humidity conditions worsen dry band arcs and possible flash-over in insulators used in the field.

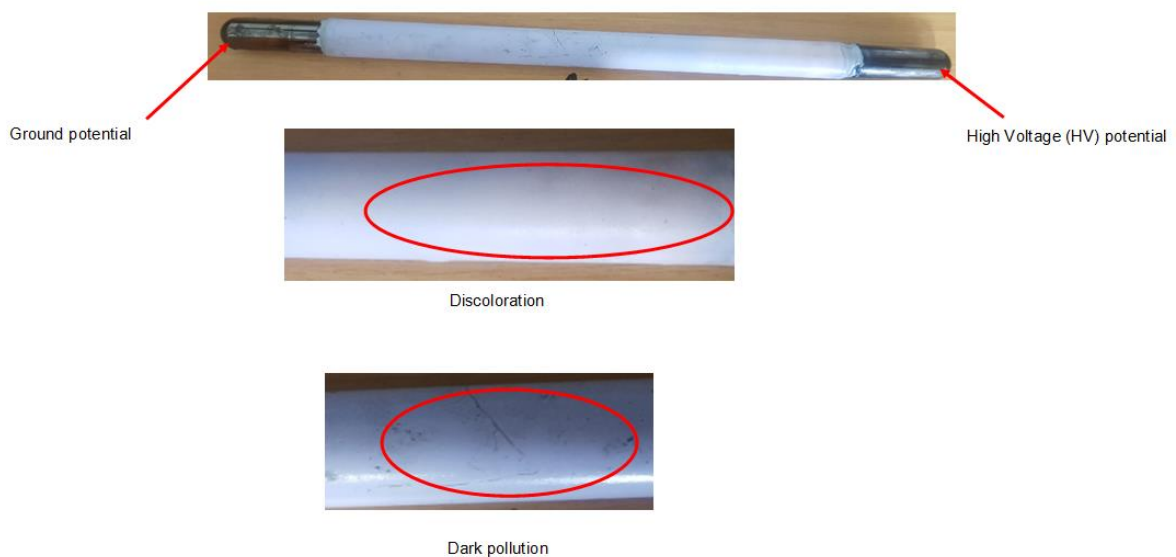
Figure 5-15: Dark pollution build-up and discolouration on RTV-SR test sample

Discolouration on the surface of polymer insulators can occur due to cyclisation (a process that limits the degree of polymerization of their intramolecular structure) and high electrical voltages in combination with other stresses (Ullah *et al.* 2020).

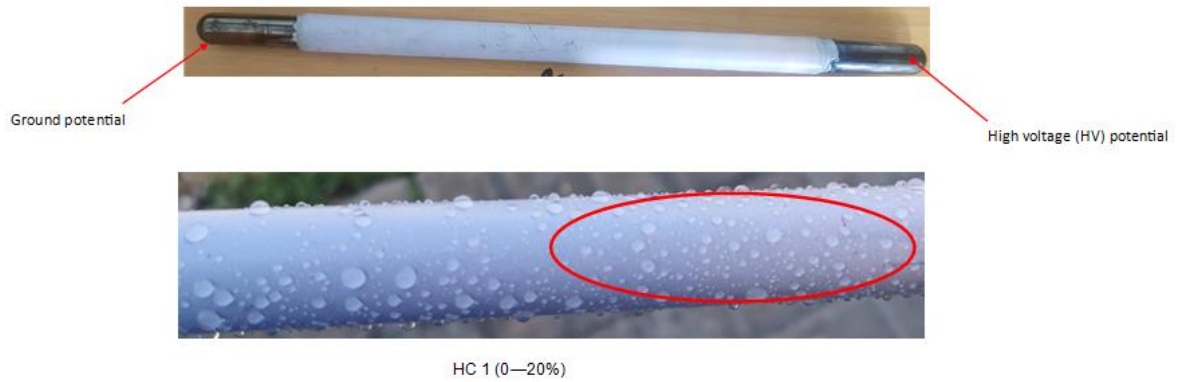
Figure 5-16: *Hydrophobicity of the RTV-SR sample 2*

After the 6-day test, a reduction in hydrophobicity was observed for the sample tested under AC excitation. Figure 5-16 below shows the hydrophobicity percentage given for each test sample. Only discrete droplets corresponding to HC1 (0-20%) are formed, and therefore the test sample is considered highly hydrophobic.

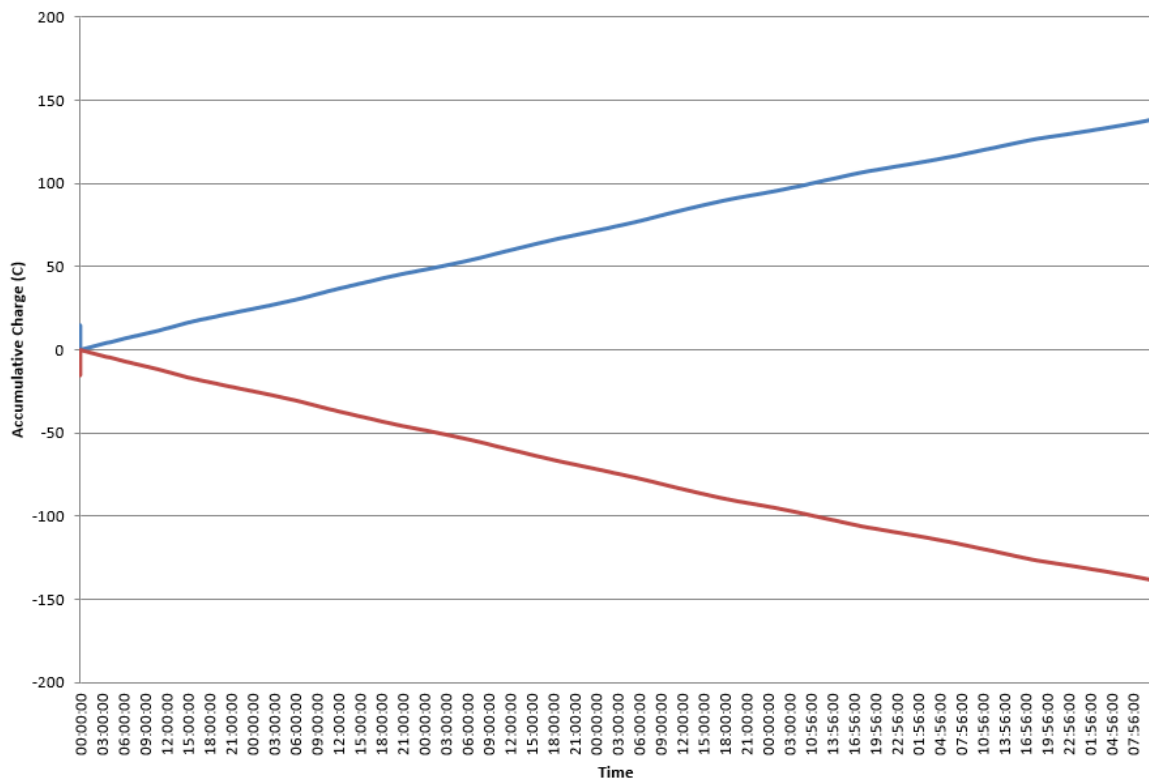
Figure 5-17: Positive/negative cumulative electric charge graph

The cumulative electric charge represents the leakage current flowing through the pollution layer over time. The cumulative electric charge for the RTV-SR test sample 2 tested under AC excitation for six days is presented as follows: Figure 5-17 indicates that the slope of the cumulative electric charge graph is slightly changed (slight drop) after the 100-coulomb value line. Therefore, the rate of change in leakage current is slightly lower (i.e. slight increase), which might be attributed to dry band formation on the surface of the test sample. Keep in mind that the saline solution and stresses to which the test samples were subjected seemed constant throughout the testing period, given the levels of discolouration on the surface of the test sample. The positive and negative cumulative electrical charge flowing over the surface of the insulator reached approximately 120 coulomb over six days or 144 hours of testing.

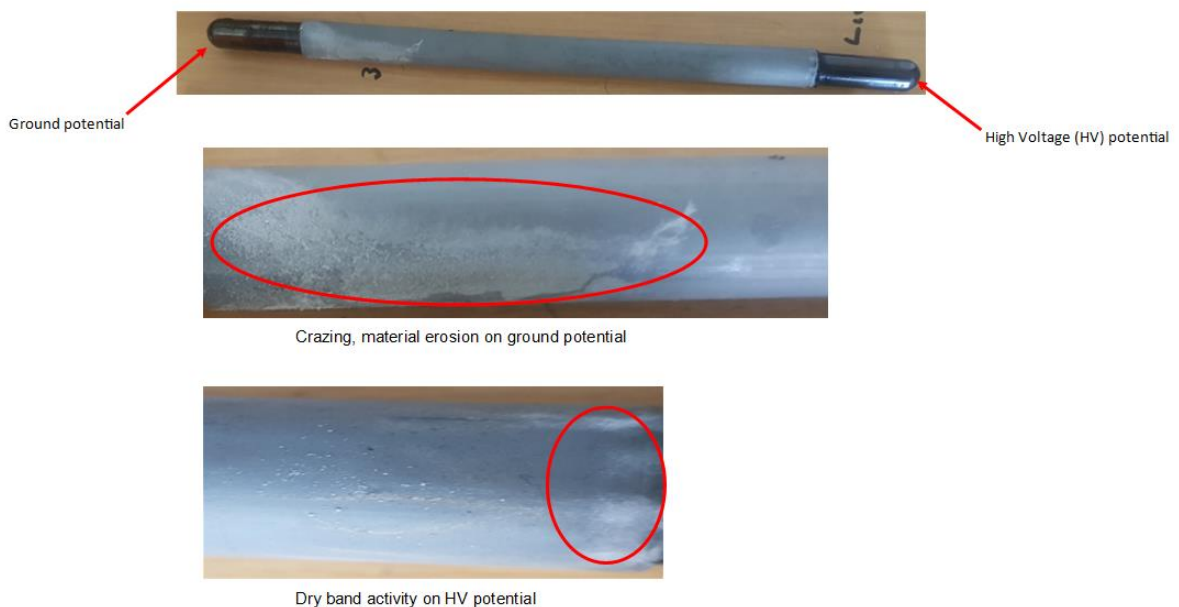
Figure 5-20: Traces of dry band activities, crazing and material erosion on HTV-SR test sample

Material tracking and erosion in the HTV-SR test sample 3 are caused by localised heat generated by the discharges during the test. Material tracking and erosion can occur due to the dry-band discharges on insulating surfaces (Schmidt *et al.* 2010). Further, researchers such as Macey *et al.* (2004) and Thomazini *et al.* (2012) suggests that tracking and erosion are exacerbated if the housing material is exposed to solar ultraviolet (UV) radiation when the insulators are outdoors.

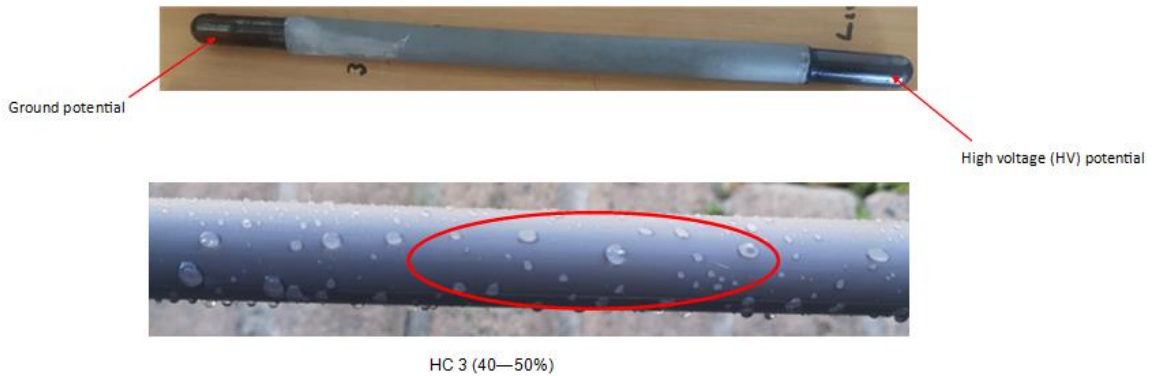
Figure 5-21: Hydrophobicity of the HTV-SR sample 3

After the 6-day test, a reduction in hydrophobicity was observed for the sample tested under AC excitation. Hydrophobicity classification (HC) and the percentage given for each test sample can be observed in Figure 5-21. Only discrete droplets corresponding to HC3 (40-50%) are formed, and therefore the test sample is considered hydrophobic.

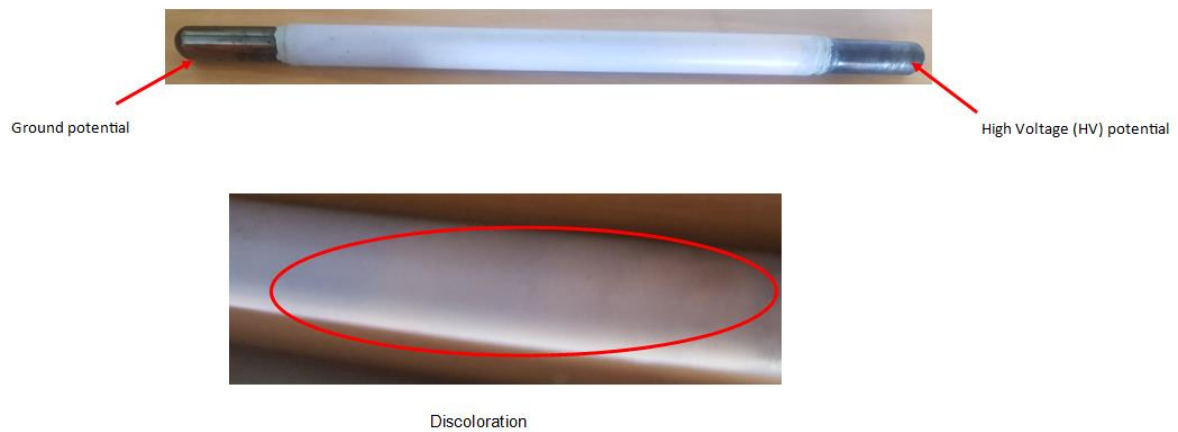
Figure 5-25: Tracking and erosion, discoloration, and pollution on RTV-SR test sample

At the end of the test, discolouration and pollution build-up on the surface and towards the high-voltage potential side of the test sample were observed. These observations are presented in Figure 5-25 below.

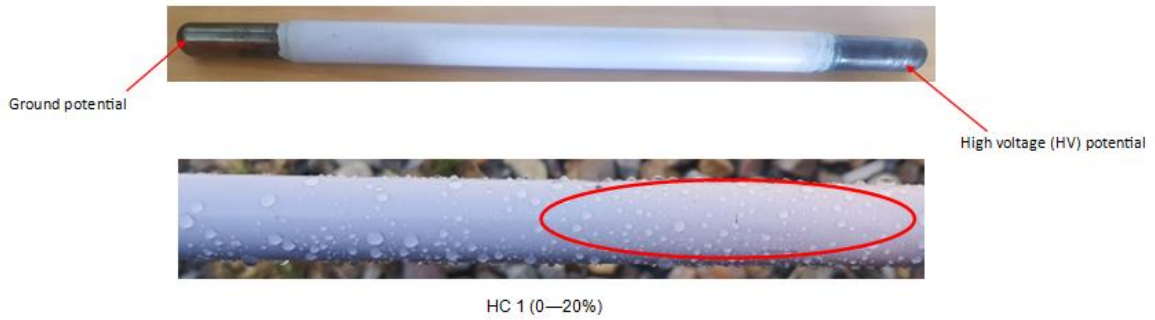
After the 6-day test, a reduction in hydrophobicity was observed for the sample tested under AC excitation. Figure 5-26 shows the hydrophobicity classification (HC) and the percentage given to the test sample. Only discrete droplets corresponding to HC3 (10-20%) are formed, and therefore the test sample is considered highly hydrophobic.

Figure 5-26: Hydrophobicity of the RTV-SR sample 4

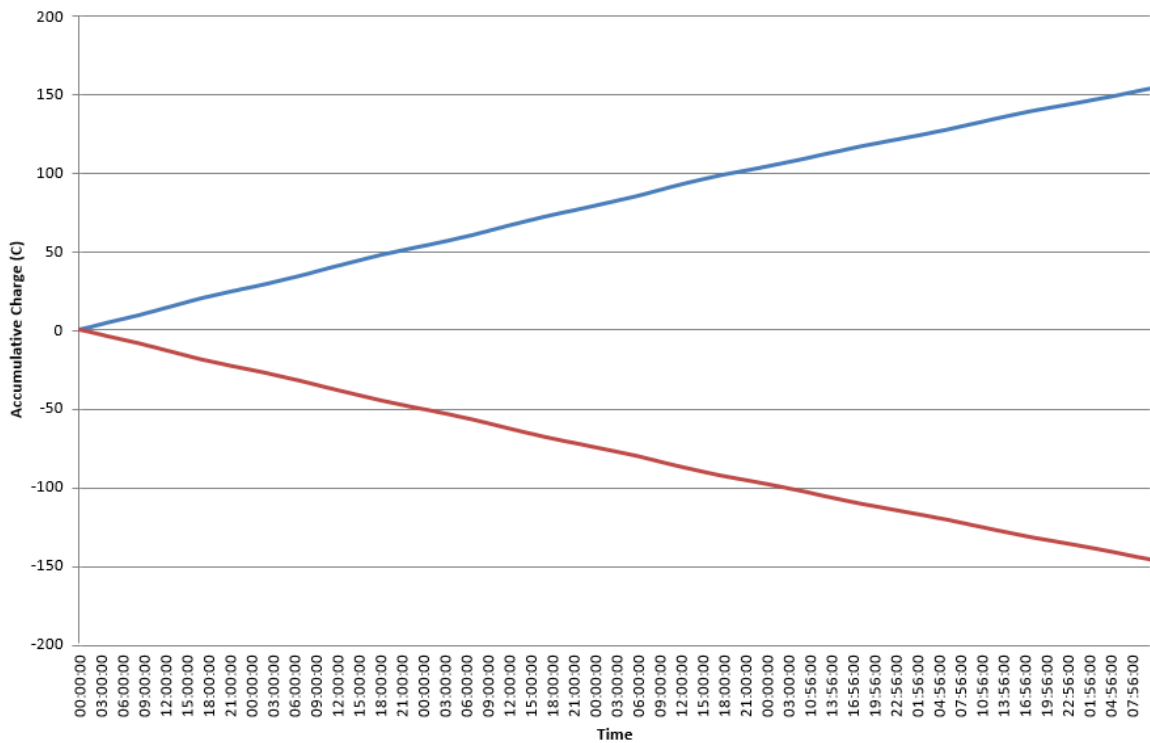
Figure 5-27: Cumulative positive/negative charge

The cumulative electric charge for the HTV-SR test sample 3 tested under AC excitation for six days is presented below. Figure 5-27 indicates that the slope of the cumulative electric charge graph has a slight drop in it at the 50-coulomb level. This may be attributed to fluctuations in the leakage current and dry band formation on the surface of the test sample. This raises questions about the saline solution distribution on the surface of the insulator and the stresses to which the sample was subjected. The positive and negative cumulative electrical charge flowing over the surface of the insulator reached approximately 150 coulomb over six days or 144 hours of testing.

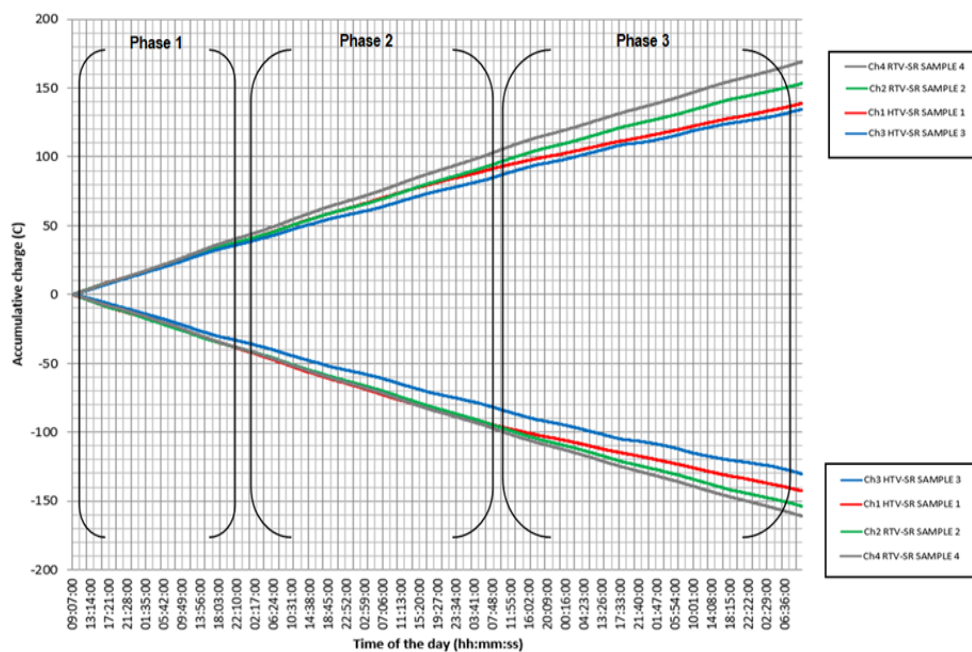
Figure 5-28: Overall cumulative positive/negative electrical charge between HTV-SR and RTV-SR

Phase 3: Both RTV-SR test samples and HTV-SR test samples follow different paths. The trends for RTV-SR samples 2 and 4 are similar, whereas HTV-SR 1 and 3 are close, and because the slope of these lines seems to drop, one can deduce that the leakage current is trending towards stabilization and a lower rate of charge. Further, the relative average difference in leakage current between RTV-SR and HTV-SR is 14.2% = $[(162 - 139)/162] \times 100$.

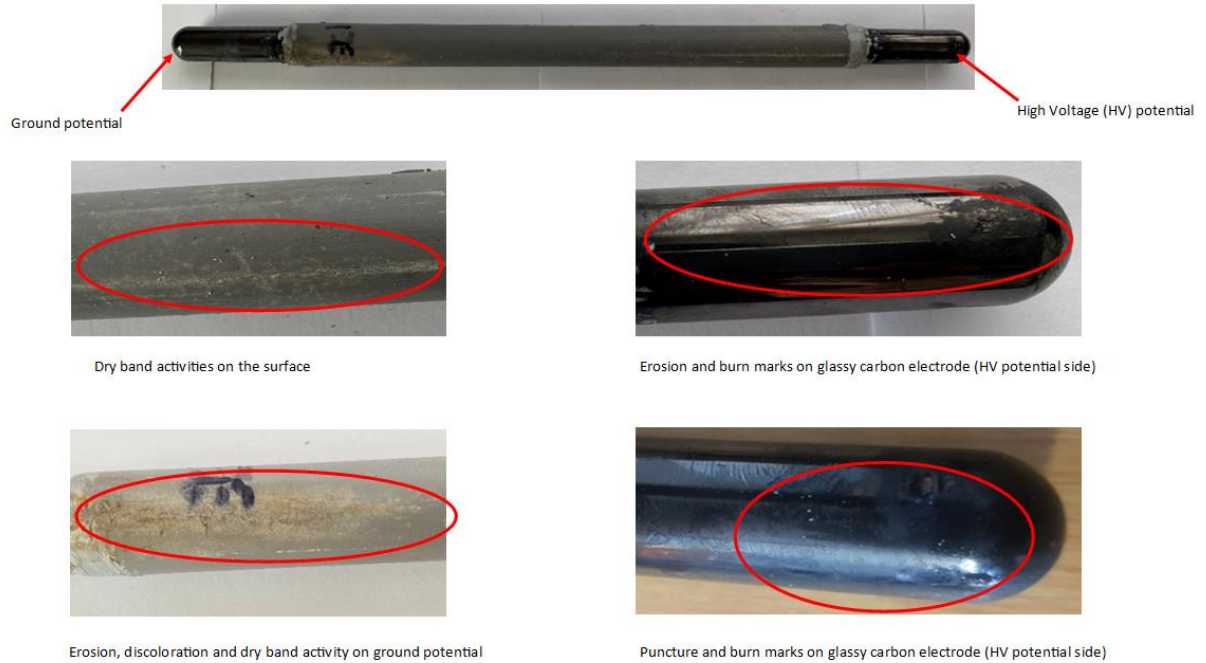
Figure 5-32: Crazing, pollution build-up, and burn marks over a glassy carbon electrode on the HTV-SR test sample

At the end of the test, crazing was observed in the ground potential side. Pollution build-up on the surface of the test sample and burn marks over the glassy carbon electrode were noted. These observations are presented in Figure 5-32 below.

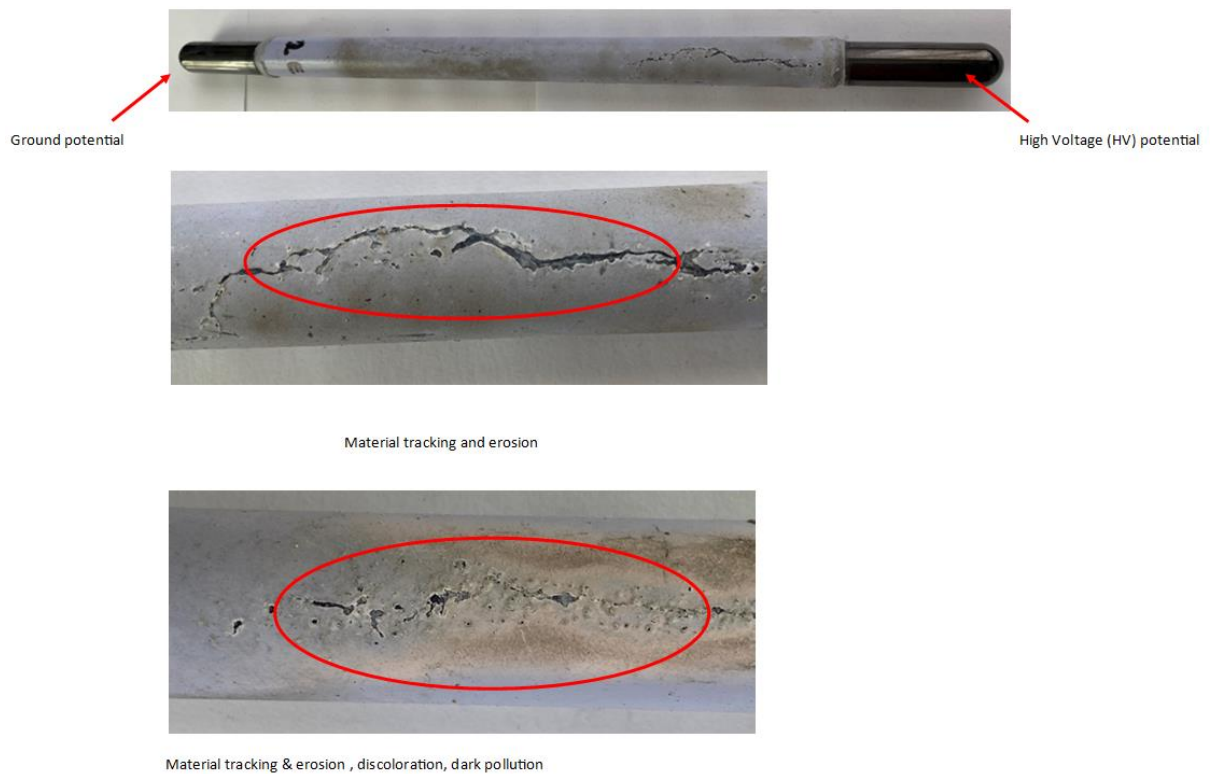
Figure 5-37: Black marks, burn marks on glassy carbon electrode, discoloration, and pollution on RTV-SR test sample

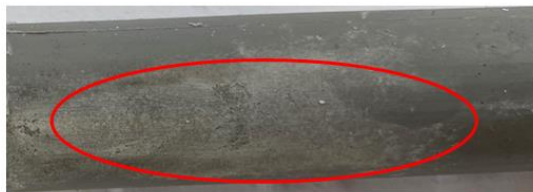
Crazing, material erosion and discoloration

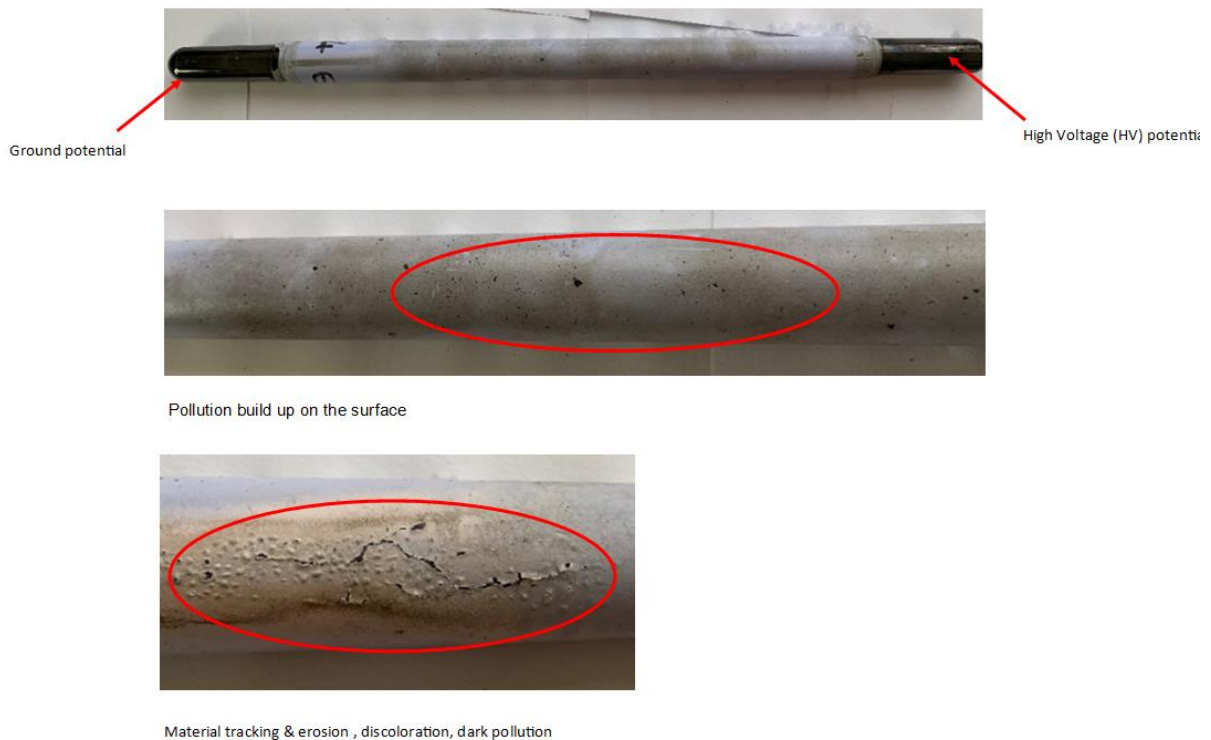
Figure 5-47: Material erosion, pollution, and discolouration on RTV-SR test sample

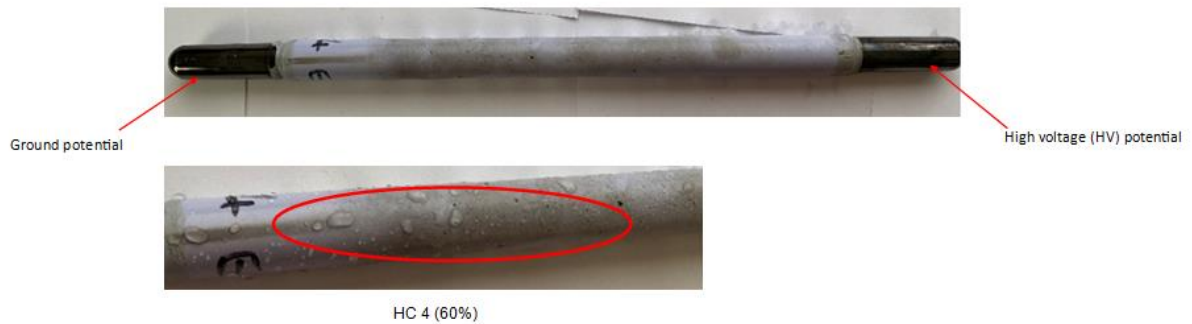
After the 6-day test, a reduction in hydrophobicity was observed for the sample tested under DC+ excitation. Figure 5-48 shows the hydrophobicity classification (HC) percentage given for the test sample. A very small surface section is covered by

discrete droplets corresponding to HC4 (60%), suggesting that the test sample is mostly hydrophilic. The loss of hydrophobicity in the test sample material may have been caused by the increased electrical stress and discharge activities on the surface.

Figure 5-48: *Hydrophilicity of the RTV-SR sample 8*
