**Evaluation of the Leakage Current Performance of
RTV Silicone Rubber-Coated Glass Samples,
energized under AC, DC+, and DC- in a Controlled
Local Laboratory**

**A thesis submitted in fulfilment of the requirements
for the degree**

Master of Engineering: Electrical Engineering

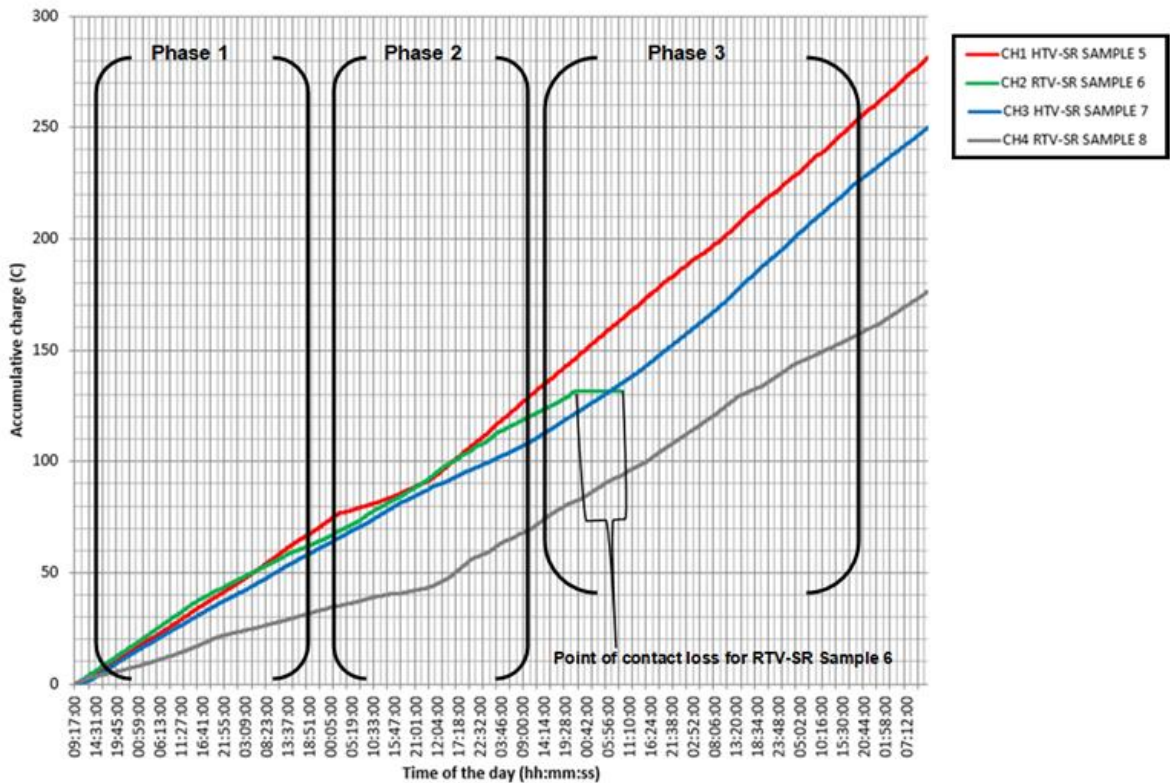
Figure 5-50: Overall cumulative positive electrical charge between HTV-SR and RTV-SR

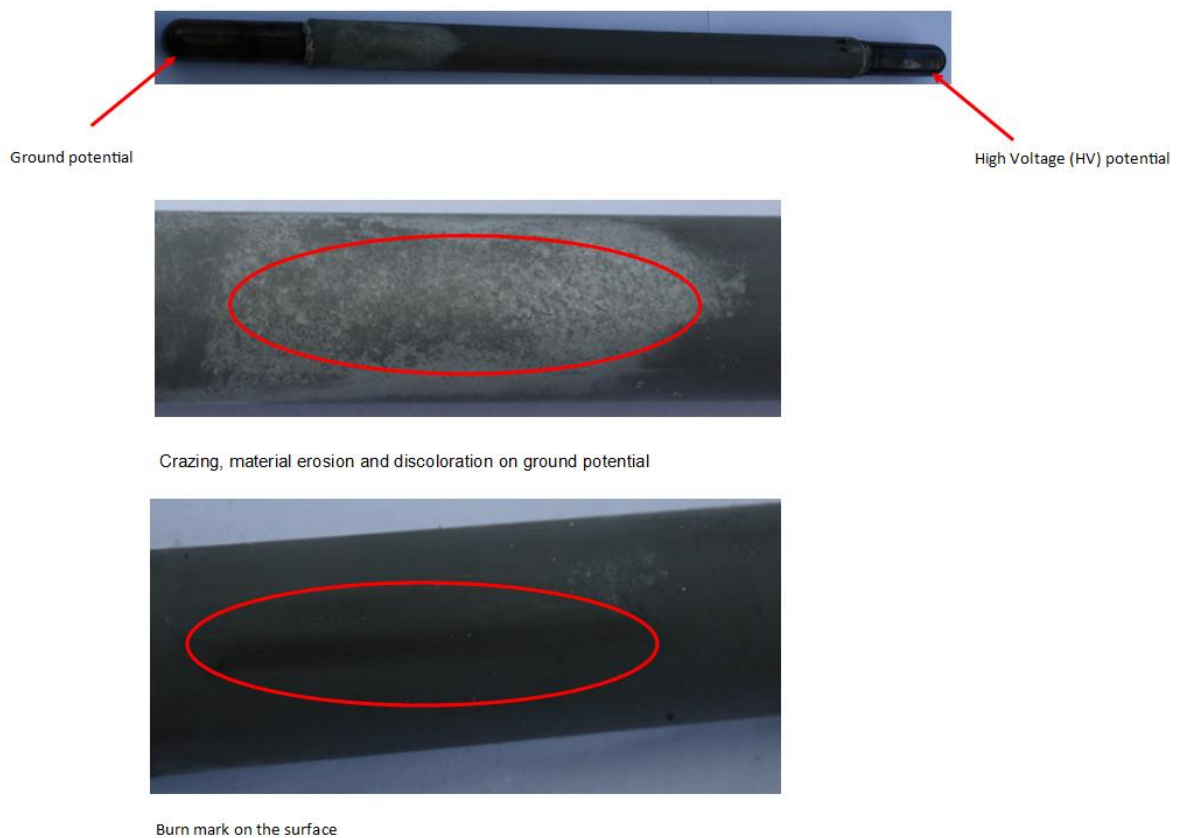
Figure 5-54: Discoloration, material erosion, crazing and dark pollution/contamination build-up on the HTV-SR test sample

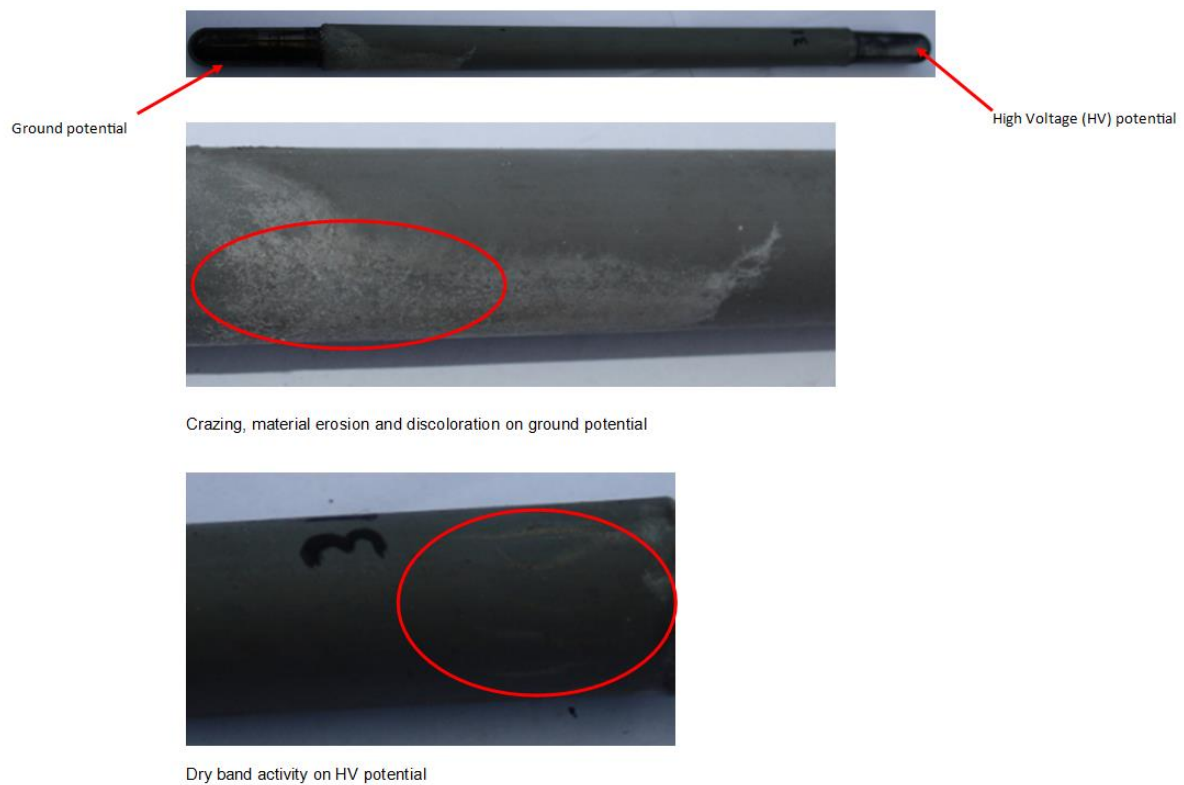
Figure 5-64: Dry band activity on HTV-SR test sample

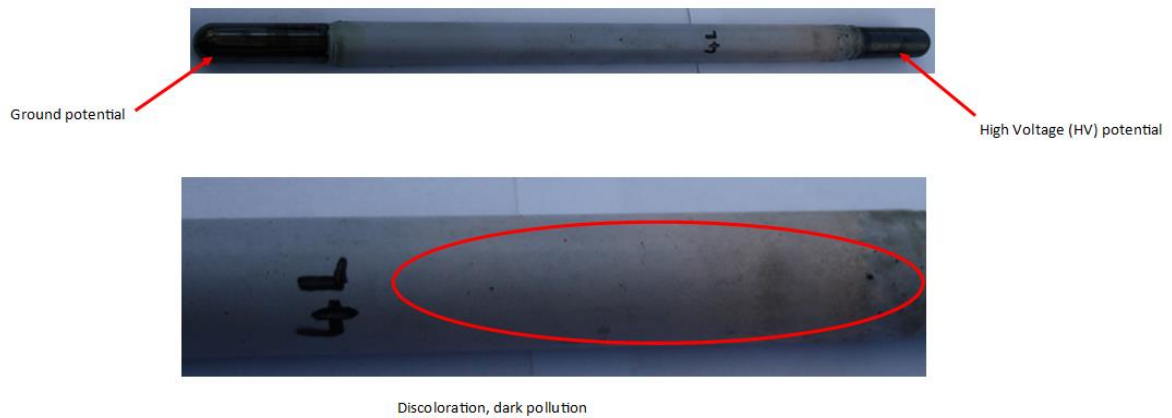
Figure 5-69: Discolouration, burn marks and pollution observed on an RTV-SR test sample

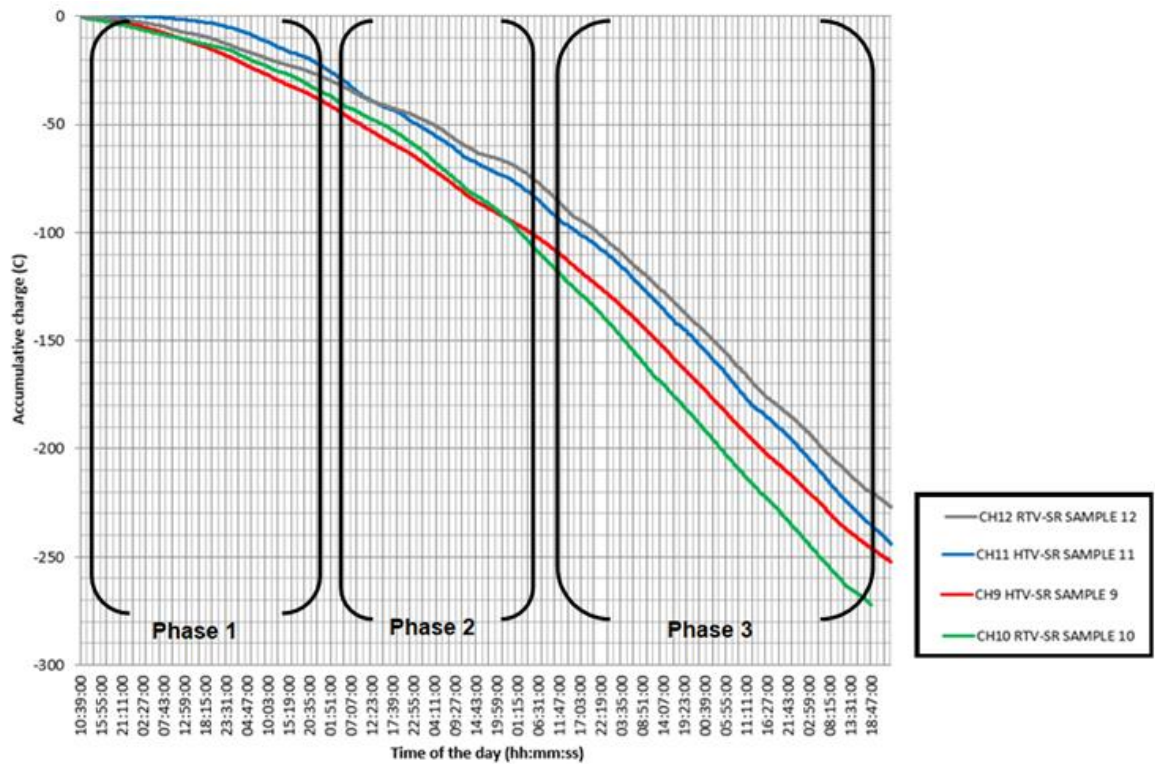
Figure 5-72: Overall cumulative negative electrical charge between HTV-SR and RTV-SR
