NON-DESTRUCTIVE TESTING AND FINITE ELEMENT MODELLING OF HISTORICAL MASONRY WALL

Thesis submitted in fulfilment of the requirements

Master of Engineering: Civil Engineering

Cape Peninsula University of Technology

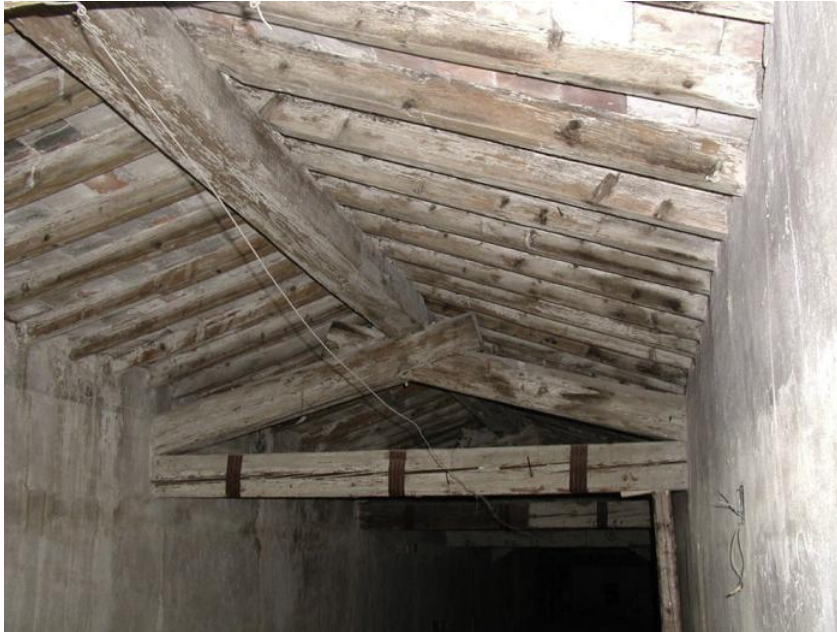
Figure 2.1: Substandard fastening of a truss tie (Tampone and Ruggieri, 2016)

Tampone and Ruggieri (2016) studied visual imperfections of ancient timber roof structures in Italy. In one such example, the researcher found substandard fastening of a truss tie at Villa Demidoff, Florence, as shown in Figure 2.1.

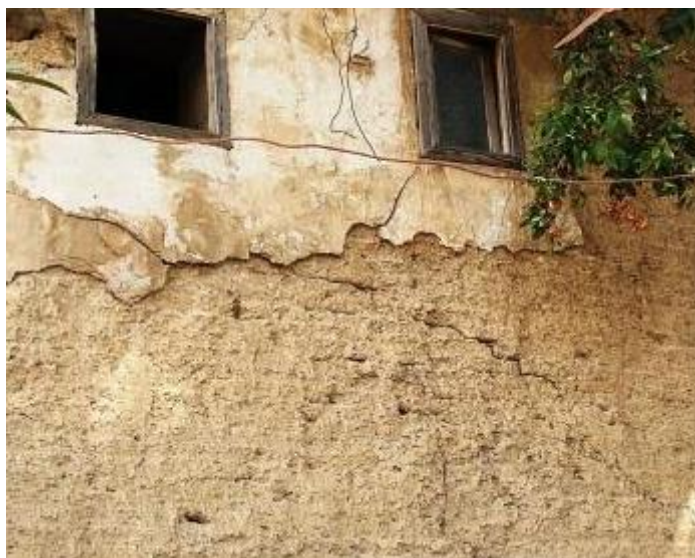
Figure 2.2: Cracking of a structure in Cyprus built with adobe bricks (Illampas et al., 2017)

Masonry is an ancient construction material that has evolved throughout history, one example being adobe bricks. Adobe bricks consist of compressed unfired earth combined with natural fibres commonly used in ancient construction. While modern structural use of adobe bricks is limited, ancient adobe structures are found in various parts of the world, including Southern Europe, East Mediterranean, North Africa and South Asia. These historical structures constitute a great part of cultural heritage worldwide. Illampas, Silva, Champis, Lourenço and Ioannou (2017) studied the effect of clay-based grout injections on an adobe model building after conducting a field inspection of existing structures. The researcher found that, due to the low tensile strength and quasi-brittle nature of adobe bricks compared to modern clay bricks, adobe structures are particularly vulnerable to cracking damage (Figure 2.2).

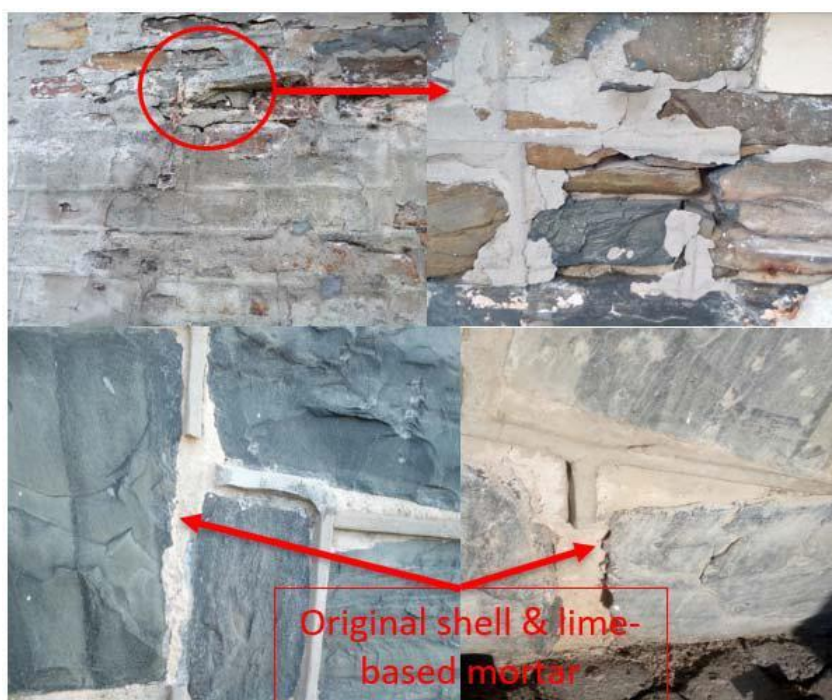
Figure 2.3: Repairs done with incompatible material at Robben Island, causing further damage (Loke et al., 2019)

Robben Island, South Africa, is classified as a UNESCO World Heritage site due to its significant contribution to its cultural heritage as a prison, hospital and military base between the 17th and 20th centuries. In the late 20th century, Robben Island was employed as a maximum-security prison until the dawn of democracy and victory over the oppression of Apartheid (UNESCO, n.d.). With the progression of time, the structures have endured constant damage, and the need for intervention has escalated. Loke, Pallav and Haldenwang (2019) studied the sustainable repair of historic masonry elements at Robben Island. With recent repairs, it is evident that modern materials and methods are incompatible with the construction materials used originally, as evidenced by the detachment of the new mortar from the original surface shown in Figure 2.3.

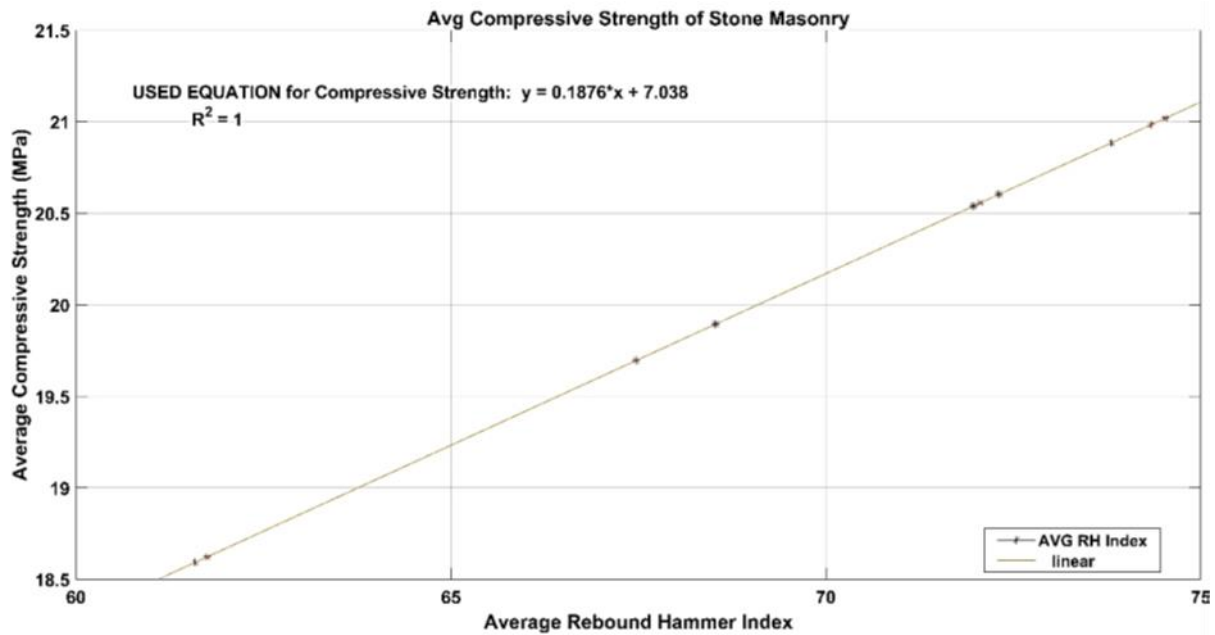
Figure 2.9: Correlation of the rebound number with the compressive strength of stone masonry (Kumar and Pallav, 2020)

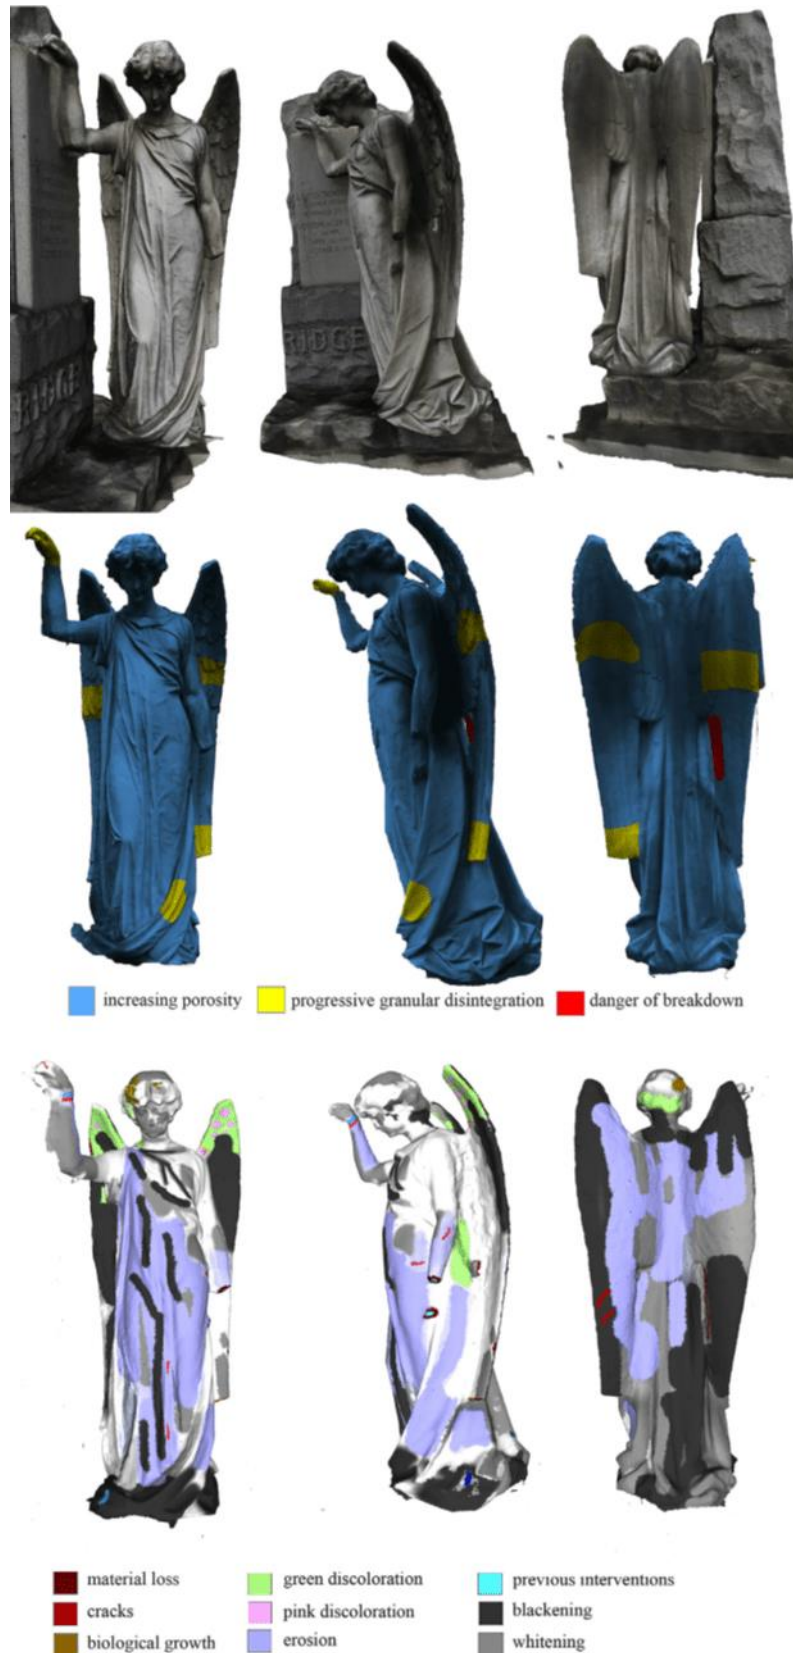
Figure 2.15: Trowbridge Angel Memorial model mapping by UPV testing (above) and the damage mapping by visual inspection (below) (Akoglu et al., 2020)

Researching the cemetery's conservation ensures that the history will not be lost as time progresses. The researcher produced 3D renderings of each memorial tombstone, visually mapping the results of the UPV testing. The rendering of the Trowbridge Angel Memorial is shown in Figure 2.15.

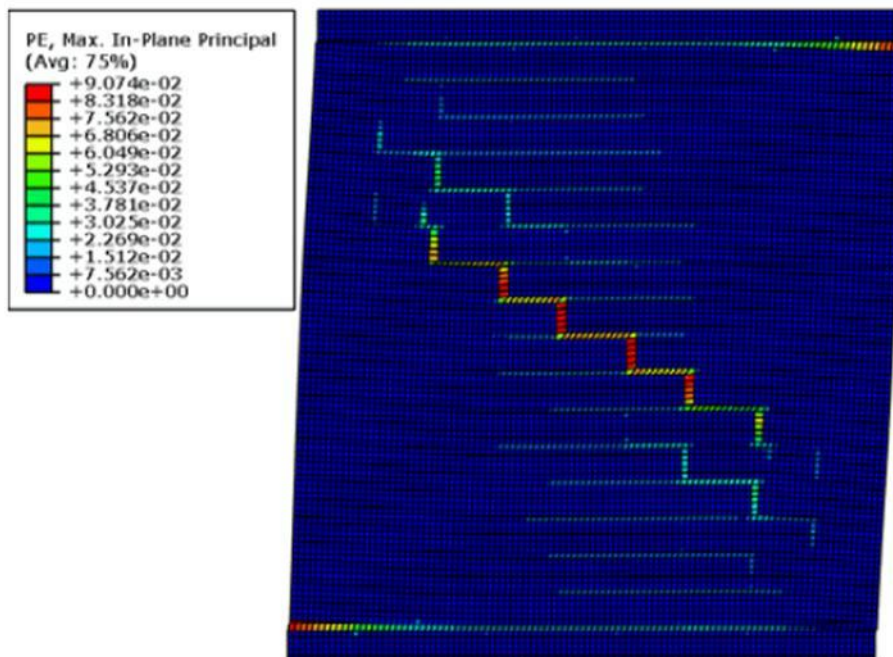
Figure 2.37: Maximum principal stresses in the micro-model indicating a fine stress response (Anecchiarico et al., 2010)

From the results shown in Figures 2.36 and 2.37, it is clear that the micro-model showcases a higher accuracy in predicting possible crack and failure patterns due to the higher sensitivity in the mesh. The results from the model have been compared with the experimental results shown in Figure 2.38.

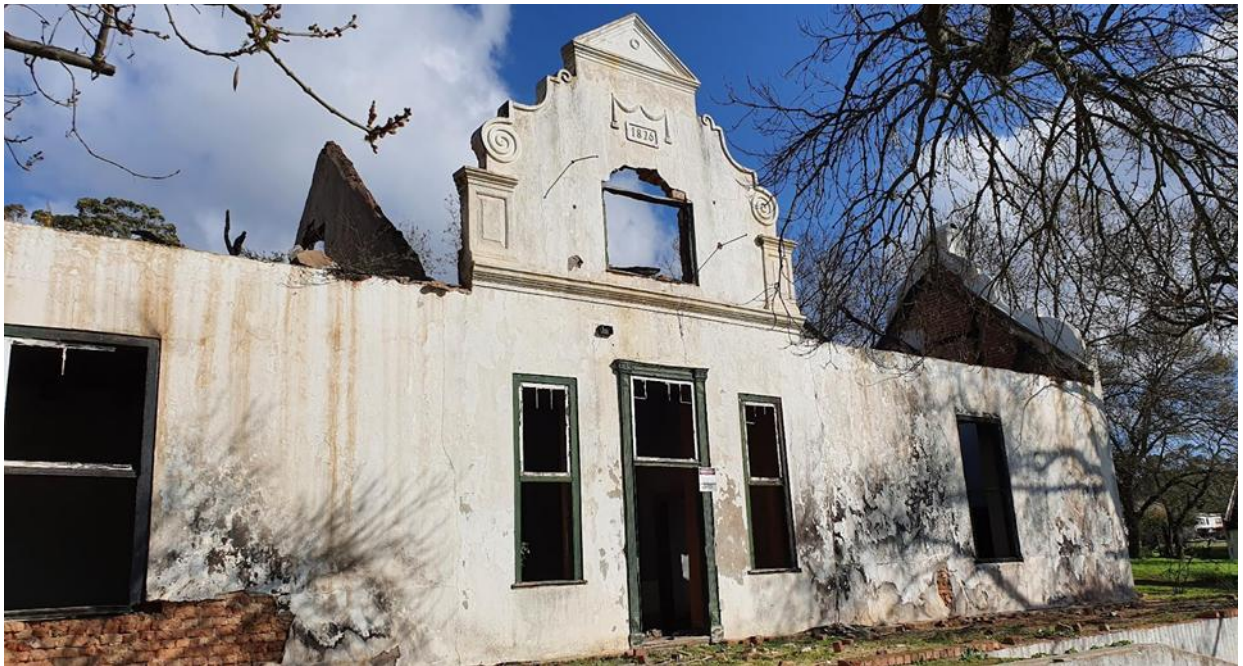
Figure 3.10: Recent photo of the gable wall of the Non-Pareille manor house indicating overall damage

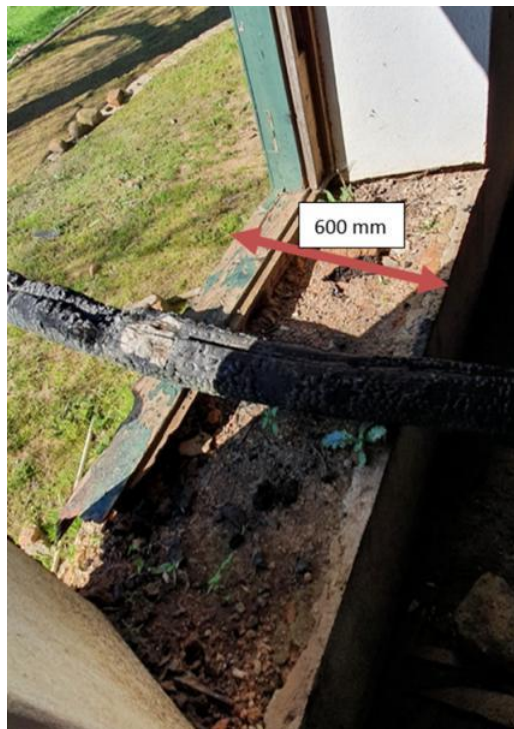
Figure 3.13: Wall width measured at the window opening

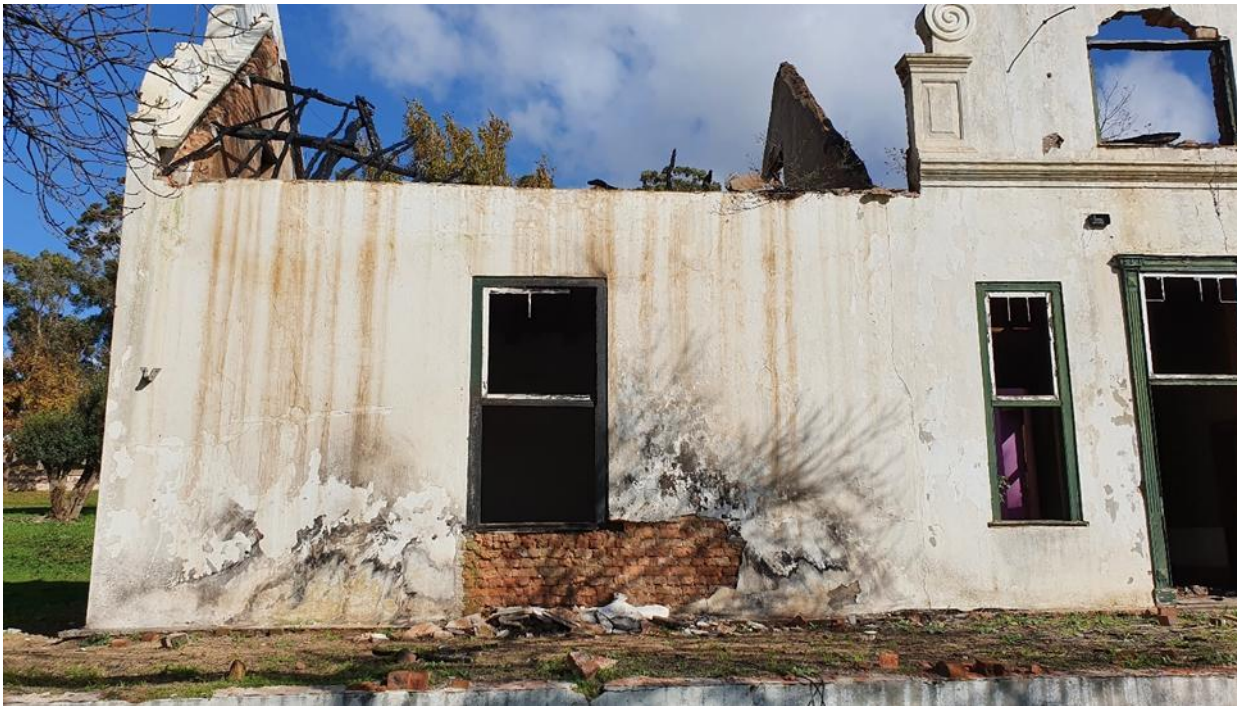
Figure 3.14: Visual damage on the eastern section of the gable wall

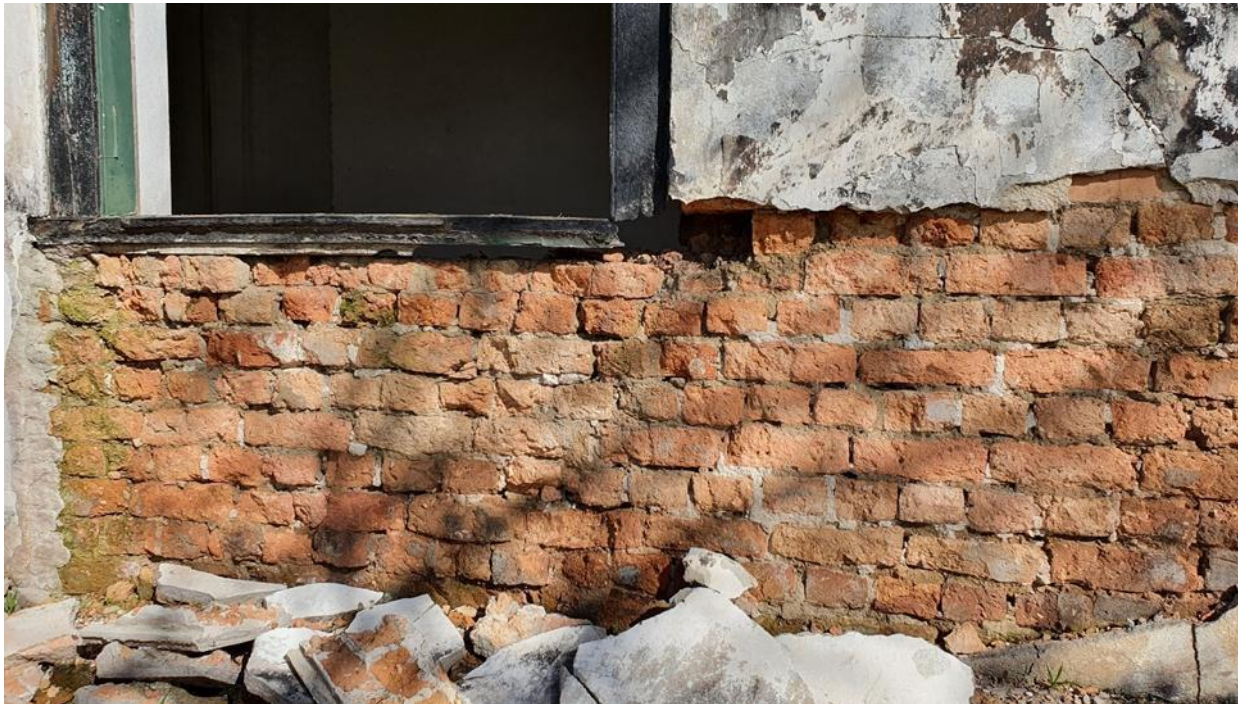
Figure 3.16: Plasterwork breakout on east wall panel exposing the masonry bricks

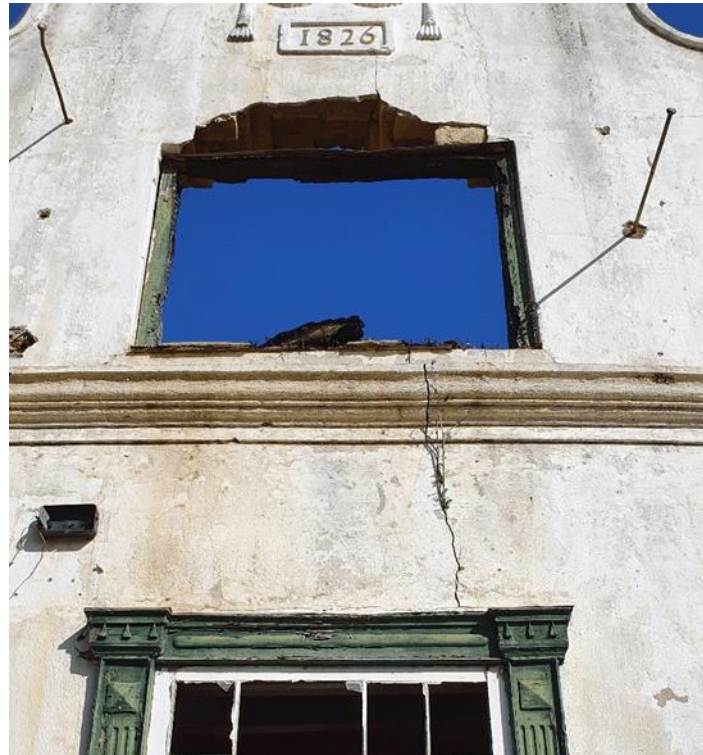
Figure 3.17: Gable crack indicating separation

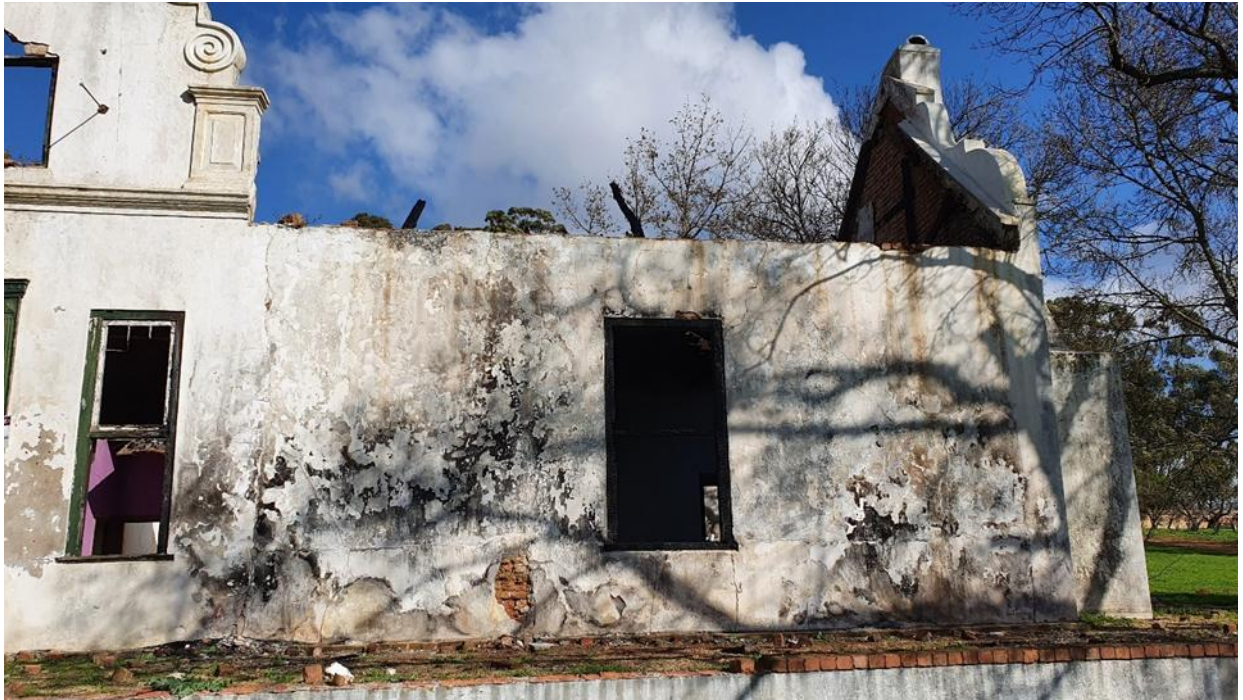
Figure 3.18: Visual damage on the western section of the gable wall

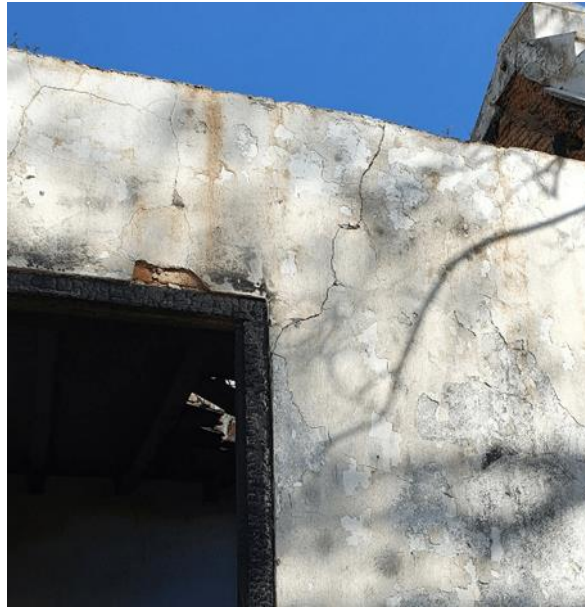
Figure 3.19: Diagonal crack above window of the west wall panel

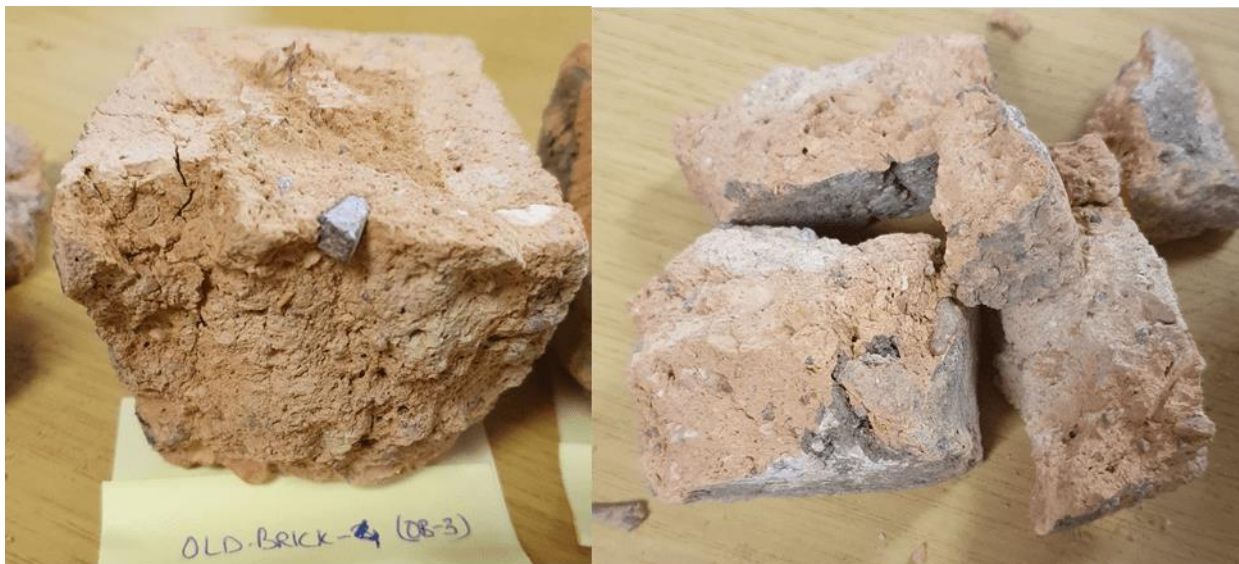
Figure 4.4: Masonry brick sample (left) and broken sample (right)

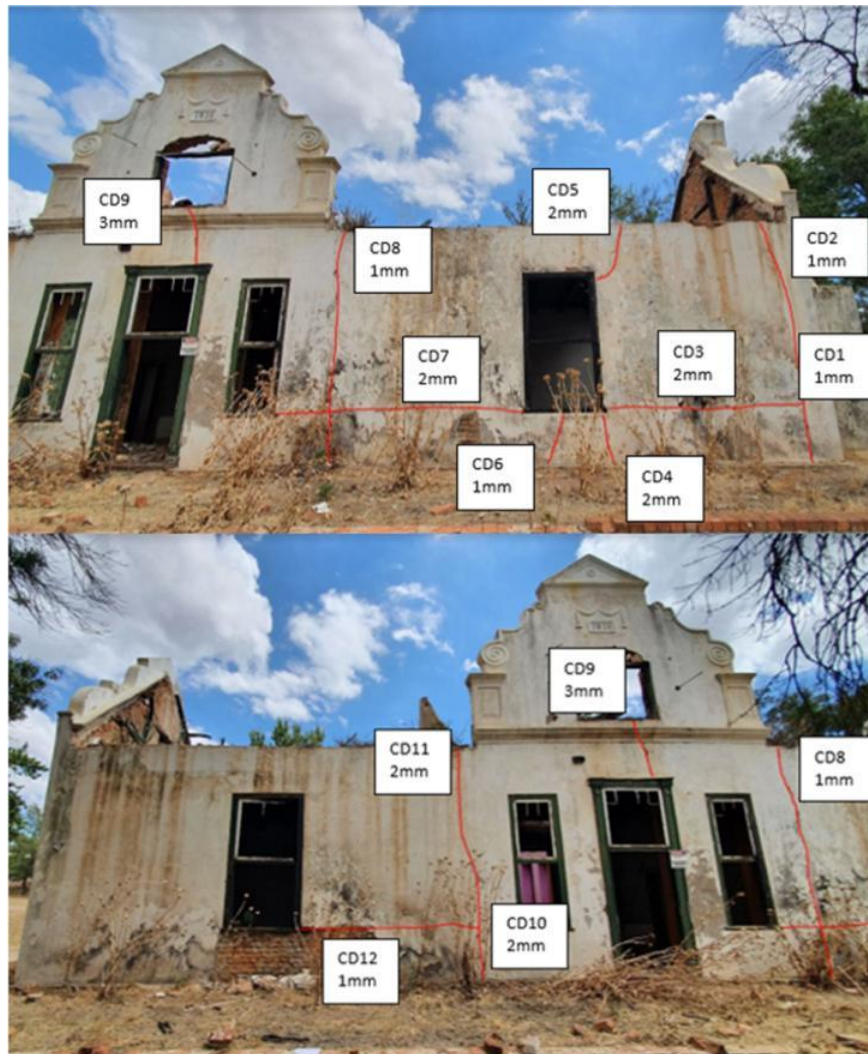
Figure 6.6: Crack depth measurement positions and corresponding crack widths

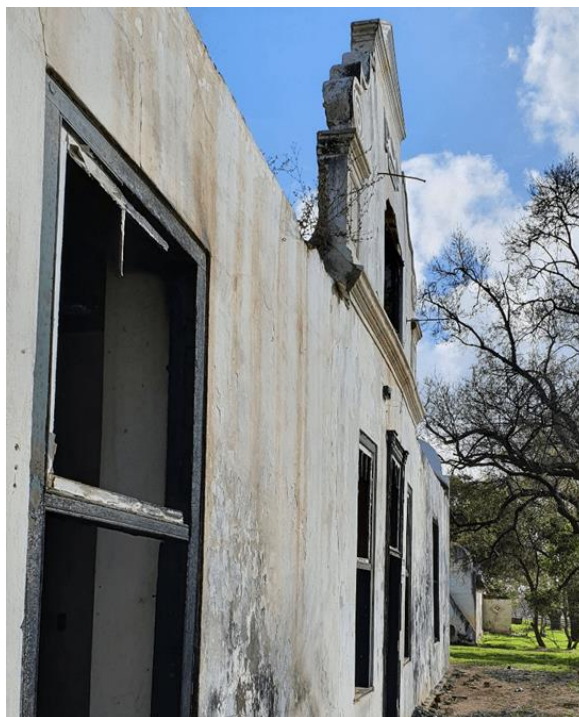
Figure 6.10: Out-of-plane deflection above the architectural ridge of the gable wall
