Correlative analysis between sampling direction and the mechanical properties of the friction stir welded AA5083/AA6082 dissimilar joints

MOLEBOGENG OARABILE MMANYANE SEGAETSHO

Master of Engineering: Mechanical Engineering

**in the Faculty of Engineering and Built Environment at the
Cape Peninsula University of Technology**

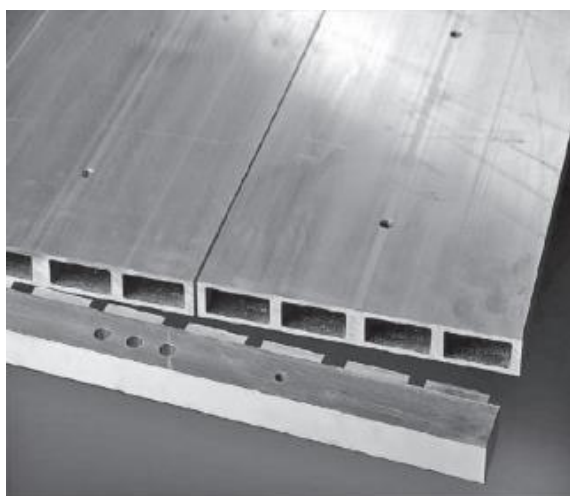
Figure 1.3: Sapa friction stir welded freezer panel [37]

Other construction composed of aluminium can be found in a different industry. These, however, were made after the advent of the FSW process which made its way into the marine industry. Companies in the marine industry, for example, have used FSW to create massive metal panels built from aluminium extrusion profiles. Sapa created the first friction stir welded freezer panels (Figure 1.3) in 1996 to keep fish trawlers frozen [37]. FSW was also used to complete the riveting of numerous components of the Eclipse 500 business aircraft (Figure 1.4) [38].

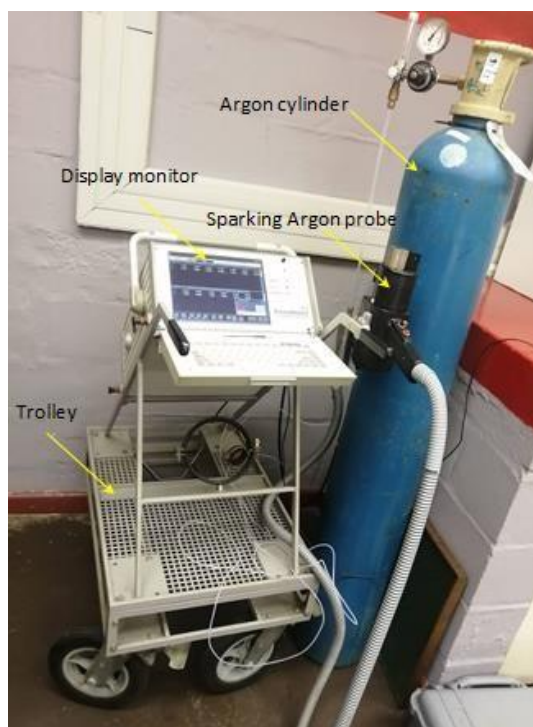
Figure 3.2: Belec spark optical emission spectrometer

The Belec Compact Port Hybrid Low Carbon (HLC) was used to determine the material composition of the chosen material (Figure 3.2). This device can determine the amount of each element present in materials. A display monitor, argon cylinder, sparking argon probe and trolley are included with the spectrometer.

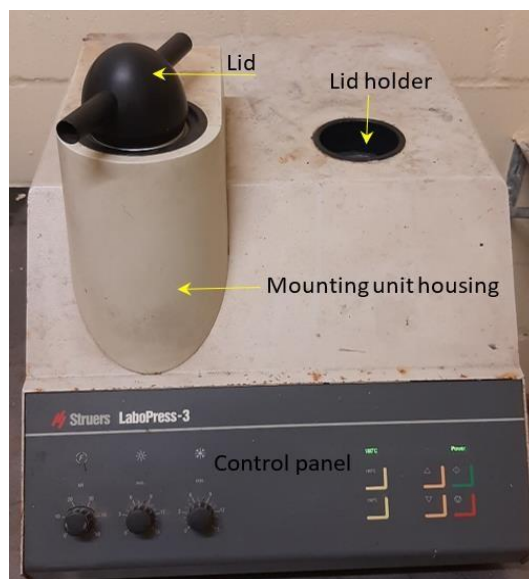
Figure 3.5: Struers LaboPress-3 for mounting of specimens

To mount macro, microstructural, and micro-hardness samples, a Struers LaboPress-3 is required (Figure 3.5). The machine consists of a control panel, a top closure, a mounting unit and a mounting cylinder on which the samples are mounted. The sample is placed on the mounting cylinder, lowered into the mounting unit, hot mounting powder is poured, and the machine's top is closed.

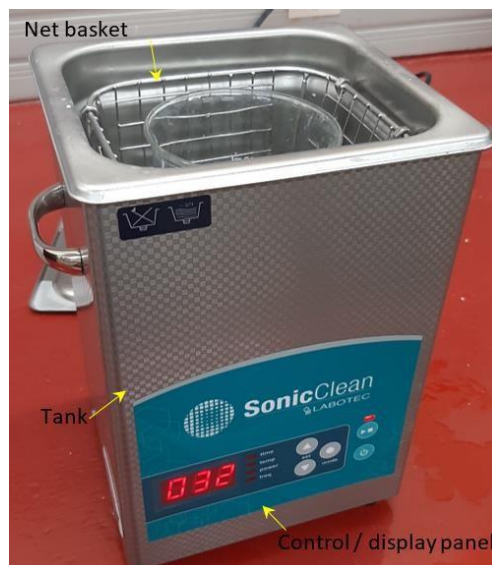
Figure 3.7: Labotec SonicClean Ultrasonic cleaner

Labotec SonicClean Ultrasonic cleaner (Figure 3.7) cleaned the mounted samples to remove contaminants from tunnels, cracks and holes. The machine consists of a tank, net basket, a sink, a lid and control panel. Ultrasonic cleaning is accomplished by passing high-frequency sound waves for a set amount of time through the sample while submerged in the solution.

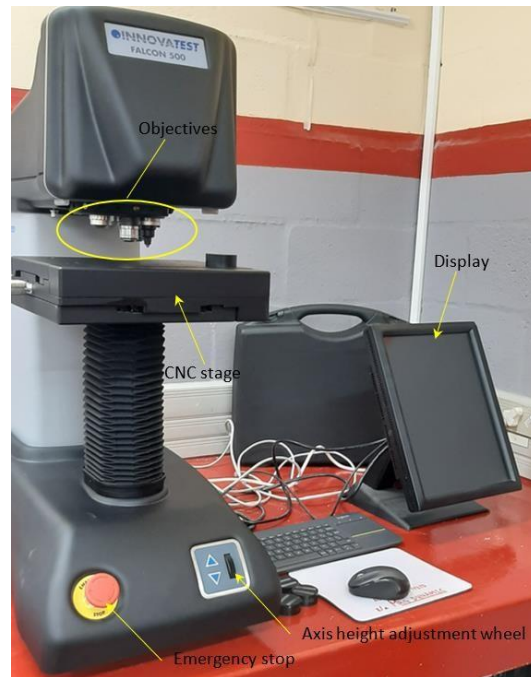
Figure 3.10: Falcon 500 micro-hardness tester

A hardness testing machine such as the Falcon 500 (Figure 3.10) can perform a variety of hardness tests using several hardness scales: the Vickers (HV), Rockwell (HR), Knoop (HK) and Brinell (HB). The machine includes a turret and optical system, a stage camera, a motorised CNC X-Y stage, and an operator interface (touch screen). The testing method entails using a diamond or hardened steel indenter to make an indentation on a flat ground sample surface under steady load under controlled conditions.

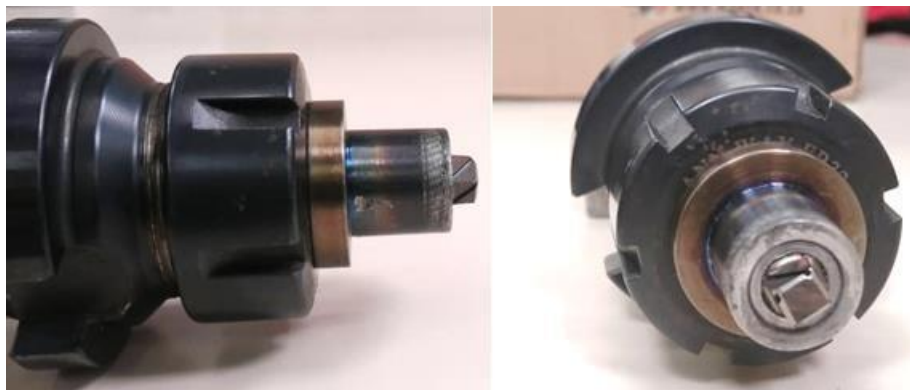
Figure 3.15: FSW tool

The square threaded pin-tipped tool (Figure 3.15) was plunged into the material until its shoulder made contact. The tool was allowed to dwell in contact with the material to create adequate heat to facilitate plasticisation while the pin stirred the mixture. While this was taking place, the tool was permitted to continue traversing along the joint line, forming a solid joint behind it. As the table was lowered at the completion of the weld, an exit hole in front of the tool from the pin was left on the work piece. Table 3.1 presents the welding setup parameters.

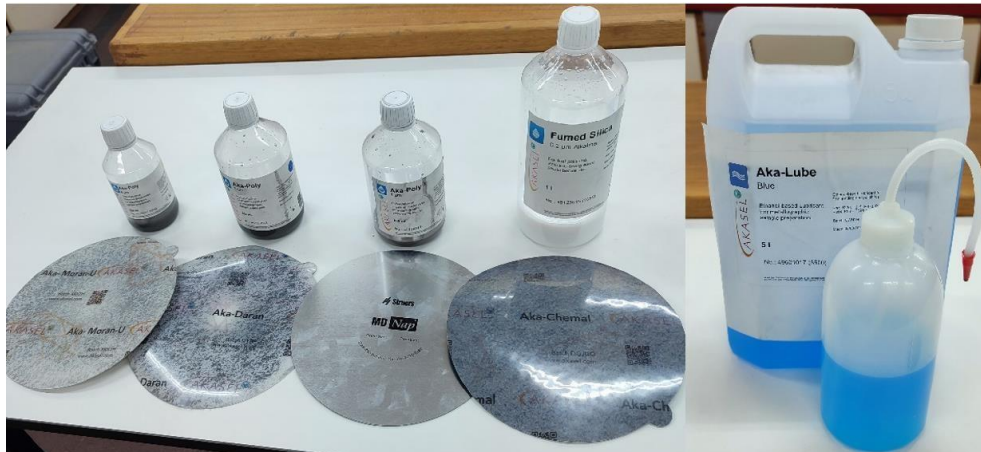
Figure 3.20: Discs and mediums

The grinding and polishing process of the macro/microstructural samples was conducted on the Struers LaboPol-5. The process was started by mounting the required disc on to the turntable. Once secure, the start button was pressed. Table 3.2 shows the discs and the mediums used for

each the polishing steps. The final step included rinsing the sample with ethanol and then drying. The procedure used in this study was adopted from the AKASEL Aka-Brief #4 Aluminium Alloys. Figure 3.20 shows the mediums for polishing.

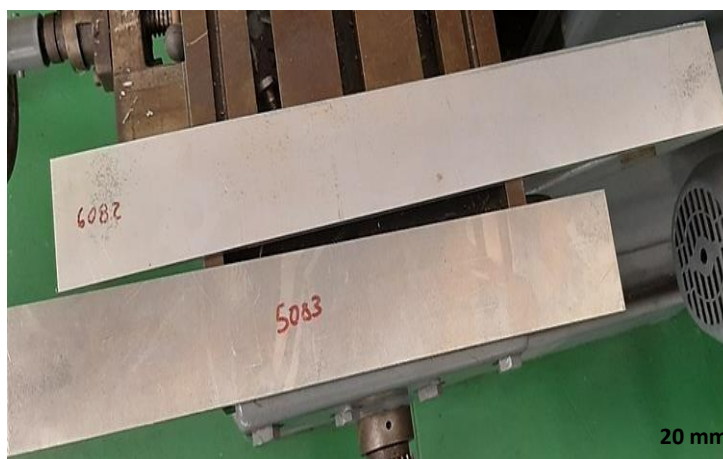
Figure 4.1: AA5083 and AA6082 blank materials

Figure 4.1 below depicts the blanks of the material used AA5083-H321 and AA6082-T651 prior to being welded. The Belec compact spectrometer HLC determined the chemical composition of each parent materials. Table 4.1 details the findings for chemical composition, showing that AA5083 had the highest concentration of Magnesium (Mg) followed by Manganese (Mn), and that of AA6082 had the highest content of Silicone (Si), followed by Mg. The primary elements—Mg for AA5083 and Si and Mg for AA6082—all fit within the previously mentioned limitations in the literature [75, 76]. Mg and Si function together to augment the strength of an alloy by enabling precipitation hardening to occur in the heat-treatable alloy and enhance metal wear and corrosion resistance properties without compromising its ductility [75, 77] Manganese may strain-harden intermetallic phases that have finely precipitated or solidified while maintaining ductility and corrosion resistance [78, 79].

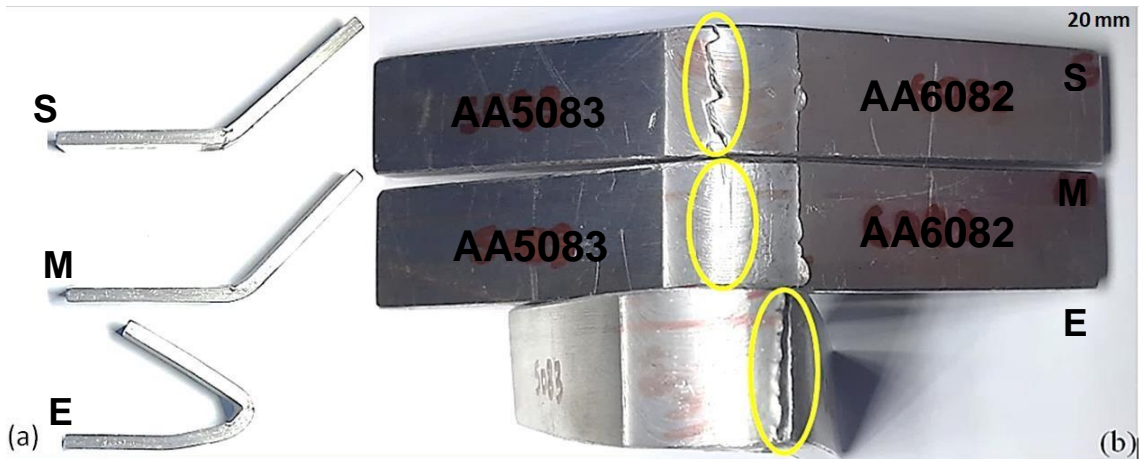
Figure 4.13: Face tested traverse samples (a) bent extent results and (b) surface and crack location results

Figure 4.13 (a) depicts the side views of the bent traverse samples, and Figure 4.13 (b) depicts the outcomes of the bent surface. The start sample was measured to an angle of 40° , exhibiting meandering crack encircled in the SZ closer toward the advancing side. The failure of the start sample may have been induced by the tunnel defect that was observed, rendering it less impervious to failure [118]. The surface of the middle sample, showing a surface thinning/stretching effect, was bent to 46° . This surface stretching can be a sign that the surface material of the joint was strong enough to withstand fracture propagation. To draw attention to the failure positions on each sample, yellow borders have been used to surround them (Figure 4.13 [b]). The key factor that could have contributed to these outcomes may have been the increased strength provided by the finely ground grains under the tool shoulder [119]. The end sample bent to an angle of 150° ; cracking occurred at the interface of the TMAZ and PM (AA6082) being the softer of the two materials [120]. This one-sided behaviour shows that the joint is significantly stronger than the PM on which the failure occurred [121-122]. The graphical presentation of the traversal findings is presented in Figure 4.14. The samples' strengths were determined at the SME locations as 6.414 MPa, 47.513 MPa and 78.575 MPa, respectively, indicating an increase in relation to the position.

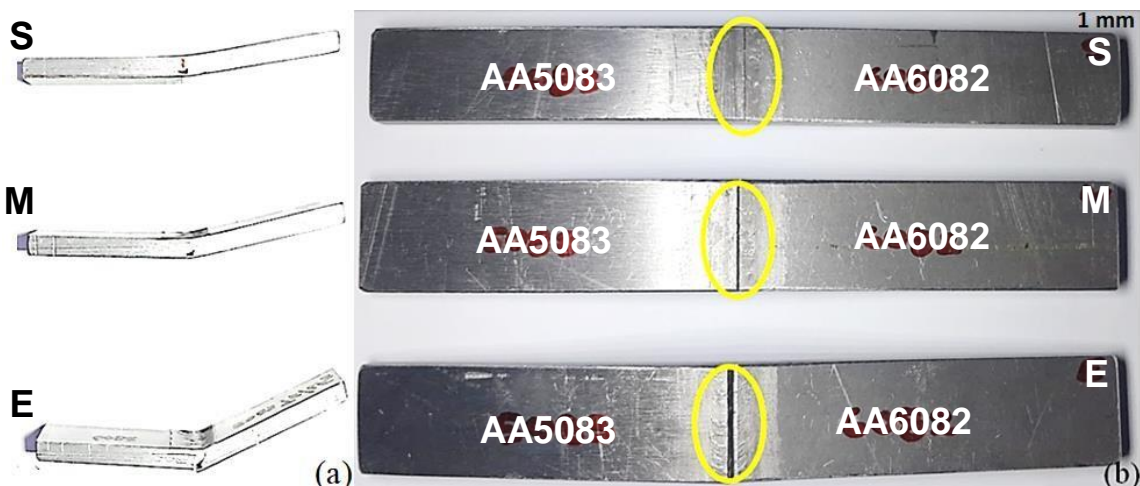
Figure 4.17: Root tested traverse samples (a) bent extent results and (b) surface and crack location results

Figure 4.17 (a) depicts side views of the traverse root tested samples, and Figure 4.17 (b) depicts bent surfaces of the samples. All the samples from the SME locations achieved maximum deflection angles less than 90°, reaching the bending angles of 5°, 10° and 20°, respectively, as seen in Figure 4.17 (a). All three samples appeared to develop a fracture at the joint line circumscribed by yellow borders (Figure 4.17 [b]). This behaviour may have been attributed to inadequate pressure, and a lack of penetrating or stirring, particularly at the plate's bottom [121,128-129], or in essence, the disparity between the input applied heat and the rate of heat transmission into the materials [130]. Furthermore, the joint's strength may have decreased

due to the presence of tunnel defects and internal microcracks. Furthermore, given that fine grains are known to contribute to joint strength, it is probable that the grains near the joint's bottom were less affected by the pin's churning, rendering the area more susceptible to cracking [131].
