**DESIGN AND DEVELOPMENT OF HERITAGE MORTAR
FOR RESTORATION**

MAPHOLE EMELLY LOKE

**Doctor of Engineering: Civil Engineering at the
Cape Peninsula University of Technology**

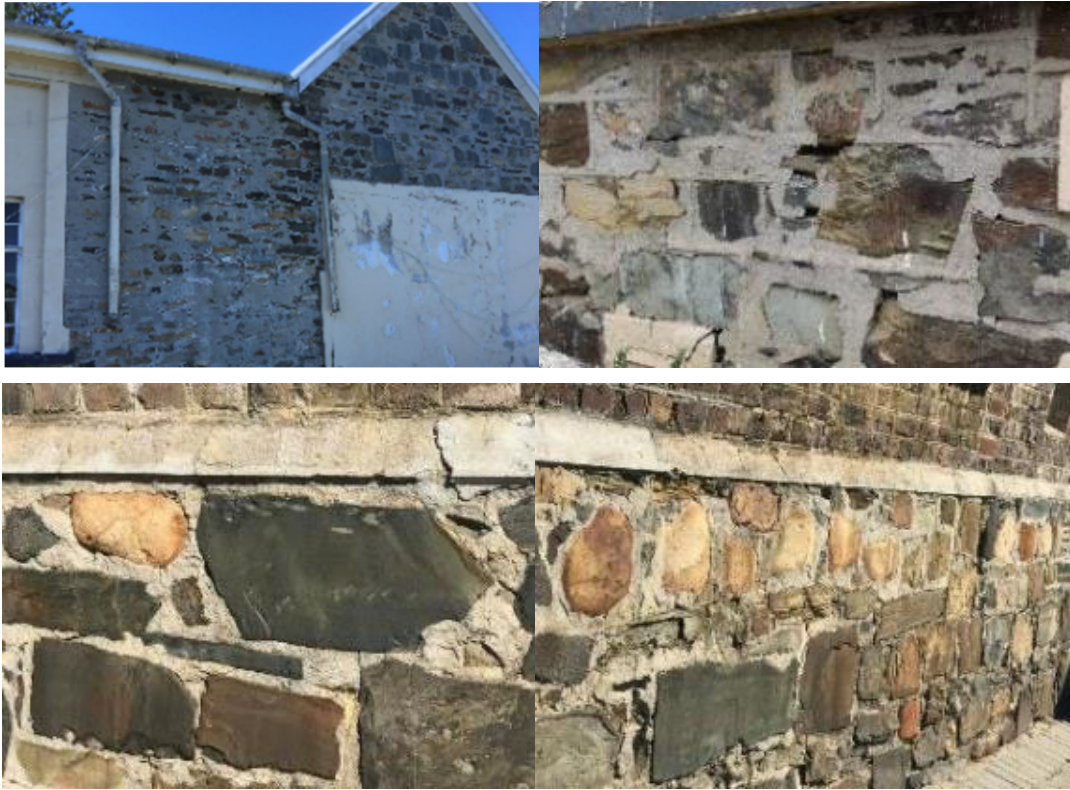
Figure 1.2 Faulty mortar repairs on some buildings on Robben Island

The restoration work conducted on these structures leaves many of the heritage buildings as safety hazards as these monumental structures undergo premature deterioration of such repairs (Al-Ostaz *et al.*, 2010 and Lukovic, 2016). According to Arito (2018), just half of the 215 case studies conducted in the United Kingdom by the Building Research Establishment (BRE) on the performance of concrete and mortar restoration materials were effective. He further highlighted that some researchers - Tilly (2006), Matthews (2007), Tilly and Jacobs (2007), Matthews and Morlidge (2008) studied 230 repair cases in Europe; of them, 20% displayed signs of failure within 5 years, 55% within 10 years, and 90% within 25 years of service. The buildings investigated were found to be more prone to cracking and debonding of repairs. Several research is undertaken in this regard to establish the root causes of early repair failure in these structures.

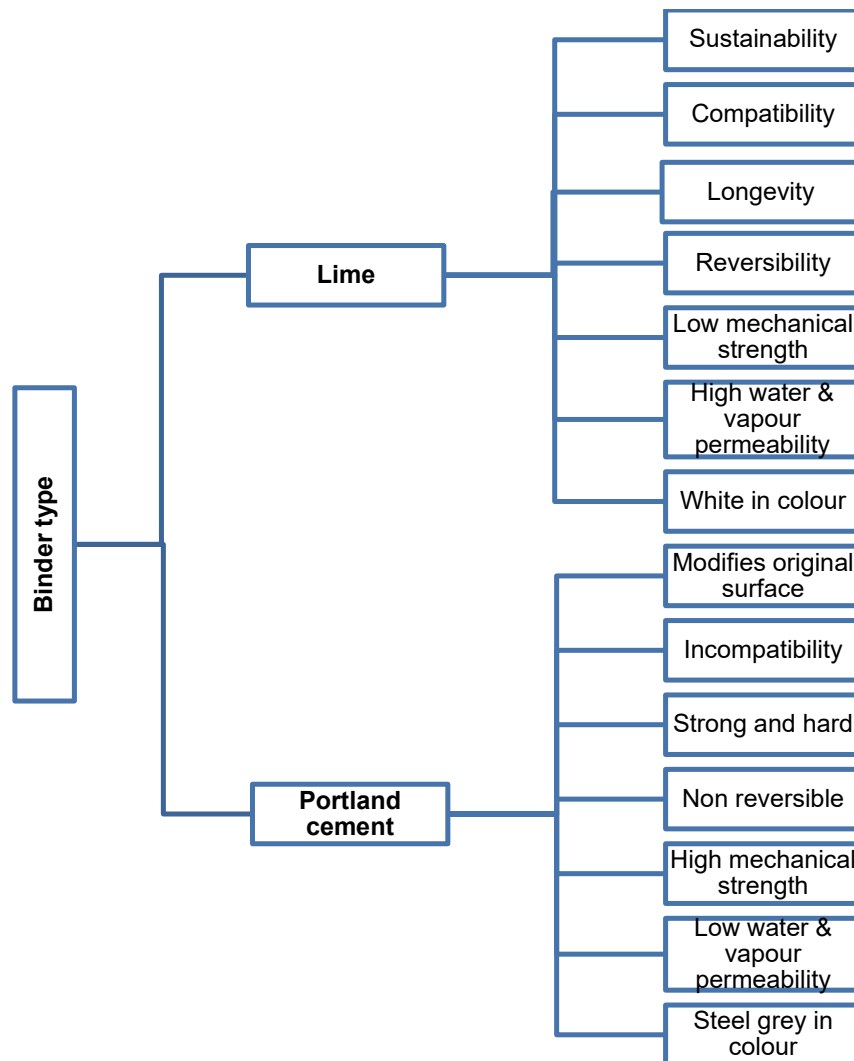
Figure 2.1 Lime-based mortar characteristics against Portland cement-based mortar characteristics (derived from Arizzi, 2012 and Palomo *et al.*, 2014)

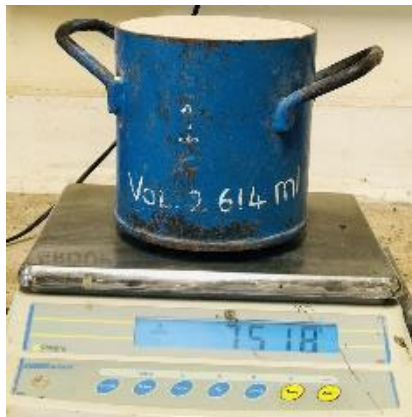
Figure 3.8 Determining the densities of aggregates using SANS 3001-GR6, Part 6

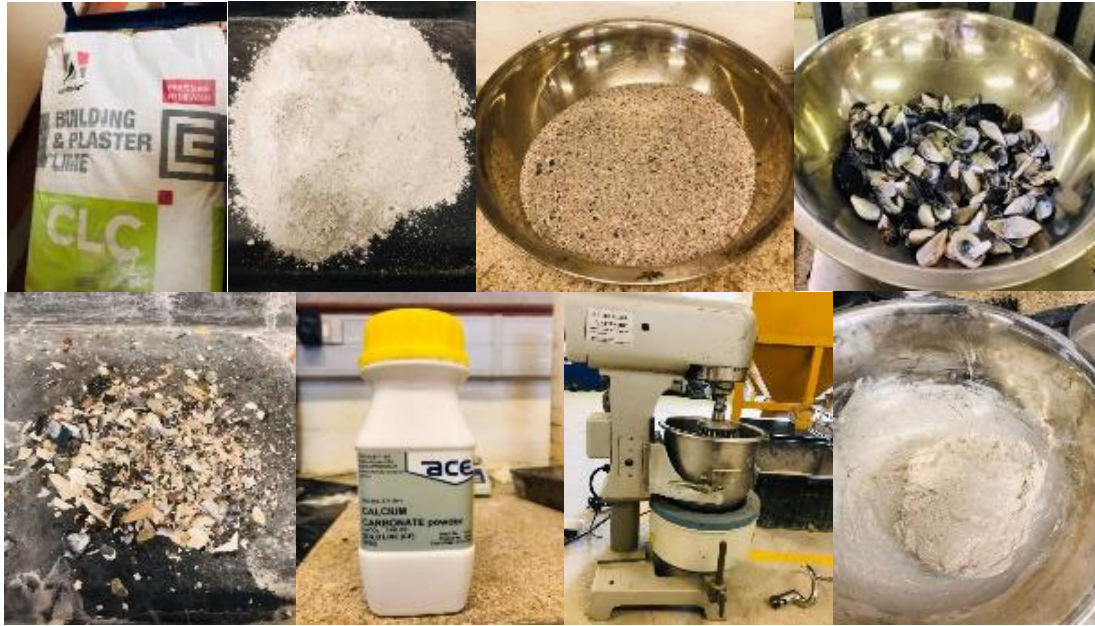
Figure 3.9 Raw materials (from left to right): hydrated lime, sea sand, seashells and calcium carbonate and mixing procedure for new mortars using both machine mixing and hand mixing

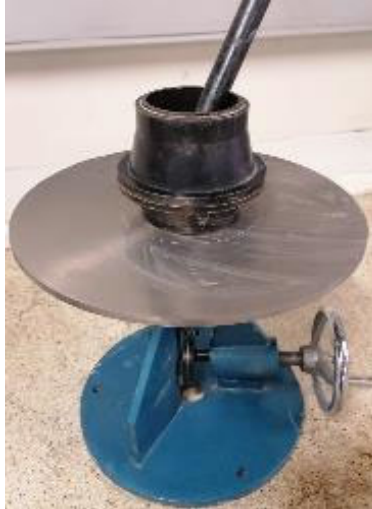
Figure 3.10 Fresh mortar workability testing using a flow table test

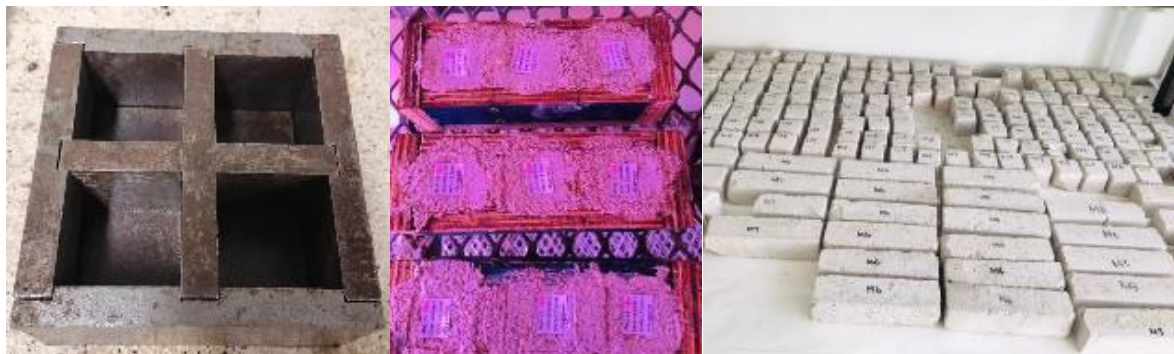
Figure 3.11 Mortar cubes preparation, casting, demoulding and curing procedure

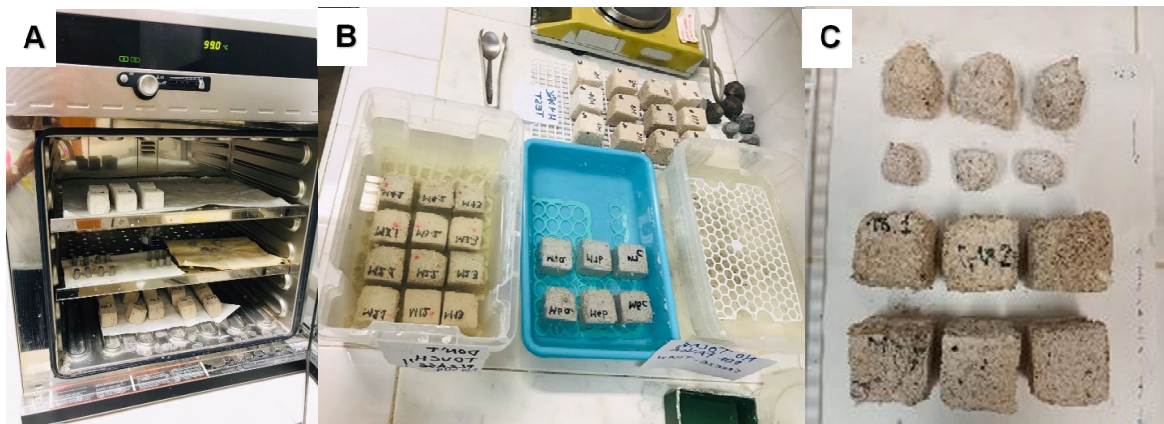
Figure 3.13 Samples during salt crystallisation cycles demonstrating A) Drying of samples at 100°C B) Immersion in deionised water and C) Change in weight and shape over the 15 cycles

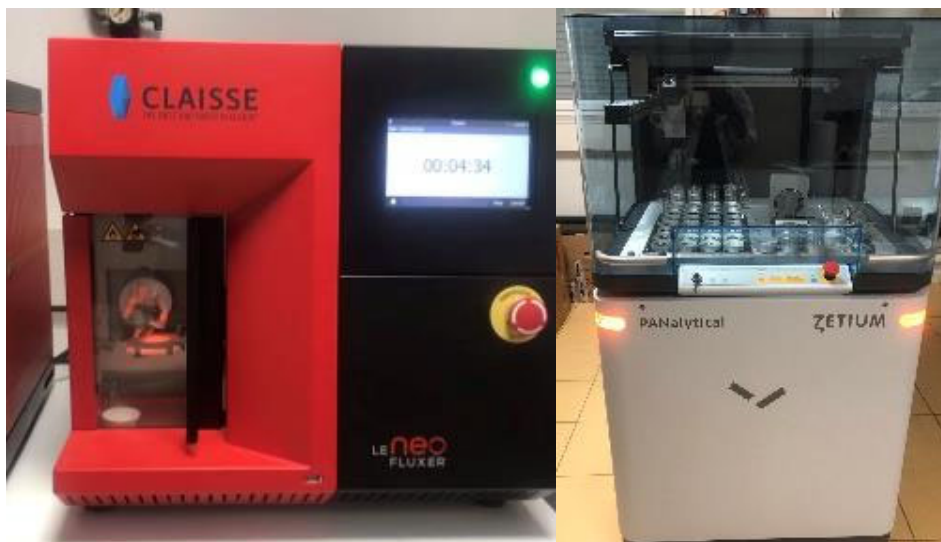
Figure 3.18 The XRF Claisse LeNeo fusion and PANalytical Zetium compact spectrometer

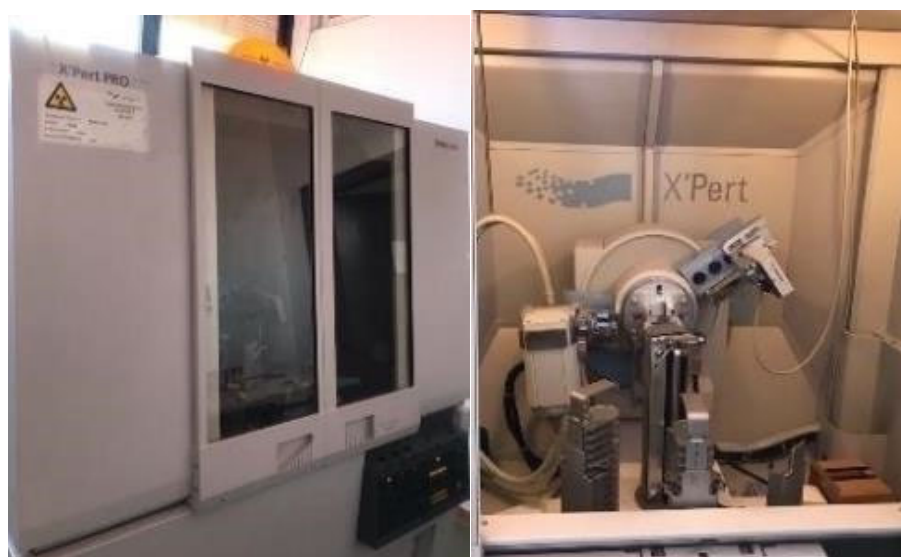
Figure 3.19 X-ray diffractometer Malvern Panalytical X'Pert PRO

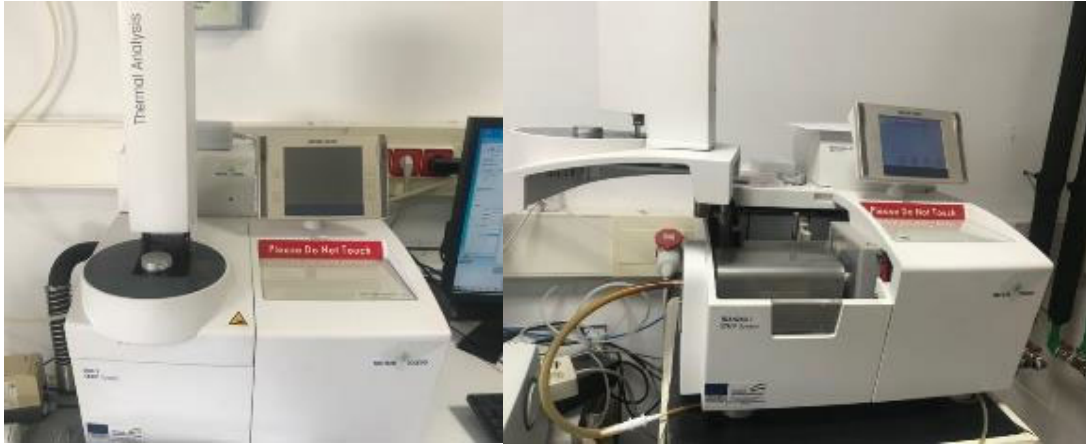
Figure 3.20 The TGA/DSC 1 HT/851 DIC-2021-2 instrumentation for analysing the thermal weight loss of binder content in mortars

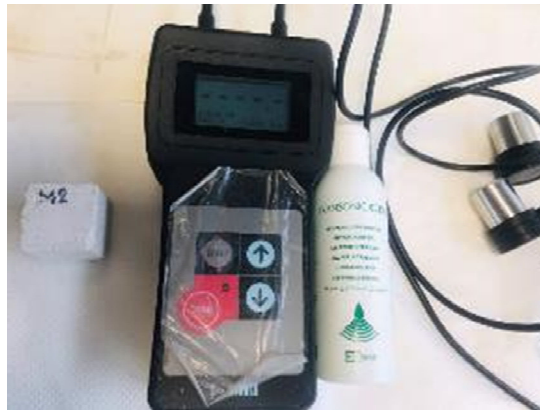
Figure 3.21 The UPV tester used to test mortar compactness using transducers with 54 kHz frequency on three perpendicular sides of 40 mm³ cube mortars

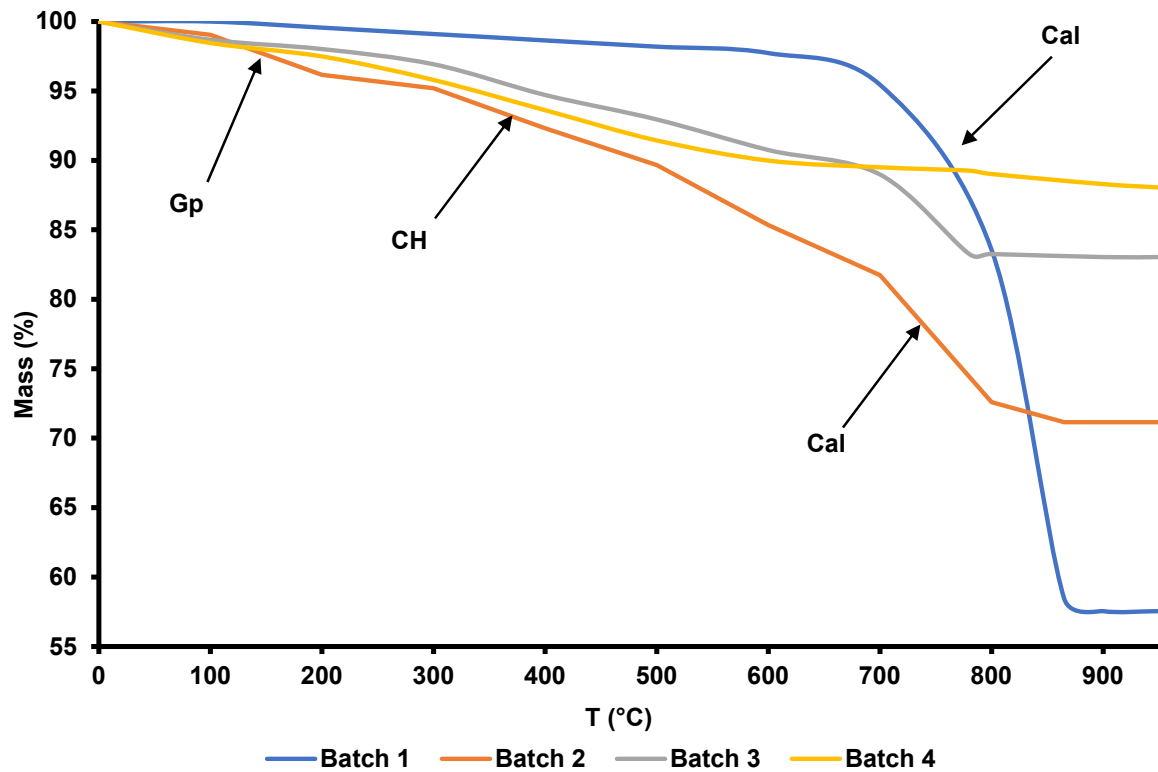
Figure 4.5 TGA curves for original Castle mortars show the weight loss over increasing heating temperature over a period of time. Legend: Batch 1 mortars represented by SK1 showed a similar pattern while Batch 2 represents sample SK2, Batch 3 represented by SK7 with a similar pattern, and Batch 4 represents SK8. Legend: Calcite: Cal, gypsum: Gp, portlandite: CH

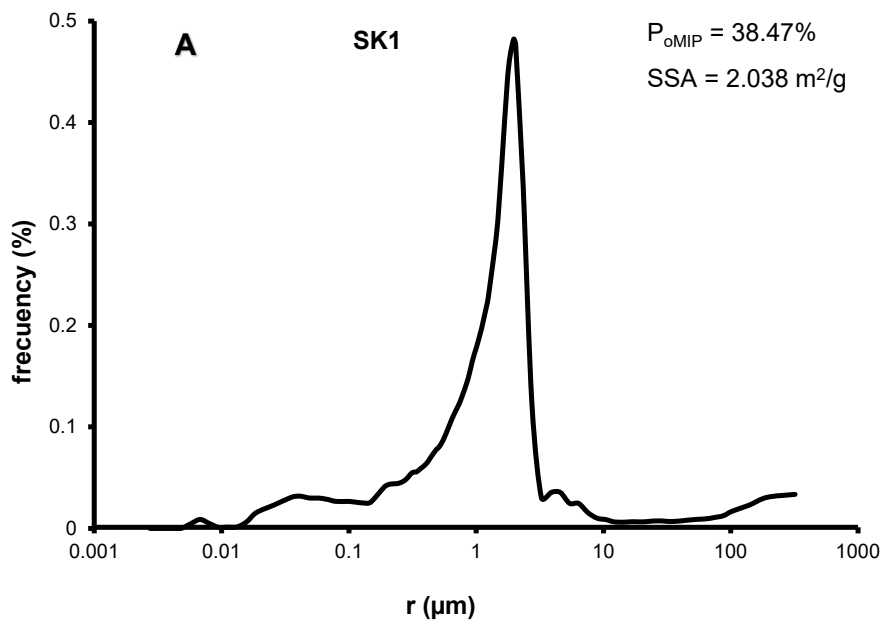
Figure 4.9 Pore size distribution curves of mortars from the Castle of Good Hope and pre-primary school on Robben Island determined by mercury intrusion porosimetry. Frequency (in %) versus pore radius (in μm). Open porosity (P_{oMIP}) and specific surface area (SSA) values are indicated in each diagram.

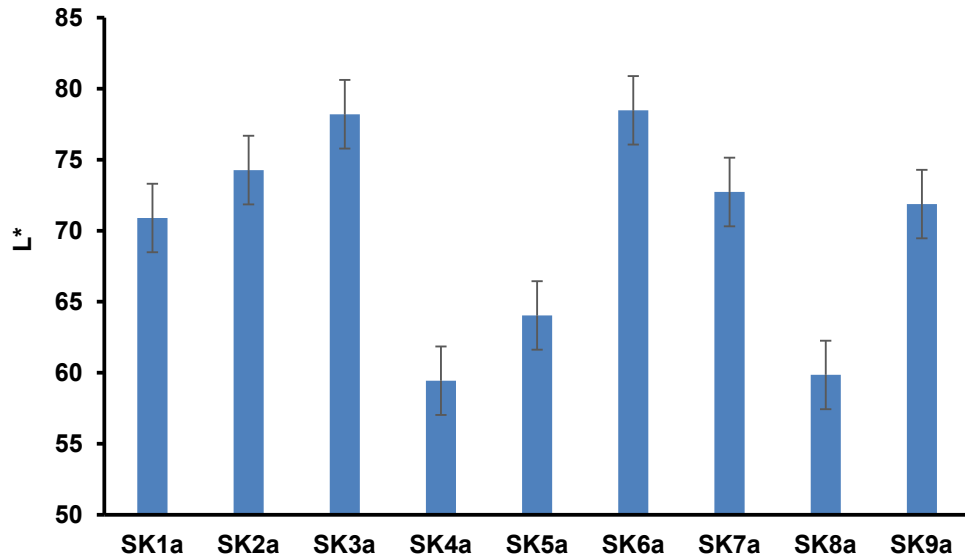
Figure 4.13 Lightness (L^*) coordinates for binders from Block B- kitchen (1666) on the Castle of Good Hope

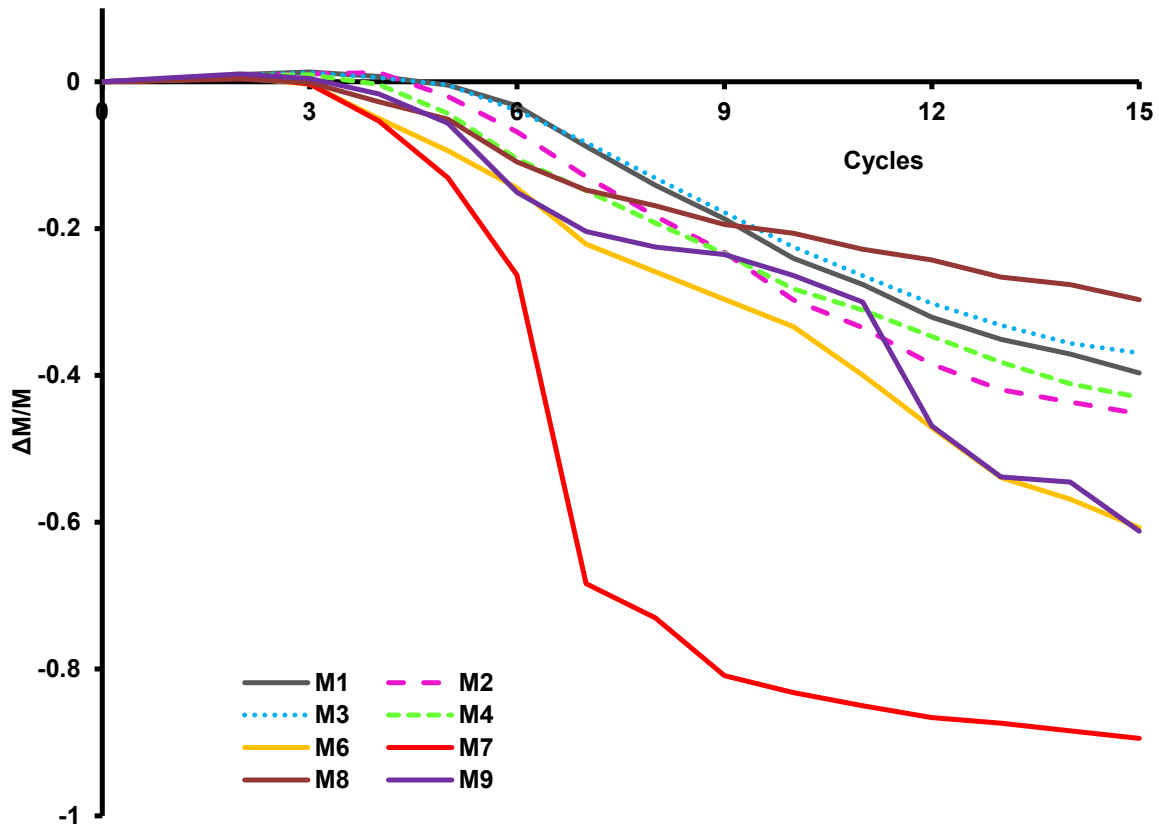
Figure 4.18 Salt crystallisation test of new repair mortars. Weight variation ($\Delta M/M$) versus number of cycles
