**WATER AVAILABILITY, INFRASTRUCTURE MANAGEMENT AND WATER
GOVERNANCE IN THE GOEDVERWACHT HISTORICAL SETTLEMENT IN THE
WESTERN CAPE, SOUTH AFRICA**

Master of Engineering: Civil engineering

at the Cape Peninsula University of Technology

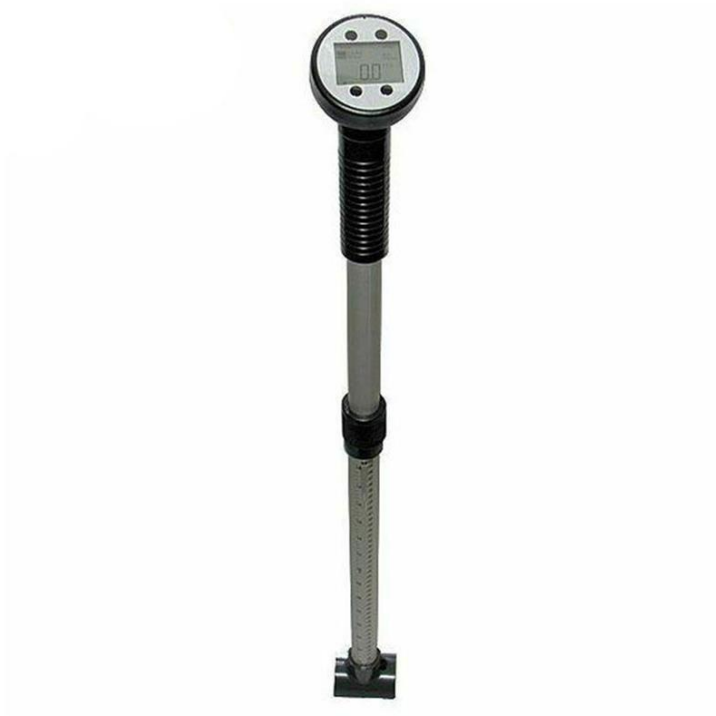
Figure 3.3: A Global water flow probe (YSI, Yellow Springs (OH), United States)

Water flow velocities were measured using Global Water Flow Probe equipment (FP211) as depicted by Figure 3.3. It was chosen for its accuracy in measuring water velocity, especially in irrigation canals, which are prevalent in the selected study area. The primary objective was to measure the amount of water delivered to smallholder farmers through the irrigation system (Figure 3.4). To obtain more accurate velocity readings, the channel was divided into sections. Measurements were conducted in April 2024, during a season of low rainfall in the Western Cape region of South Africa. Two research assistants carried out the measurements as part of the main WRC project. During the water flow measurement process, the probe was submerged in water, ensuring the propeller was correctly oriented with the water flow, and gently moved three times across the channel section. To reduce errors, the probe was set to take average readings by averaging several measurements, rather than repeating the process multiple times at each point.

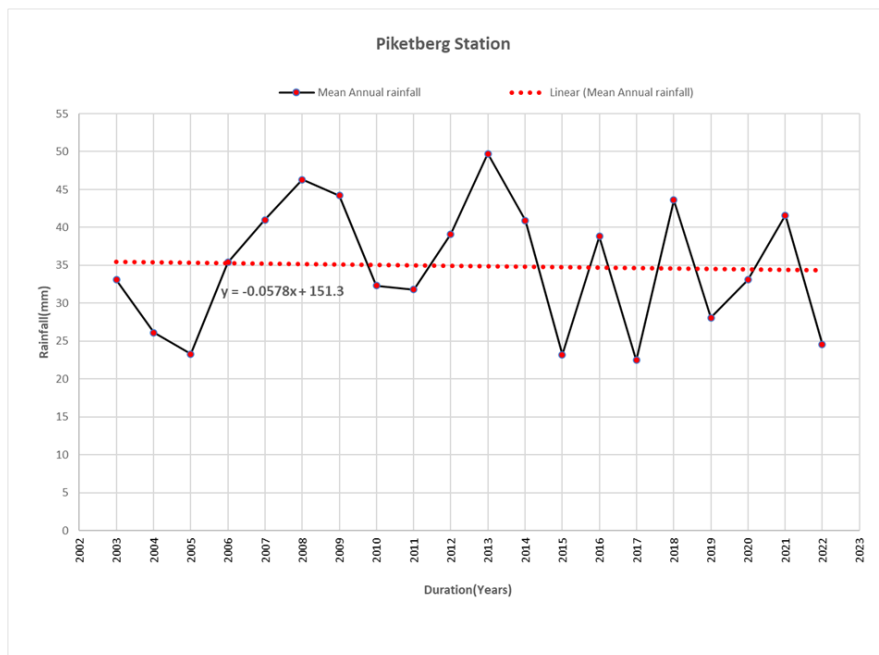
Figure 4.3: Mean annual rainfall trend for Piketberg rainfall station from 2002-2022

The Piketberg station, being a rainfall station, exclusively recorded rainfall data and did not include temperature measurements when received from SAWS. The highest mean annual rainfall (49.9 mm) for the study duration (2002-2022), was recorded in 2013 (Figure 4.3). The average rainfall data reveals the inconsistency of rainfall patterns in this area. Heavy rainfall is often followed by drought events, and conversely, droughts may be succeeded by periods of excessive rainfall. The lowest mean annual rainfall was recorded in 2005, 2015 and 2017 with just below 25 mm rainfall recorded, with 2017 being the worst year with the lowest rainfall recorded. To ascertain the trend in the rainfall data over the past two decades, an equation was generated using Microsoft Excel software.

The observations by Lakhraj-Govender and Grab (2019) align with the results from the Piketberg station, where a decreasing trend in rainfall was observed. However, it is important to note that the findings differ from those at the Porterville station, which exhibited an increasing rainfall trend during the study period. It should be acknowledged that conducting a fair comparison necessitates the use of data over the same duration. Remarkably, when the Porterville station was analysed for the same 30-year period, it displayed similar characteristics of decreasing rainfall trends (Figure 4.5). Many other parts of the Western Cape experienced similar rainfall levels (Dippenaar, 2022). Vyeboom-Villiersdorp saw the most sustained rainfall deficit, with below-average totals in all four years from 2015 to 2018. In Ceres, rainfall was below the long-term average in 2016 and 2017, with 2017 receiving less than half the typical amount. Groenland's rainfall varied across the period: 2016 and 2018 were wetter than average, while 2015 and 2017 were drier.

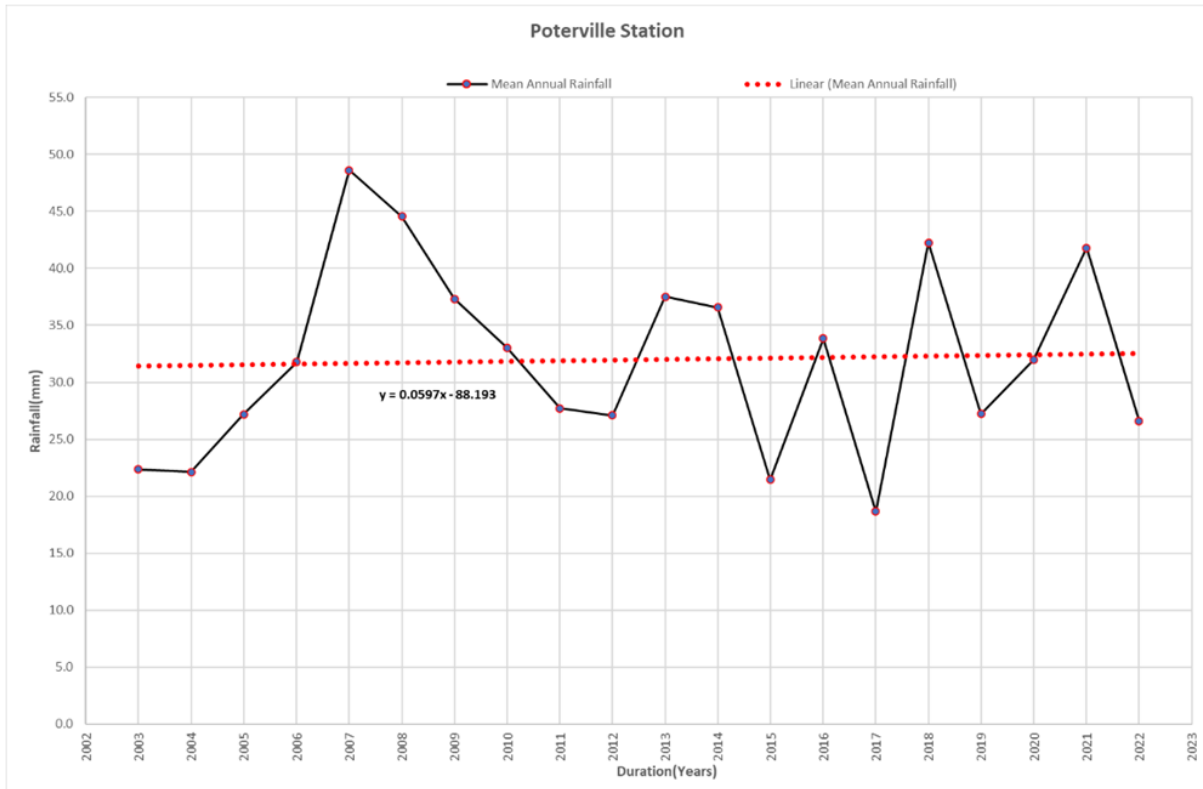
Figure 4.4: Mean annual rainfall trend for Porterville rainfall station from 2002-2022

The highest mean annual rainfall for the Porterville station was recorded in 2007, utilizing data encompassing 20 years (2002-2022) of rainfall records (Figure 4.4). The lowest mean annual rainfall was recorded in 2004, 2015 and 2017, and was below 25 mm. Notably, this station demonstrated a positive trend, indicating an upward trajectory in rainfall over the past two decades. However, both rainfall stations reported their lowest recorded rainfall in the same years, i.e. 2015 and 2017. This outcome is not surprising, given that this period marked a phase during which a significant portion of the Western Cape Province encountered reduced rainfall. Subsequently, this drought condition prompted the declaration of drought emergency in the province. Winter rain, occurring from June-August, is of great importance to the Western Cape Province, and the 2015-2018 drought had severe implications for the agricultural sector (Archer et al., 2019). Both stations recorded similar rainfall in the year 2004 and 2005, which was also the lowest level below 25 mm. The Pikertbeg station recorded a rainfall of 23.3 mm in 2005 and Porterville recorded 22.1mm in 2004. Porterville station also recorded the lowest rainfall 22.4mm in 2003. These stations displayed similar data, with slight variation.

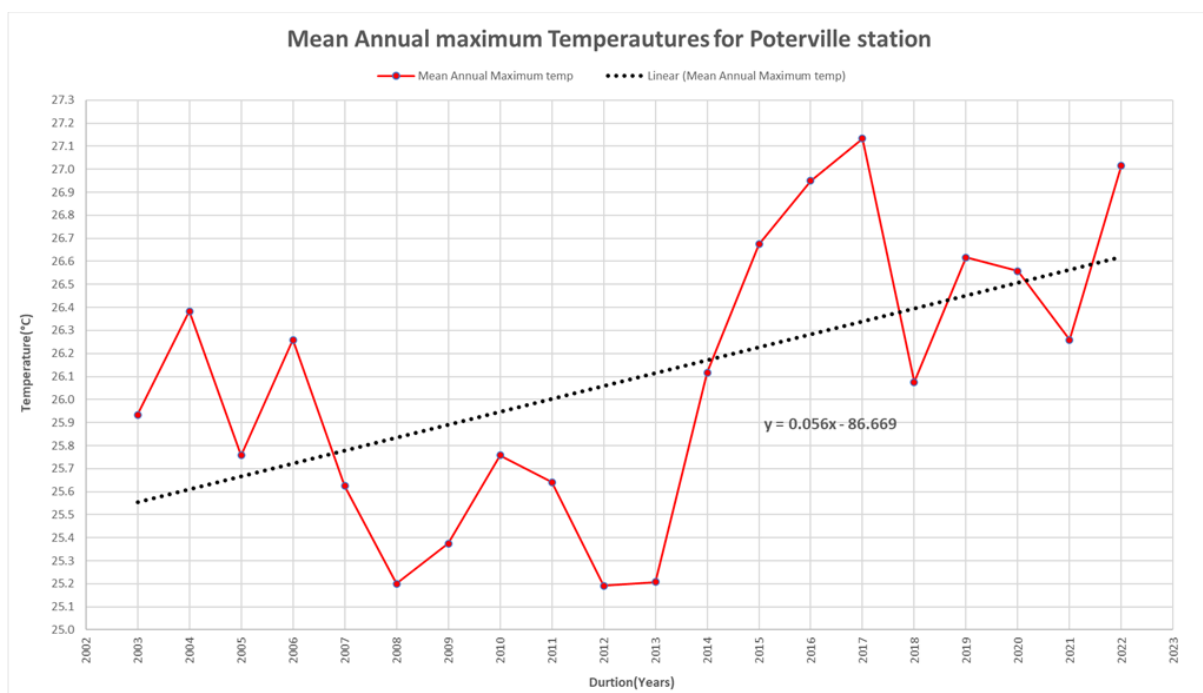
Figure 4.6: Mean annual maximum temperature for Porterville rainfall station from 2002-2022.

2016, and 2017. Furthermore, 2017 stood out as the warmest year on record that was not influenced by an El Niño event. The warming trend aligns with the trends identified by Theron et al. (2021) in their trend analysis, aimed at determining whether drought observations are part of the long-term trends in the Western Cape Province. Their findings, based on data from six stations across the region, as depicted in Table 4.4, reveal that from 1988-2018, the Western Cape consistently experienced prolonged drought conditions characterized by high spatial-temporal variability. Furthermore, the authors noted that this drought was most severe during the 30-year study period at five of the six stations. There has been a noticeable increase in temperatures across South Africa in the past 40 years. During the summer months of 2011-2012, temperatures higher than 26°C were observed in the Northern Cape, Northwest, Limpopo and northern parts of KwaZulu-Natal Provinces (SAWS, 2014). Climate change projections show some degree of increased temperature in the range of 1.5 to 3 °C for the mid-century (2040–2060) (Western Cape Government, 2018a).

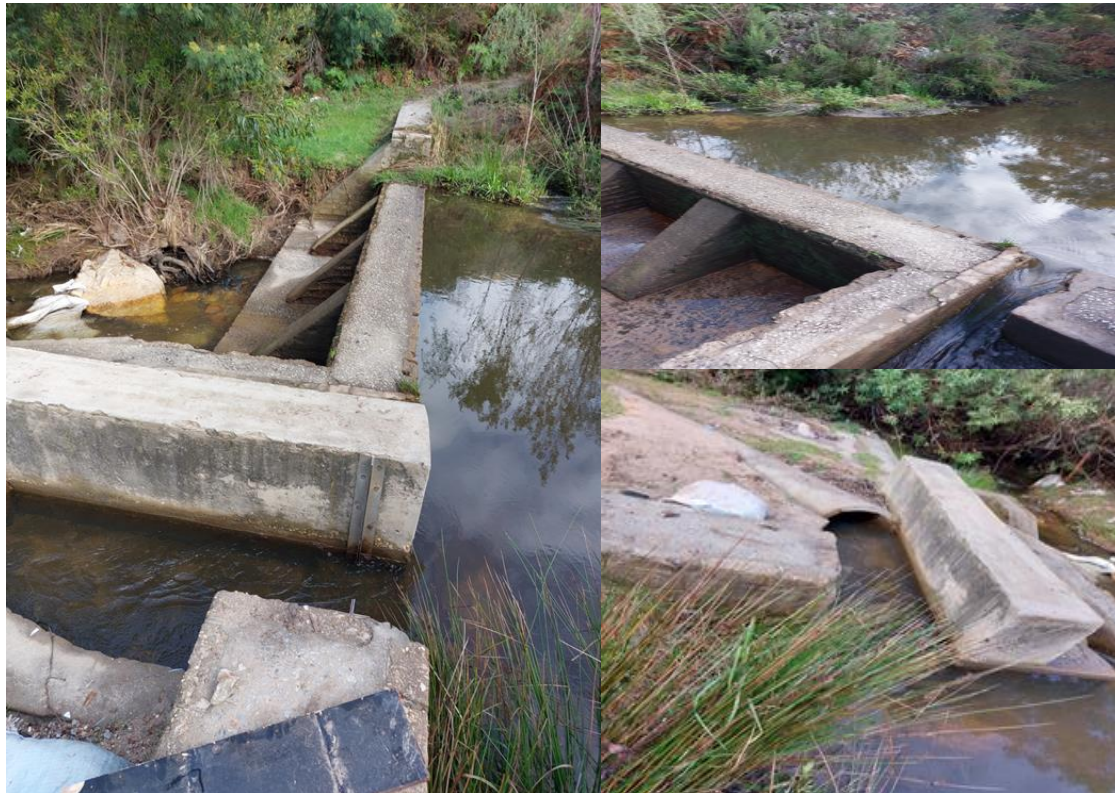
The smallholder farmers in Goedverwacht received their water for agricultural use through a weir constructed in the Platkloofrivier (Figure 4.7). The weir is used to divert water from the river to the farmers downstream. Based on the visual inspection, the weir was designed and constructed to ensure even distribution of water flowing downstream and diverting water to the smallholder farmer's irrigation systems through openings on the same level. There was a visible configuration for a sluice gate at the entrance of the canal used for water diversion, however, no sluice gate was attached. The opening for river water that flowed downstream, did not have a sluice gate configuration. There were visible sandbags nearby, which, according to the farmers, were used during the summer season when the river flow decreased, to increase the flow to the canal. The weir structure showed no major cracks, with slight exposed aggregates mostly at the corners of the structure.

Figure 4.7: The weir in the Platkloofrivier which is used to obtain irrigation water

The cross-sectional area of 715 mm and 690 mm was measured for the offtake structure that conveys water from the weir to the concrete pipe. The offtake is constructed using reinforced concrete and concrete blocks, running for a length of 1.7 m. It transitions into a 525 mm nominal diameter concrete pipe, which is 2.5 m long and has a cut at an angle on the female joint side. The condition of the offtake structure appeared to be fine, with minor aggregate exposed, especially on the apron slab.

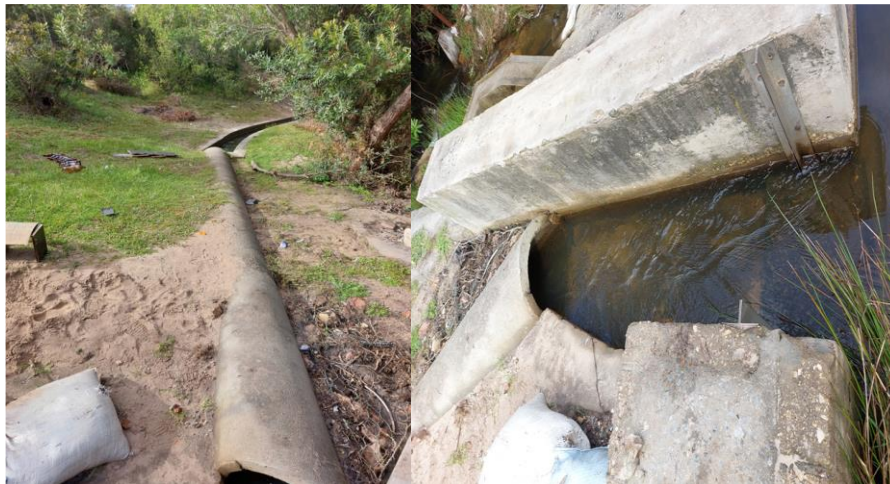
Figure 4.8: Concrete pipe

The concrete pipe is partially buried underground, and there is no visible encasement to prevent pipe movement caused by soil pressure, water pressure, and soil erosion (Figure 4.8). However, the concrete pipe appears to be in good condition, with no fractures or visible reinforcing materials. The measured inside diameter of the pipe was 525 mm.

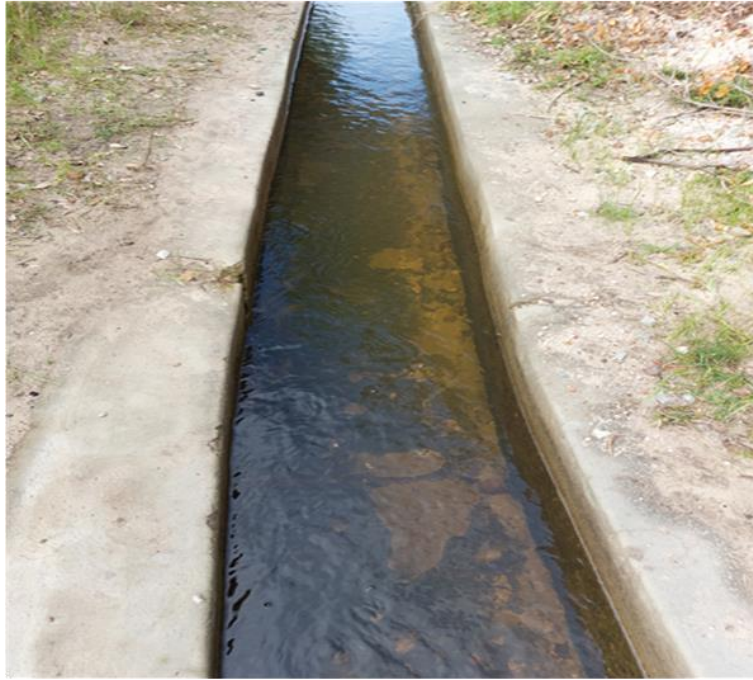
The concrete pipe transitions into the rectangular main lined concrete canal (Figures 4.8 and 4.9). The concrete rectangular canal measures 300 mm in width, 443 mm in depth, and extends over a length of 3 m. Since the water was clear during the site visit, the condition of the canal was visible, revealing minor defects but an overall structurally sound condition. The canal follows a curved path, following the natural ground level slope, all the way to the rectangular sedimentation tank.

Figure 4.9: Canal conditions

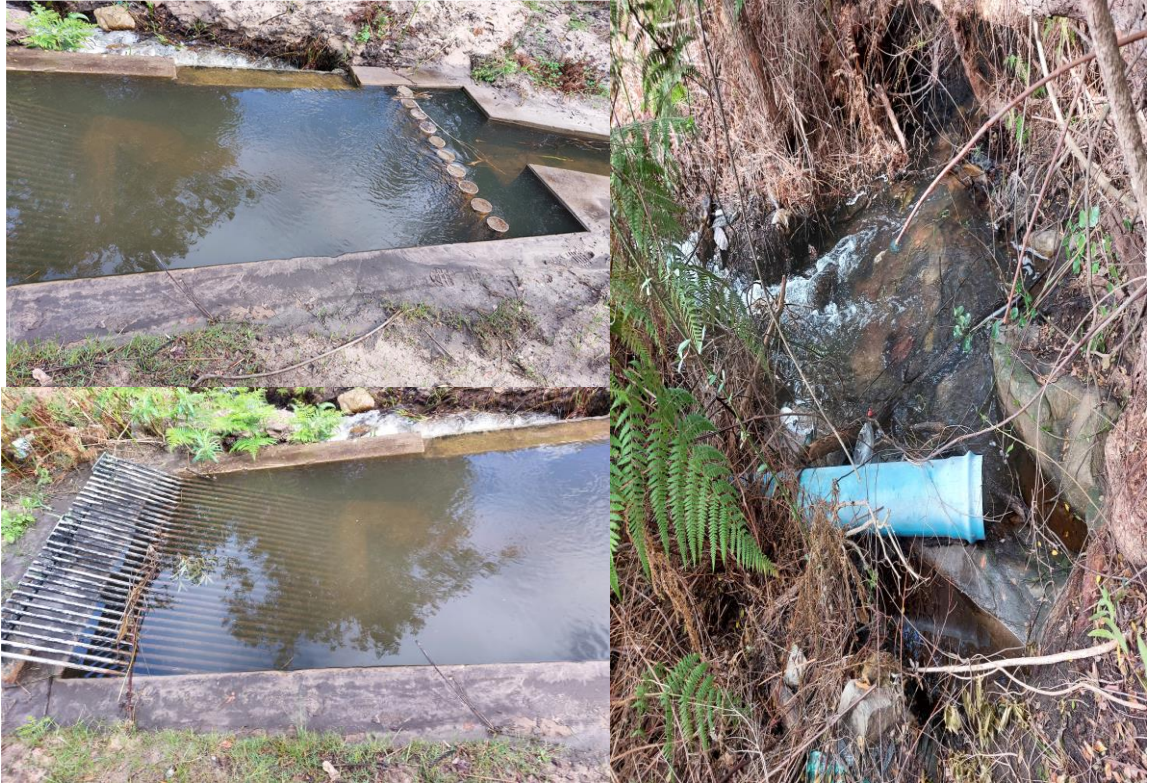
Figure 4.10: Sedimentation tank

The sedimentation water storage tank (Figure 4.10) is connected via a 300 mm x 447 mm concrete canal. The tank has a rectangular shape with a length of 3300 mm, a width of 1400 mm, and a depth of 700 mm. Inside the storage tank, there are ten 100 mm diameter uPVC pipes cast at the base of the tank vertically, each cut to an equal length of 780 mm. These pipes are cast into the base of the tank with equal spacing of 40 mm between them, and they are filled with concrete as measured. The 100 mm diameter pipes serve as screens to remove large objects that enter the storage tank and slowing water velocity inside the tank.

The storage tank has two main 200 mm PVC water pipes connected at the invert level. One pipe gravitates to the farmers, while the other is used for washout to the river stream during the cleaning of sediments inside the storage tanks. When the main pipe is in use, the pipe used for cleaning is closed using a sandbag as a flushing sluice, and no water flows into that pipe. The storage tank has an overflow section, which is 1000 mm wide and 50 mm deep, located at the top level on the side facing the river. The storage tank is equipped with a bar screen at the outlet section, where the pipe inlet is located for water transportation to the farmers. The bar screen consists of 30 steel bars, each measuring 12 mm in diameter, and they are spaced at equal intervals of 40 mm. The screen serves the purpose of deliberately capturing small objects that may manage to pass through, and it requires regular cleaning as it might clog if not taken care off.

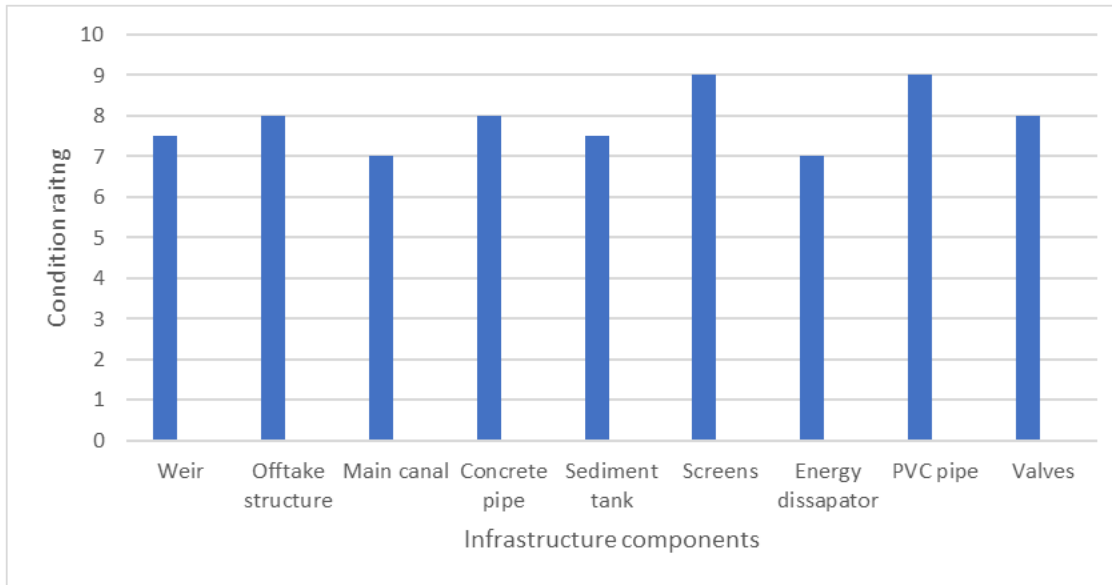
Figure 4.11: Study infrastructure condition rating

The results of the condition assessment (Figure 4.11 indicate that all evaluated components, including the weir, offtake structure, main canal, concrete pipe, sediment tank, bar screen, energy dissipator, PVC pipe, and valves, achieved condition ratings above 7. This suggests that the infrastructure is generally in good condition, with no significant structural defects, leakage, or deterioration observed. Such results are indicative of sound construction quality and effective maintenance practices. Although no detailed hydraulic modelling was undertaken, the good condition ratings of the conveyance and control structures provide a strong indication of satisfactory hydraulic performance under current operating conditions. The absence of visible sediment accumulation, structural deformation, leakage, or flow obstructions suggests that the system can convey design flows with limited hydraulic losses. Consequently, infrastructure condition is unlikely to be a limiting factor to water delivery efficiency at present.

Infrastructure condition scores were used as simple performance indicators, where higher scores represent satisfactory operational performance, low failure risk, and minimal maintenance requirements. Components with ratings above 7 were classified as being in good to very good condition, indicating that they are structurally sound, well-maintained, and capable of fulfilling their intended function without immediate intervention. These thresholds are consistent with commonly applied infrastructure management norms, where assets scoring within this range are considered serviceable and compliant with acceptable operational standards.
