**Impact of continuous temperature variations on the strength of
railway line steel**

Thesis submitted in fulfilment of the requirements for the degree

Master of Engineering: Mechanical Engineering

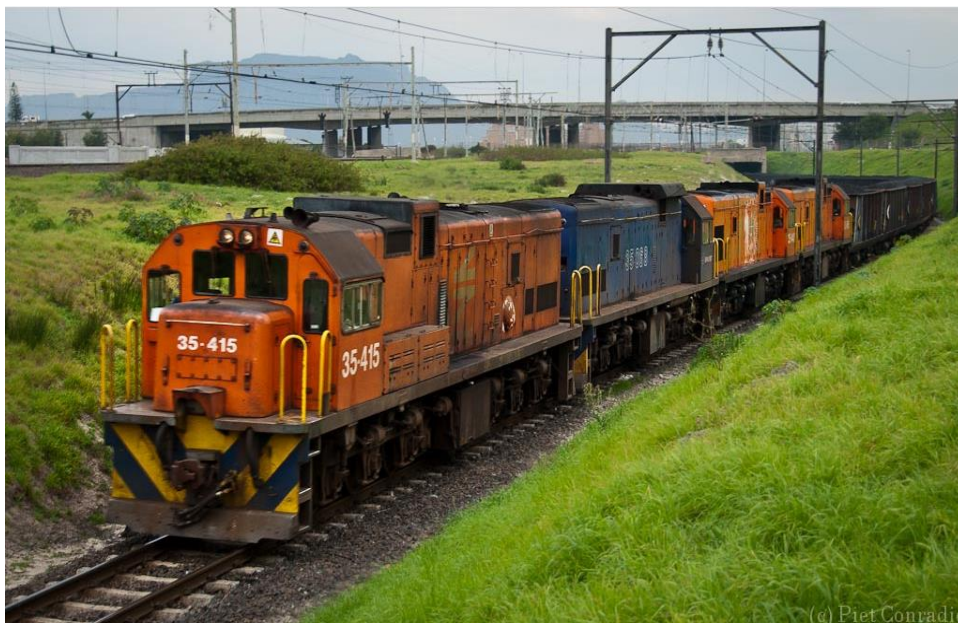
Figure 1.3: Loaded freight rail from Bellville Transnet yard (Conradie, 2012)

Figure 1.3 shows a coal freight rail fully loaded, departing from Transnet yard in Bellville.

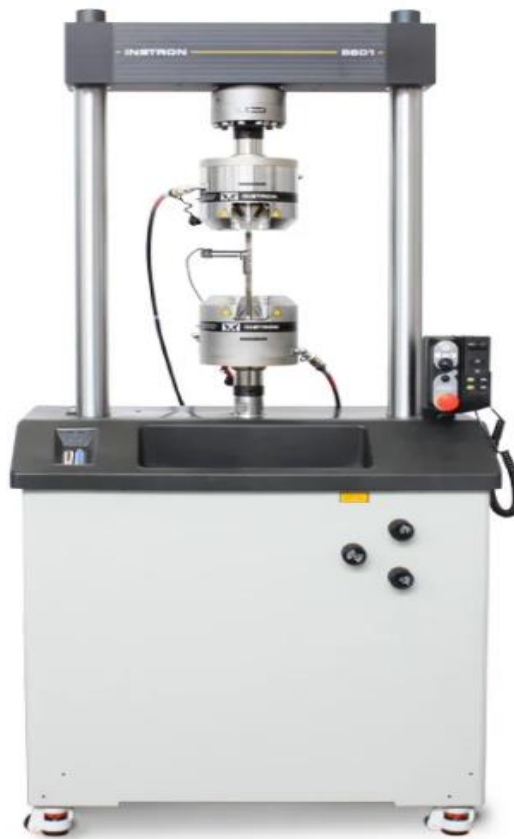
Figure 3.1: Instron Machine 8801 - Fatigue Testing System

The 8801 Fatigue Testing System is a servo-hydraulic testing system for static and dynamic testing with a large workspace, rigidity, precision alignment and a capacity of up to 100 kN.

Three of four specimens were exposed to a fatigue test on a repeated vertical linear load of 50kN using the Instron Machine (see clamping of specimens in Figure 3.8 d). Each specimen was under the load of 50 kN, but the difference was in times. One specimen was under load for six minutes, another one for eight minutes and the last one for 10 minutes.

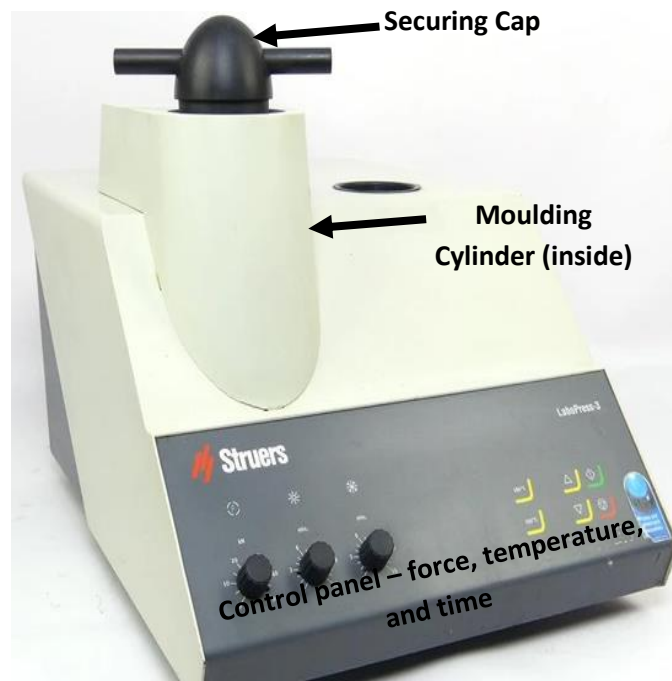
Figure 3.2 Struers LaboPress-3 Thermal Compression Moulding Machine

Struers LaboPress-3 Moulding Machine is an automatic electro-hydraulic metallographic mounting press with 32mm mould cylinders diameter, 40mm diameter securing cap, water cooling supply and drain. It has temperature, force, and time (heating and cooling times) setting parameters for monitoring compressed samples.

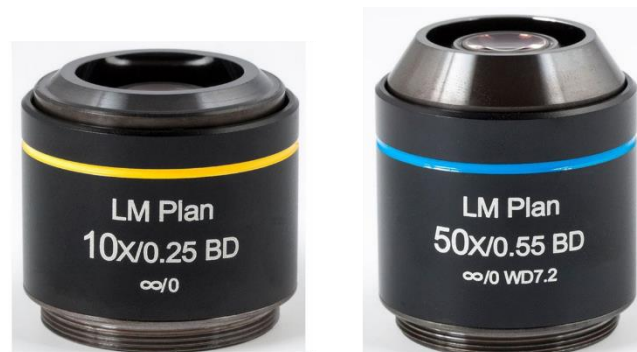
Figure 3.5: LM Plan Achromatic inverted microscope objectives: nosepieces

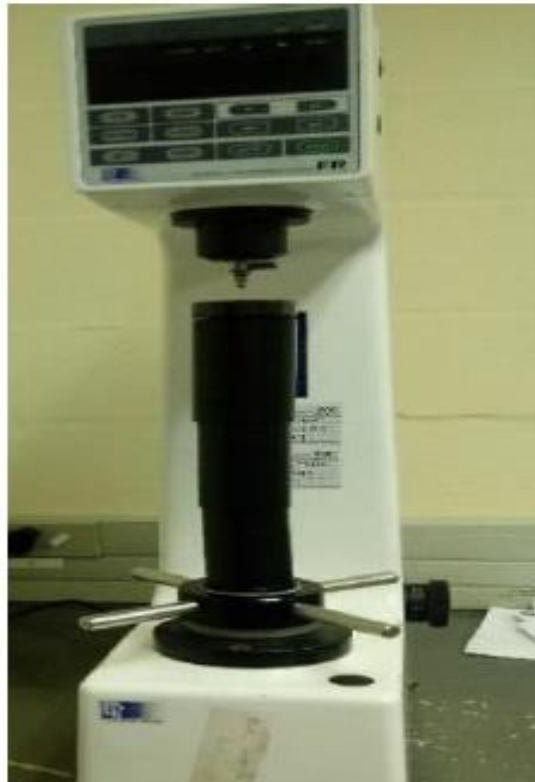
Figure 3.6: InnovaTest Falcon 505 Machine – microhardness tester

This is a hardness tester which indicates the hardness of a material by measuring the effect on a material surface of a localised penetration, using a diamond indenter with a pyramid shape on the tip. It operates with a load of up to 200 kilogram-force for a maximum of 15 seconds.

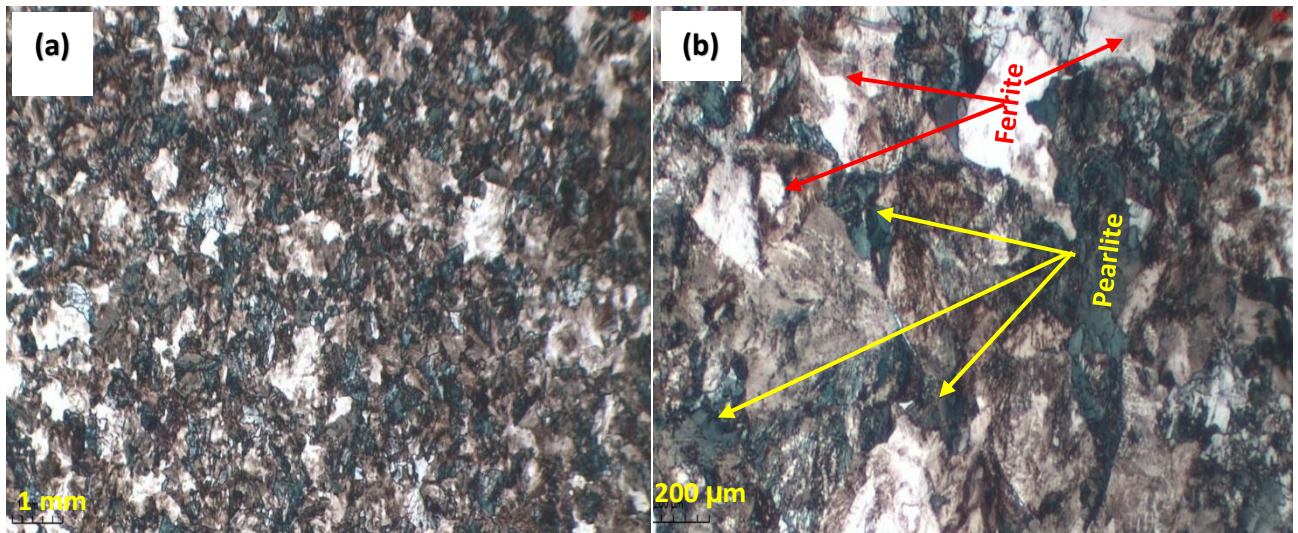
Figure 4.2 shows a slight change in the characterisation of elements. The imbalance of elements is identified in Figure 4.3 where the colour has slightly changed to brown, indicating the solubility of carbon in iron.

Figure 4.2: Optical Microscope Micrograph – Specimen 1 (a) at low resolution; (b) at high resolution

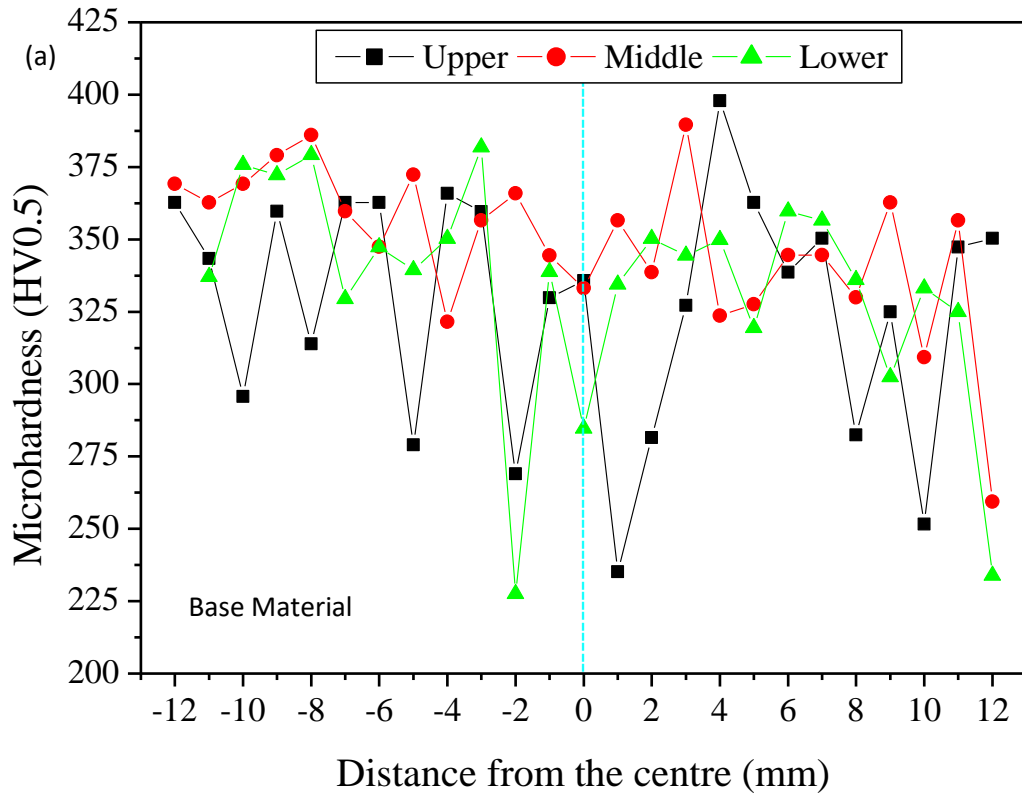
The graphs in Figure 4.9 and Table 4.5 illustrate the results of Vickers microhardness test performed on four samples; Table 4.5 presents the statistical analysis of the hardness values. The graph in Figure 4.9 (a), an observation of a base material sample, shows trends of lower hardness values with a maximum value of 389.53 HV0.5 (ref. Table 4.5). Figure 4.9 (d) shows the highest trend of hardness values, indicating an increase in hardness values. This is Specimen 3 which was placed under load for 10 minutes: its maximum value obtained is 443.34 HV0.5. The observed increase in hardness is caused by a repeated load applied for a longer period on the sample which resulted in the reduction of pearlite interlamellar spacing. It can be assumed that the rail line surface where the rail vehicle wheels contact the rail can develop plastic deformation due to drastic change in temperature caused by repetitive loading, weather conditions and frictional heat coming from the rolling contact load (Franklin *et al.*, 2008; Zhou *et al.*, 2020).

Figure 4.9: Microhardness profiles (a) base material; (b) Specimen 1; (c) Specimen 2; (d) Specimen 3

It is true that after many cycles of loading, the surface material hardens over time due to the high temperature on the contact surface and the development of a brittleness which renders the material more vulnerable to crack initiation and propagation. With the increase in rail hardness, the segment of broken cementite decreases, and the fraction of curled cementite increases. These results correspond to the microstructure results observed with the Optical Microscope which have shown plastic deformation on Specimen 3 due to carbon content reduction (Masoumi *et al.*, 2019).
