**AN APPROACH TO THE MANAGEMENT OF ROAD DETERIORATION ON
NATIONAL ROUTE 12 BETWEEN BEAUFORT WEST AND KLAASTROOM,
WESTERN CAPE, SOUTH AFRICA**

Dissertation submitted in fulfilment of the requirements for the degree

Master of Engineering in Engineering Management

at the Cape Peninsula University of Technology

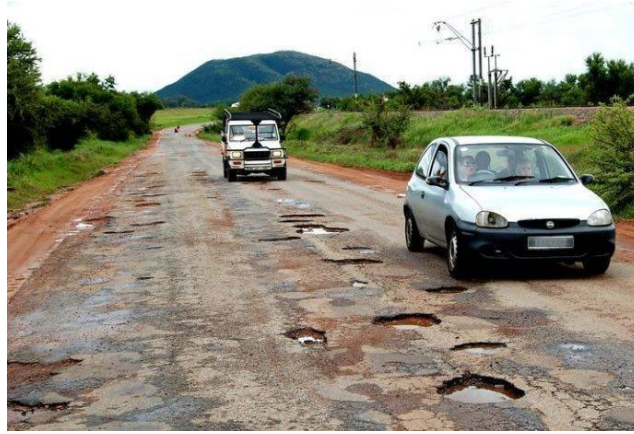
Figure 1: Examples of pavement deterioration (Arrive Alive, 2019).

The TR33/5 road shows pavement deterioration, which is the result of pavement cracking or deforming of pavement layers that is evident on the road surface, such as shown in Figure 1. The stresses imposed on the road surface by the external loads of the vehicle together with environmental conditions gradually increase the deterioration. Kaare et al. (2012) argue that this effect depends on the technology and materials of the road, but the greatest effects depend on traffic loads and volumes.

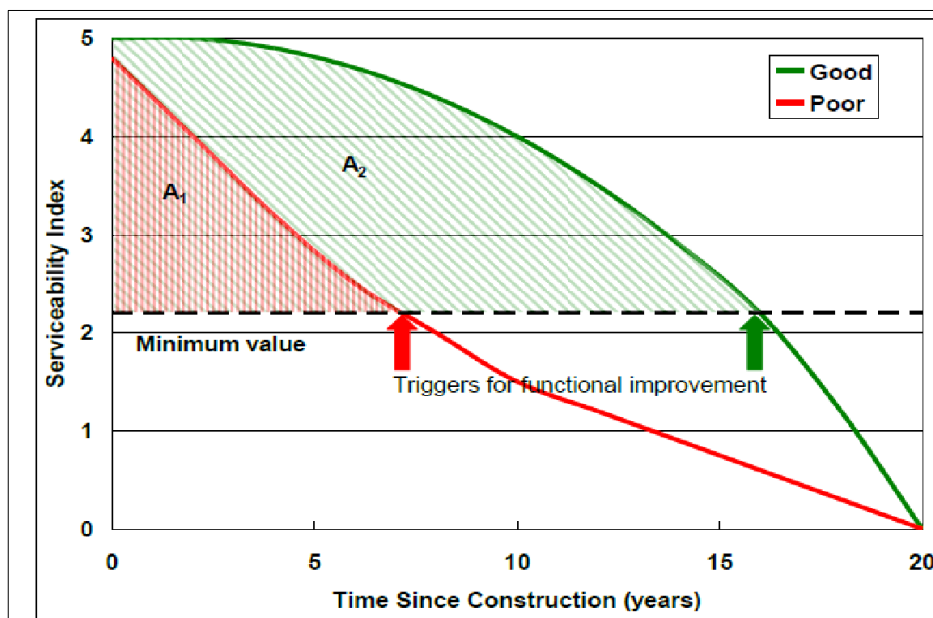
Figure 3: Functional performance of good and poor road pavement (SAPEM, 2014)

The purpose of design and construction of road pavement is to provide acceptable riding roads (SAPEM, 2014). The American Association of State Highway and Transportation Officials (AASHTO) (1993) *Guide for Design of Pavement Structures* provides a comprehensive set of procedures for new and rehabilitation design. AASHTO (1993) states that traffic data is a basis of road pavement design and performance analysis. Bhandari et al., (2022) argue that deterioration on the road pavement starts as soon as it is opened to traffic. SAPEM (2014) states that it is the responsibility of the appointed engineer to ensure that the road pavement does not only reach its design life but performs well during this time. Figure 3 illustrates the functional performance of a good and a poor road. The poor road reaches the serviceability index in less than 10 years since construction.

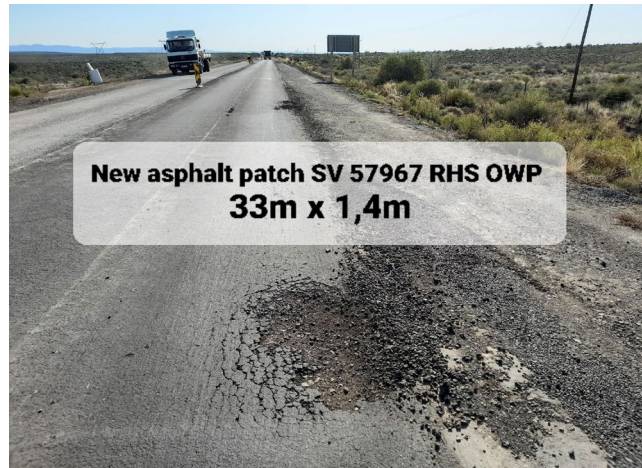
Figure 4: Base failures on the TR33/5 (Western Cape Government photos, 2021)

of water into pavement layers and inability of road pavement to withstand traffic loading. SAPEM (2014) agrees that isolated patches of base layer distress are mostly caused by a poor drainage system and ingress of moisture to pavement layers that result in disintegration of the base layer. Figure 4 and Figure 5 show two examples of surface and base layers distress patches extracted from the Conditional Survey Report:

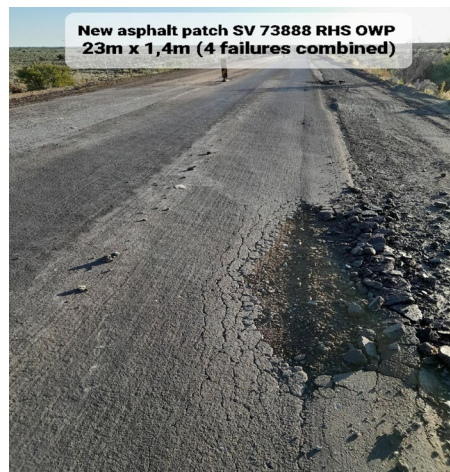
Figure 5: Base failures on the TR33/5 (Western Cape Government photos, 2021)

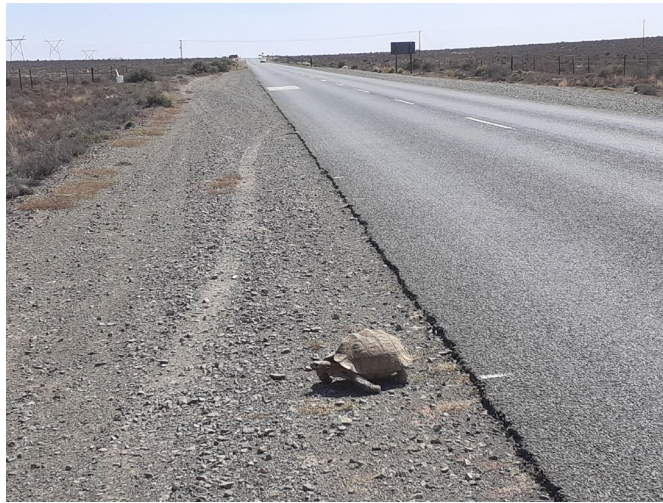
Figure 6: Shoulder drop more than 50mm (Western Cape Government photos, 2021)

Evaluation of the Conditional Survey Report revealed that about 80% of the TR33/5 road edge has a shoulder drop more than 50mm as indicated in Table 4. A shoulder drop is caused by the erosion of shoulder material (gravel) due to rain and traffic resulting in no support or weak of the surfaced road edge. This erosion is accelerated by traffic driving on and off the shoulder of the pavement, which ultimately undermines the surface edge of the pavement (SAPEM,

2014). Figure 6 is a photograph extracted from the Conditional Survey Report that shows 50mm gravel shoulder drop:

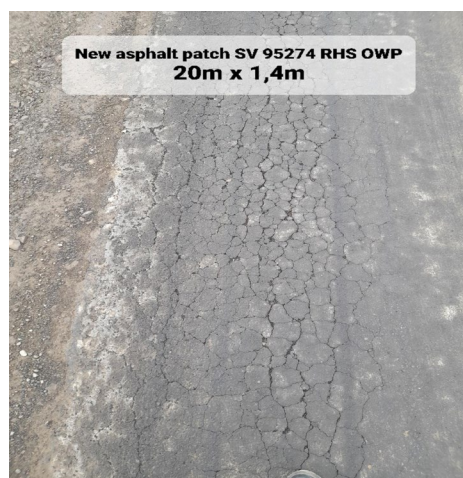
Figure 7: TR33/5 crocodile cracks failure without disintegration (Western Cape Government photos, 2021)

The Conditional Survey Report noted that potholes account for 16% of the surface and edge distresses on the TR33/5 (see Table 4). According to SAPEM (2014), potholes commence on the surface through ravelling of the asphalt or the seal surface layer. Figure 7 and Figure 8 present two photograph extracted from a Conditional Survey Report that show two typical surface distresses on the TR33/5.

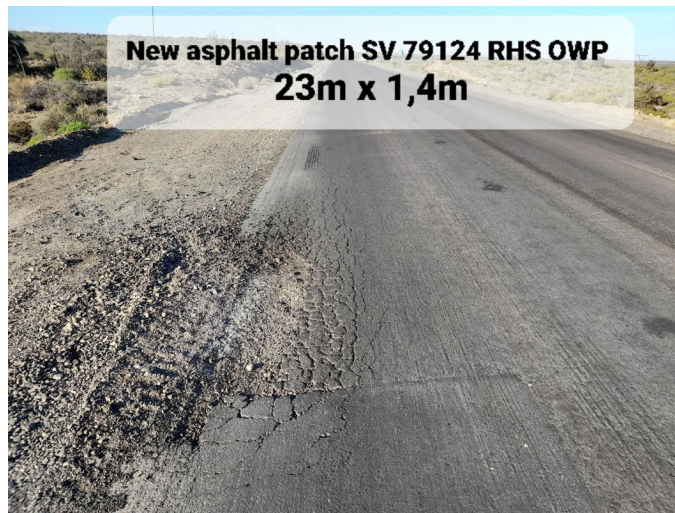
Figure 8: TR33/5 crocodile cracks with disintegration (Western Cape Government photos, 2021)

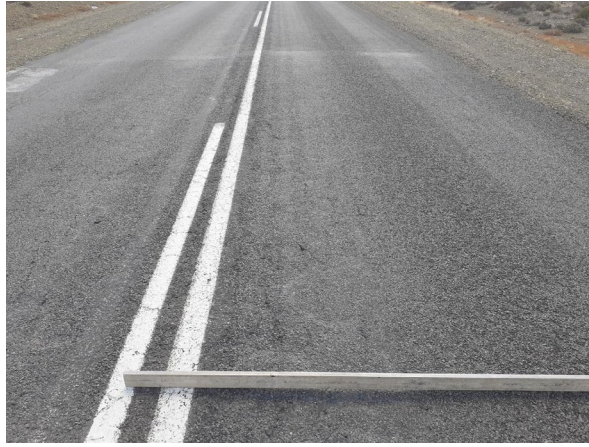
Figure 9: Road rut distress on the TR33/5 road (Western Cape Government photos, 2021)

Evaluation on the Conditional Survey Report shows that road rut distress accounts for 12% of road pavement distresses shown in Table 4. According to Padro (2014), rutting occurs along the wheel path as the road changes profile under loading, resulting in deformation. Rutting is mainly caused by both compaction and shear deformation under traffic wheel paths. Rutting in a bituminous surface can be accompanied by small crocodile cracking (SAPEM, 2014). Rutting is measured with a 2 metre straight edge on the wheel path to check maximum deviation of the road profile. Figure 9 and Figure 10 present two photographs extracted from a Conditional Survey Report showing two typical road pavement on the TR33/5.

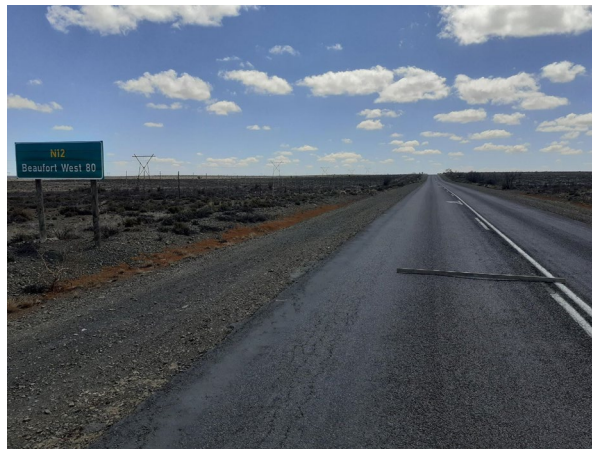
Figure 10: Road rut distress on the TR33/5 road (Western Cape Government photos, 2021)

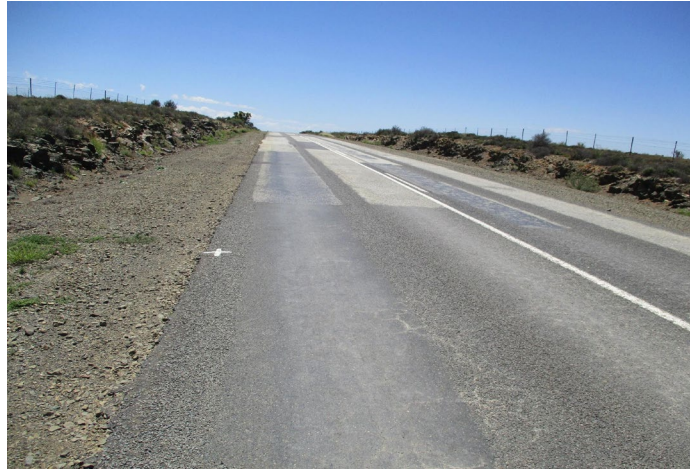
Figure 11: Aggregate loss on the TR33/5 (Western Cape Government photos, 2021)

accounts for 65% of existing road damage as evaluated in the Conditional Survey Report shown in Table 4. The aggregate loss can result in exposing the underlying layer, which might result in cracks and later develop into potholes (Padro, 2018). Figure 11 and Figure 12 show two photographs extracted from a Conditional Survey showing typical aggregate loss and bleeding on the TR33/5:

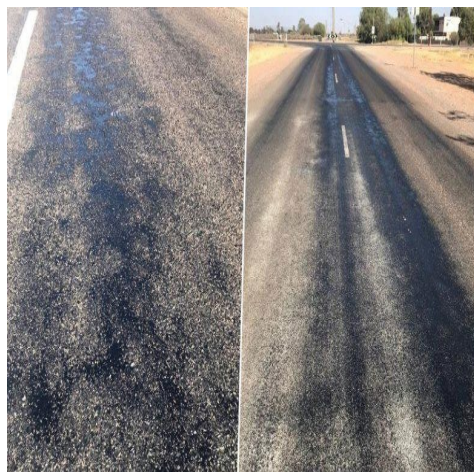
Figure 12: Aggregate loss resulting to bleeding TR33/5 (Western Cape Government photos, 2021)

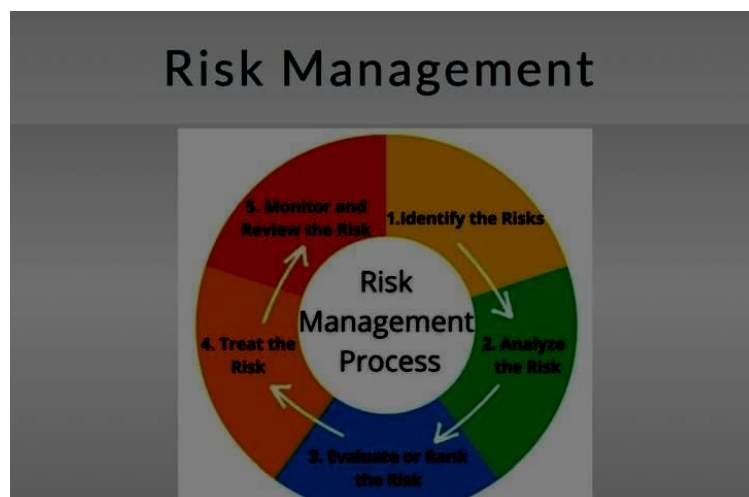
Figure 13: Risk management process (Schwartz, 2025)

As mentioned earlier in this section, a risk management process approach developed on the basis of a merger of the work of Schwartz (2025) and Boothe (2023) is most suitable. That is, an approach, aligned with the ISO 31000 (2018) standard was followed in the study. A graphic depiction of the risk management process that was applied in this research can be seen in

Expanding on research done by Schwartz (2025), she provides definitions for each stage of the proposed risk management process as seen in Figure 13. There are five steps in the risk management process in total. They are:

Consistent with the five steps in the risk management process advanced by Schwartz (2025), as seen in Figure 13, this study now sets out to determine research activities for each step. The research activities for each step, which ultimately constitute the design of this study, are discussed in the section below. Concurrently, literature exploring various quality management tools that could potentially be used in each of the steps is also explored in the section that follows, in order to ultimately develop the most suitable risk management approach to address the research problem.

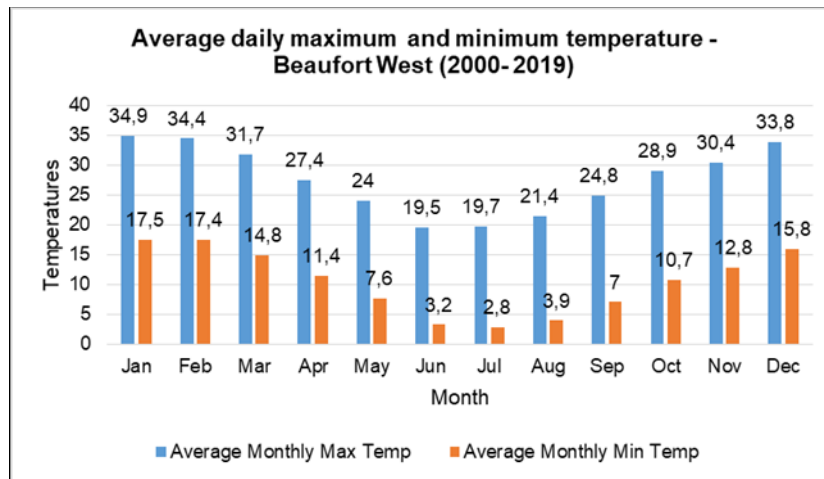
Figure 18: Average daily maximum and minimum temperature (RNIS, 2023)

Figure 18 illustrates the summary data of average monthly maximum air temperature and average monthly minimum air temperature that was further analysed using engineering management tools to find road cause for pavement distresses.

The climate data presented in Figure 18 below was obtained from Beaufort West weather station.

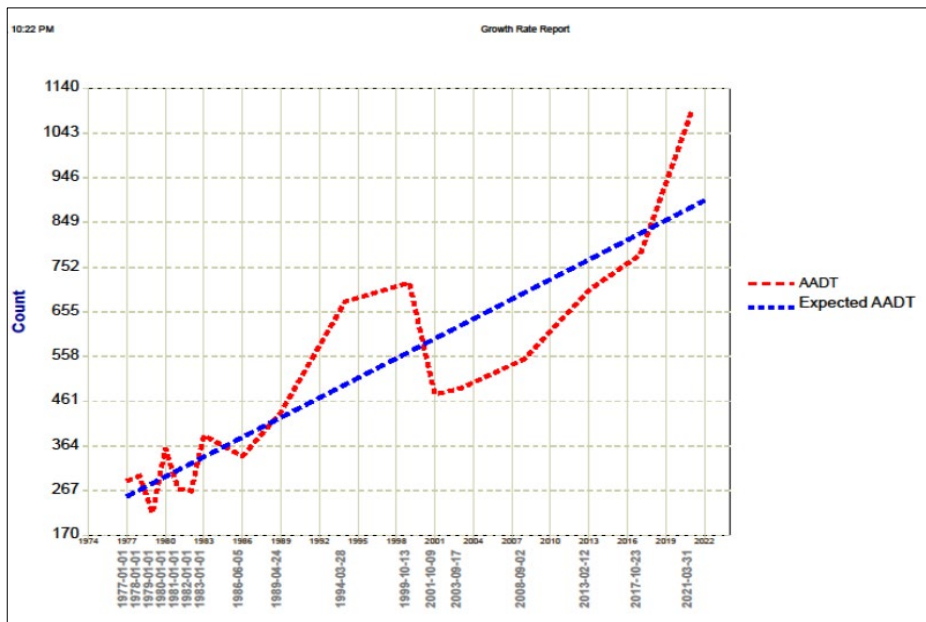
Figure 19: AADT expected versus the actual AADT traffic (RNIS, 2023)

Traffic data was obtained from the Western Cape Government RNIS website (2023), with the latest counts conducted in 1974/2022. The Figure 19 overleaf presents the average annual daily traffic (AADT) expected versus the actual AADT traffic. The data was therefore analysed using the gap analysis engineering management tool to draw road bearing capacity design realisation.

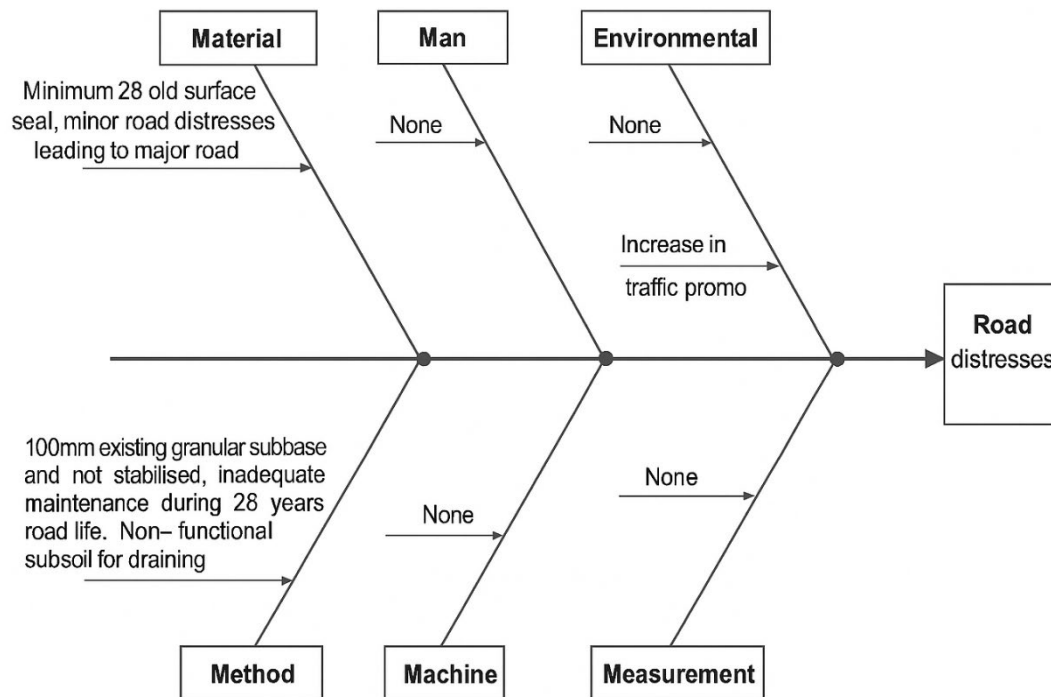
Figure 22: Fishbone diagrammed for TR33/5 road pavement distress (Researcher, 2025)

Under the categories Material and Method, a 28 year old road surface with inadequate maintenance during the road life was highlighted, which concerns the major attributes of road pavement distresses. All the findings are further investigated in the 5 Whys section below, which is the next qualitative data analysis.

In Table 8, it was noted by the project team that distress started from a minor crack or deformation and thereby was promoted by the ingress of water. This led to summarising the most common and impaction distress as illustrated in Figure 22 below.
