# Port Engineers Department Port of Cape Town

## AN INVESTIGATION WITH RECOMMENDATIONS OF THE PRESENT CONDITIONS SURROUNDING THE CAISSON EXTENSION TO THE MAIN BREAKWATER AT THE PORT OF CAPE TOWN.

JUNE 1997

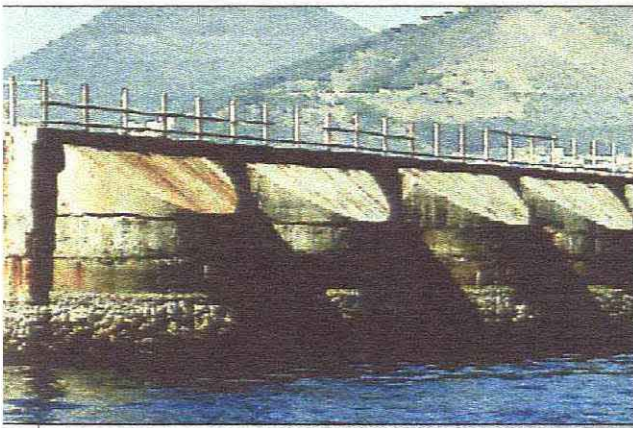
Alkali aggregate reaction is present in the concrete capping. This has caused cracks in the capping with the subsequent deterioration thereof.

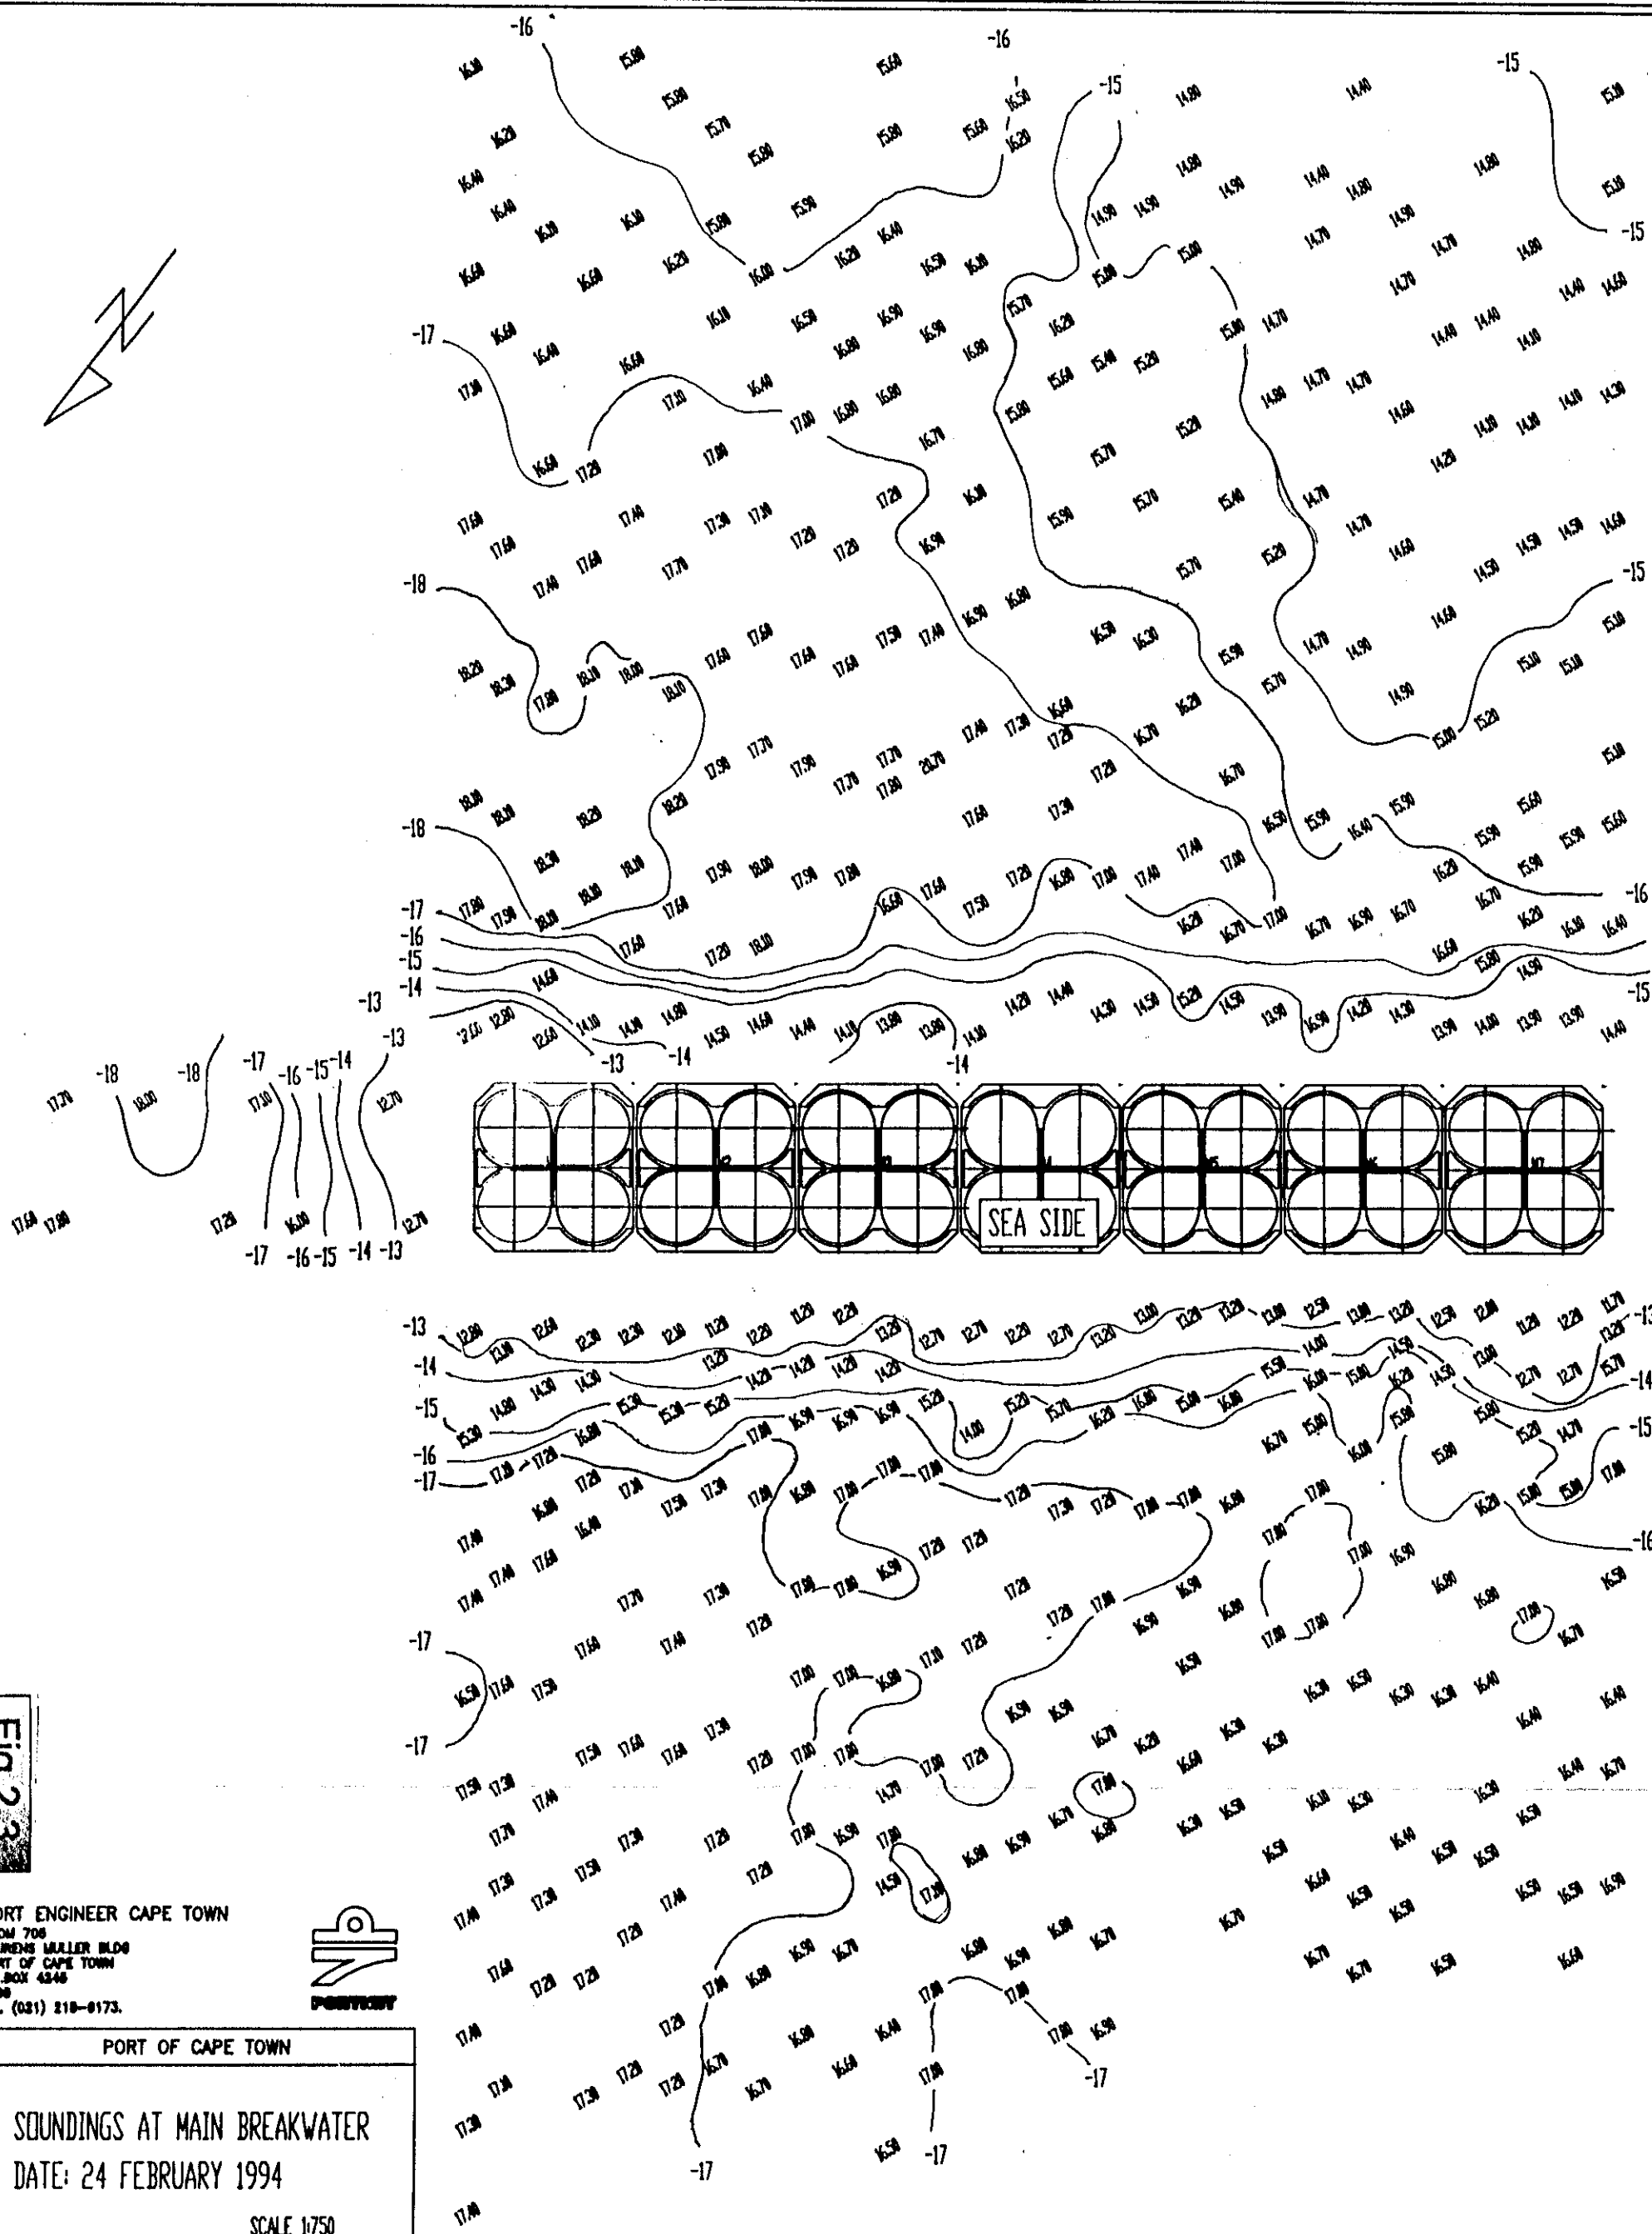
**Fig 2.3**

Soundings around the caisson structure were carried out on 24 February 1994. (see fig 2.3)

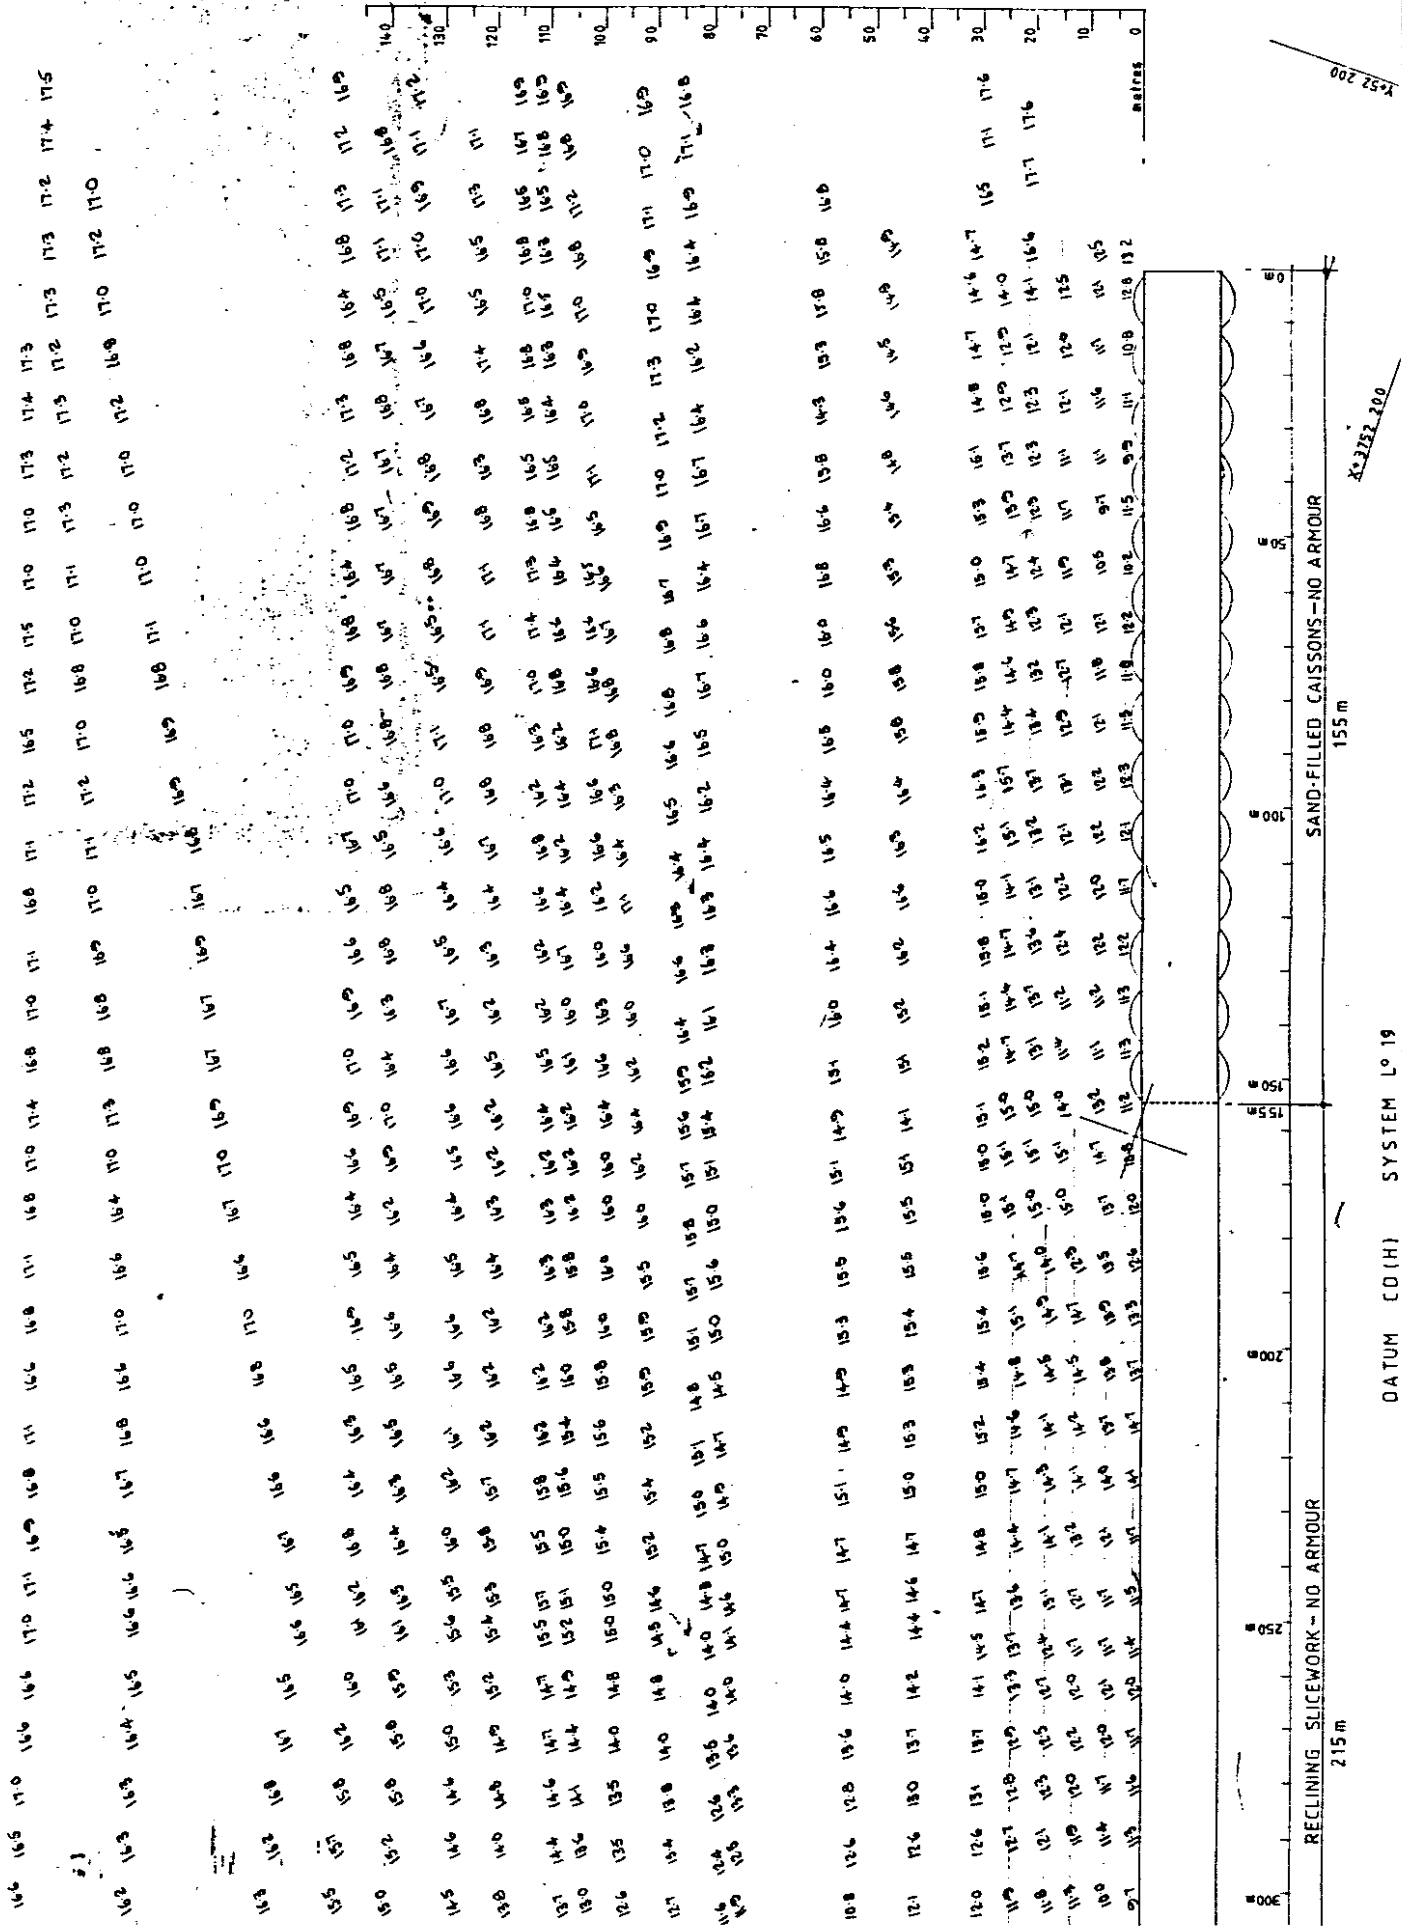
# Fig 2.4

The soundings profiles achieved on 27 February 1987 indicates a large depletion of sand on the outside of the breakwater compared with the soundings taken on February 1994. (see fig 2.4)

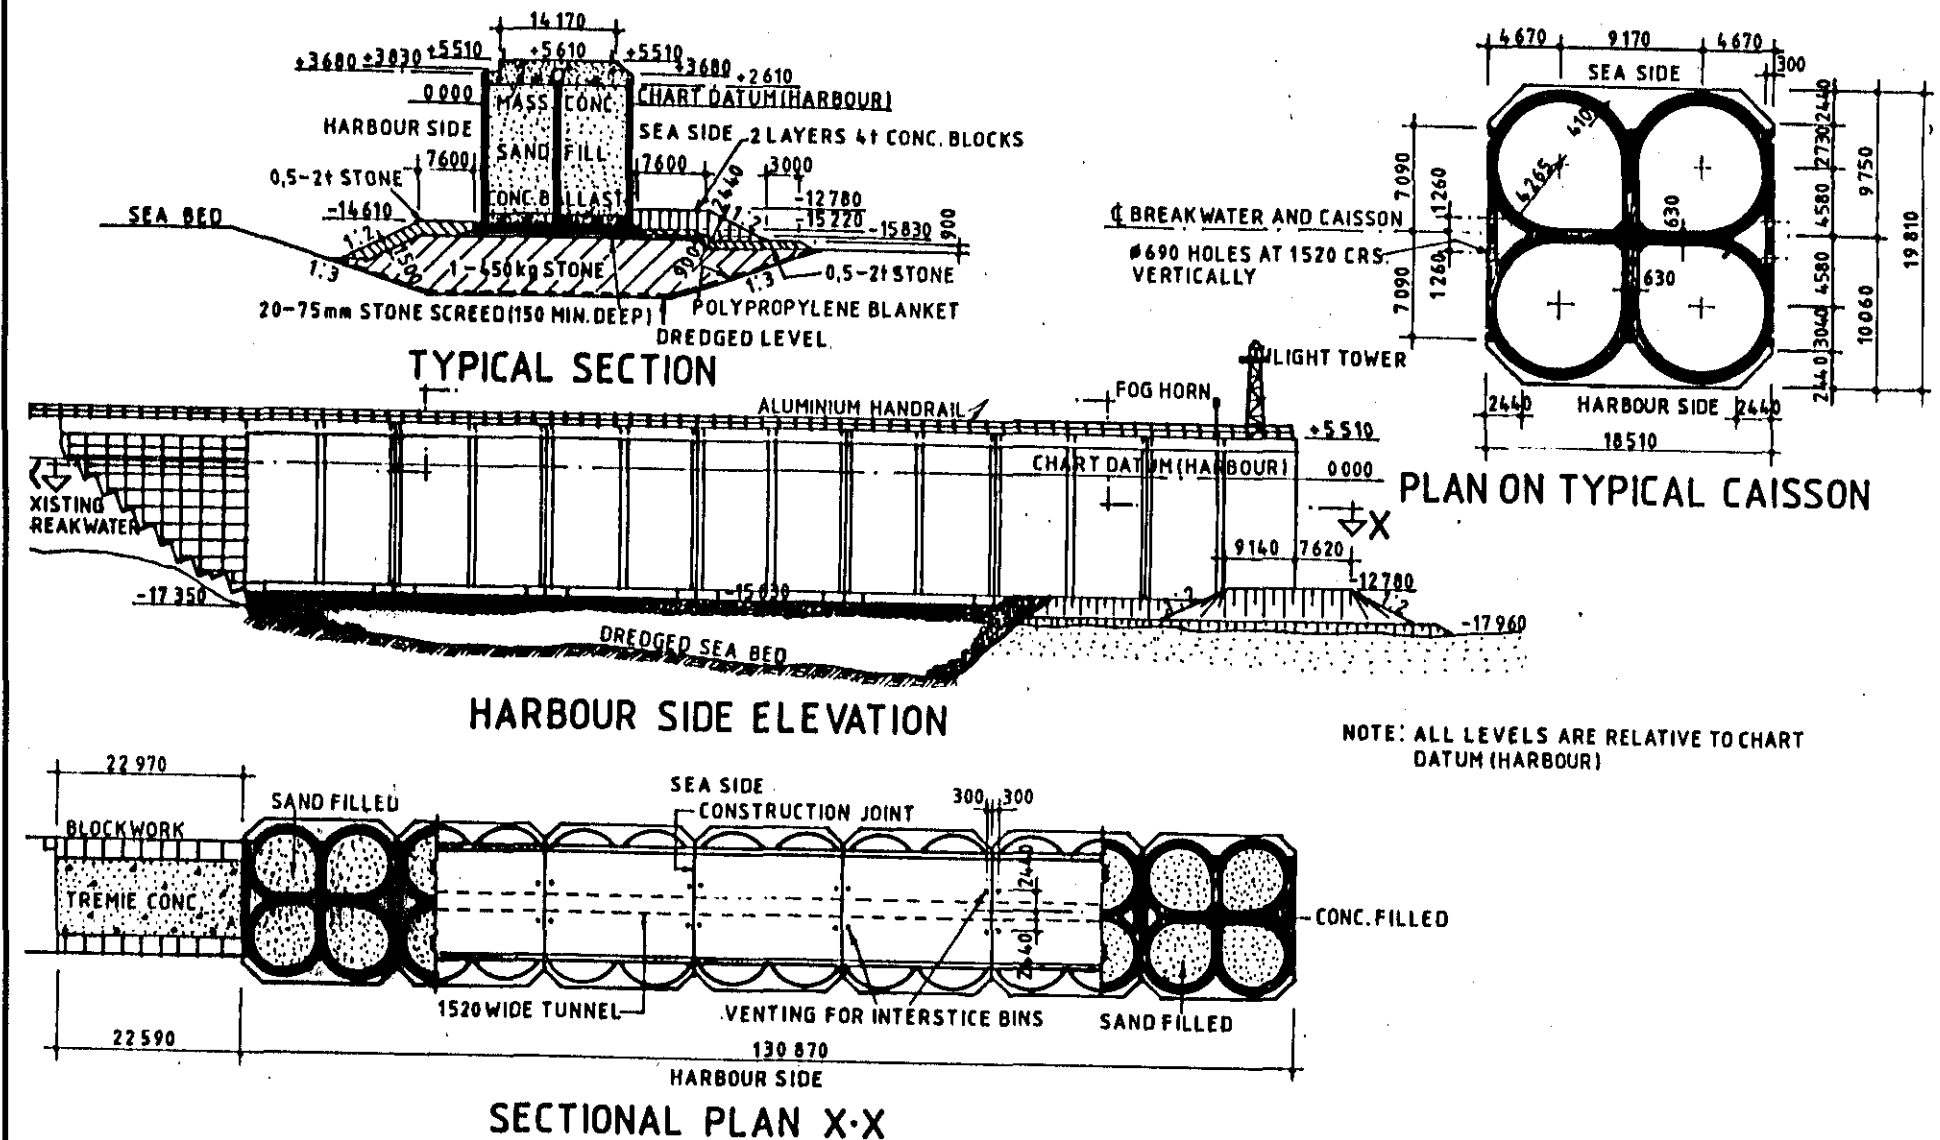
Fig 2.8

The most likely cause of caisson settlement is settlement of stone bed layers or sub soil layers. (see fig 2.8)

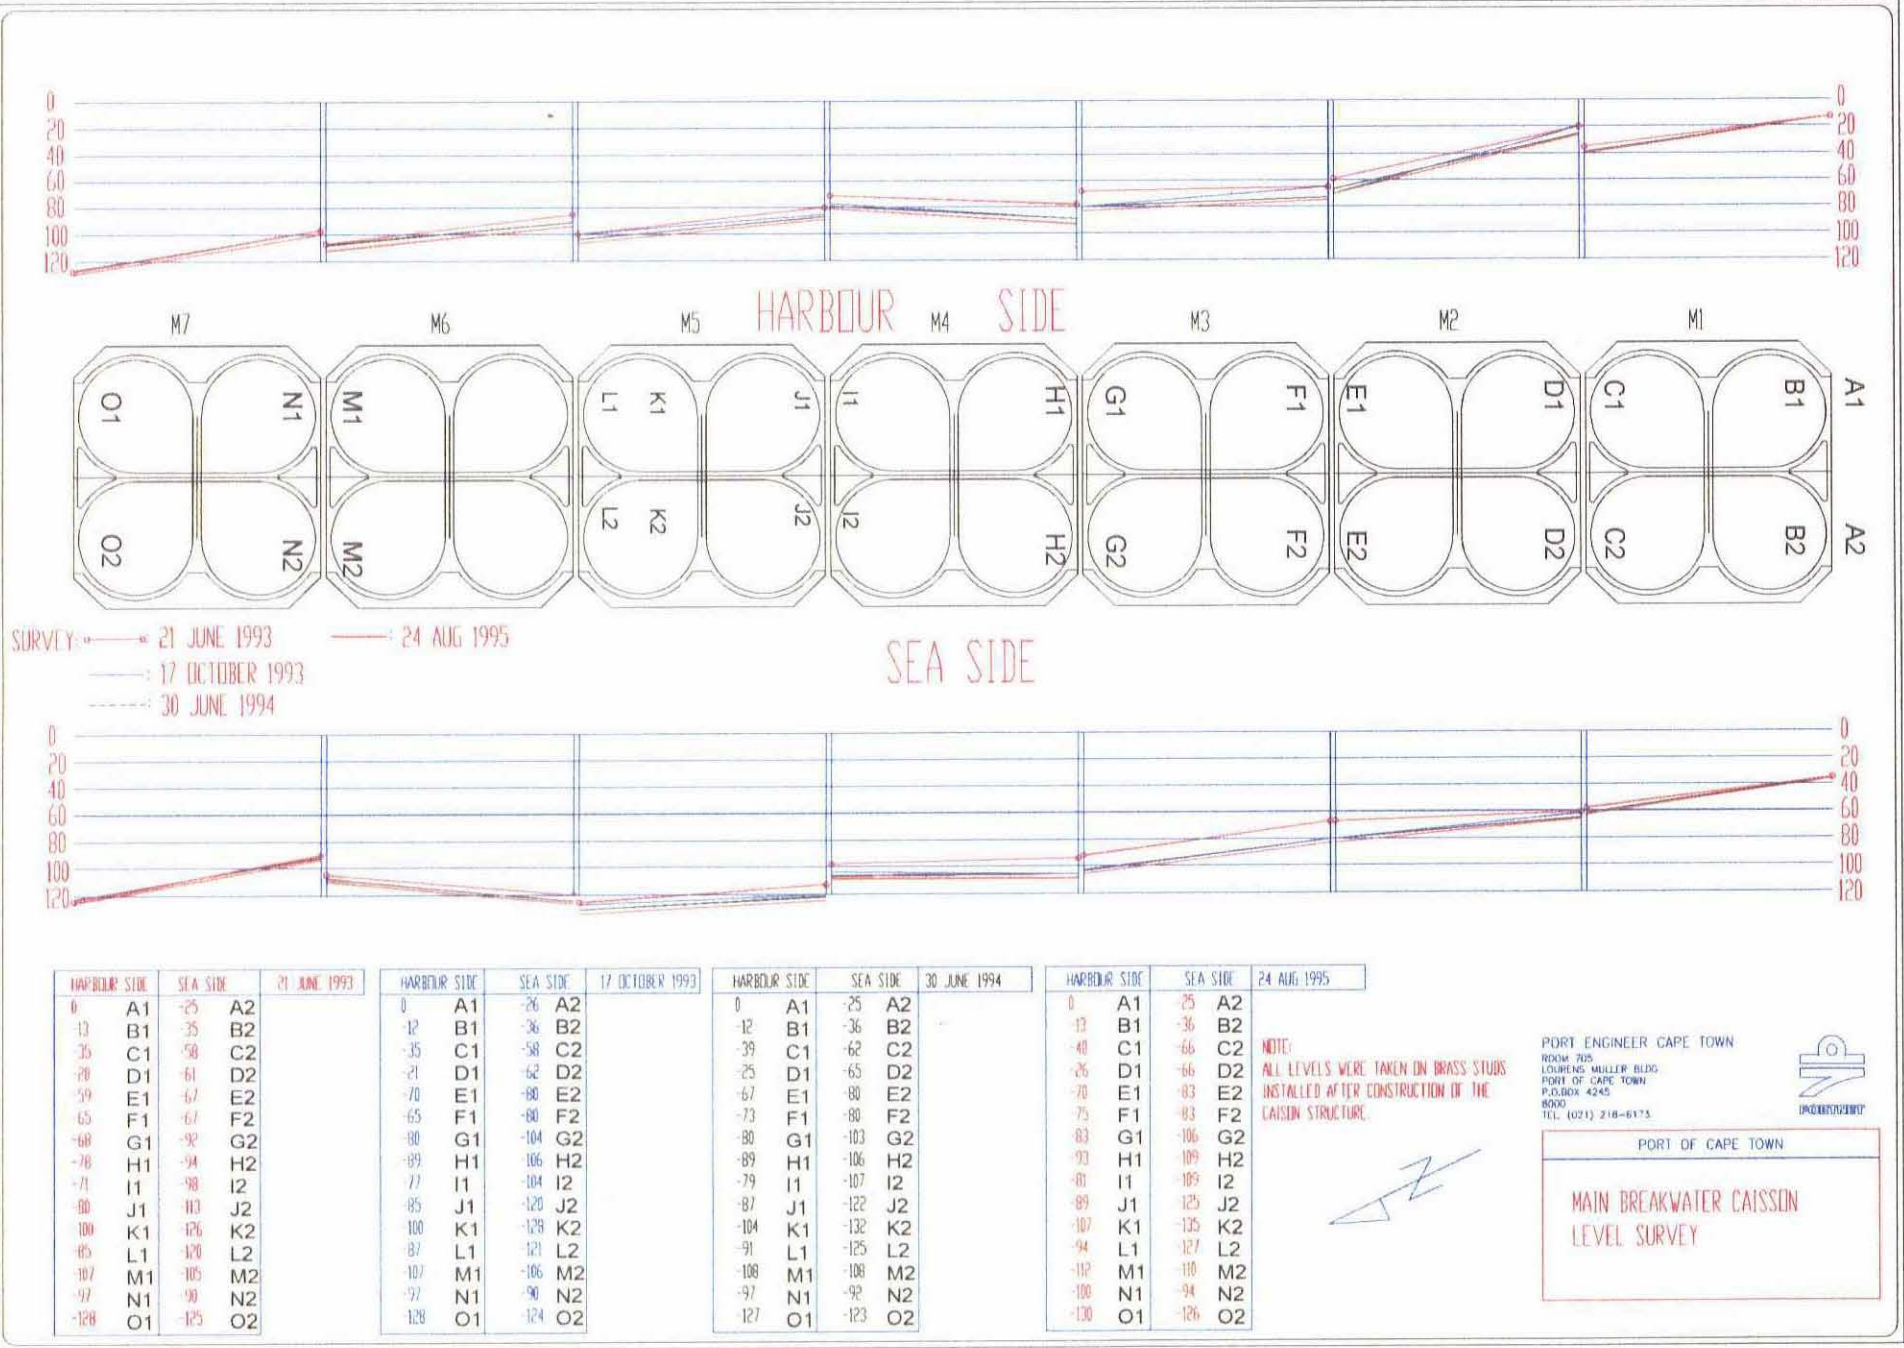
Fig 2.10

- (a) 21 June 1993
- (b) 17 October 1993
- (c) 30 June 1994
- (d) 24 August 1995 (See fig 2.10 for a graphic display of the settlement)

All measurements in the table were taken on the East side (Harbour side) of the structure. A1 was the bench mark and therefore has a zero value. The rest is a settlement in relation to the bench mark A1. (See fig 2.10)

All measurements in the following table were taken on the West side (Sea side) of the structure on the brass studs. (See fig 2.10)

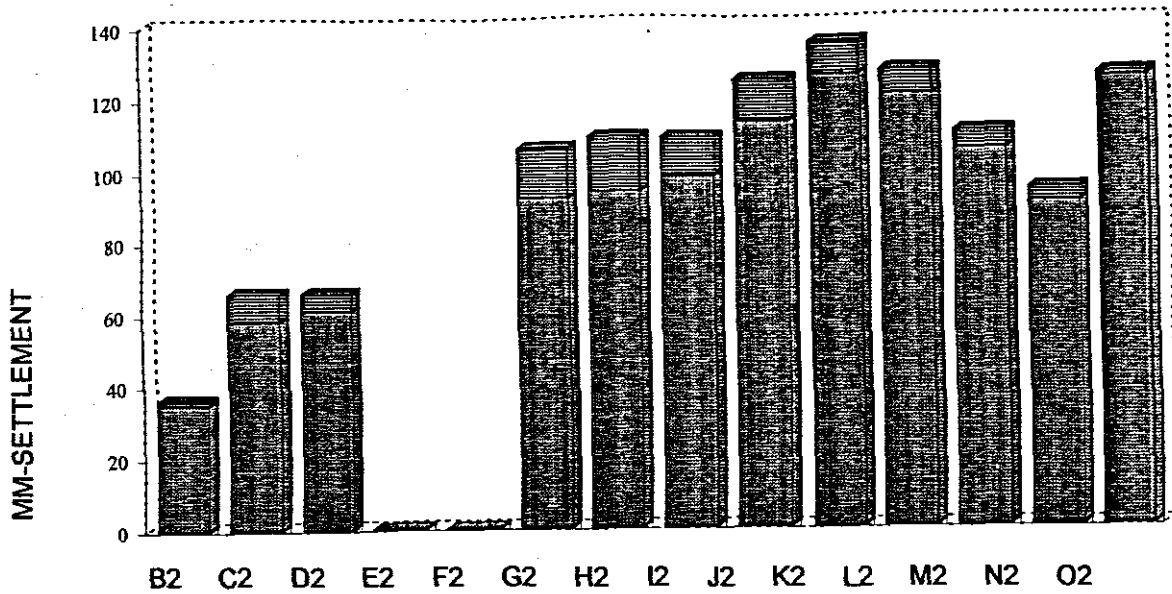
CAISSON BRASS STUD LEVELS-(sea side)  
JUNE 1993 TO AUGUST 1995

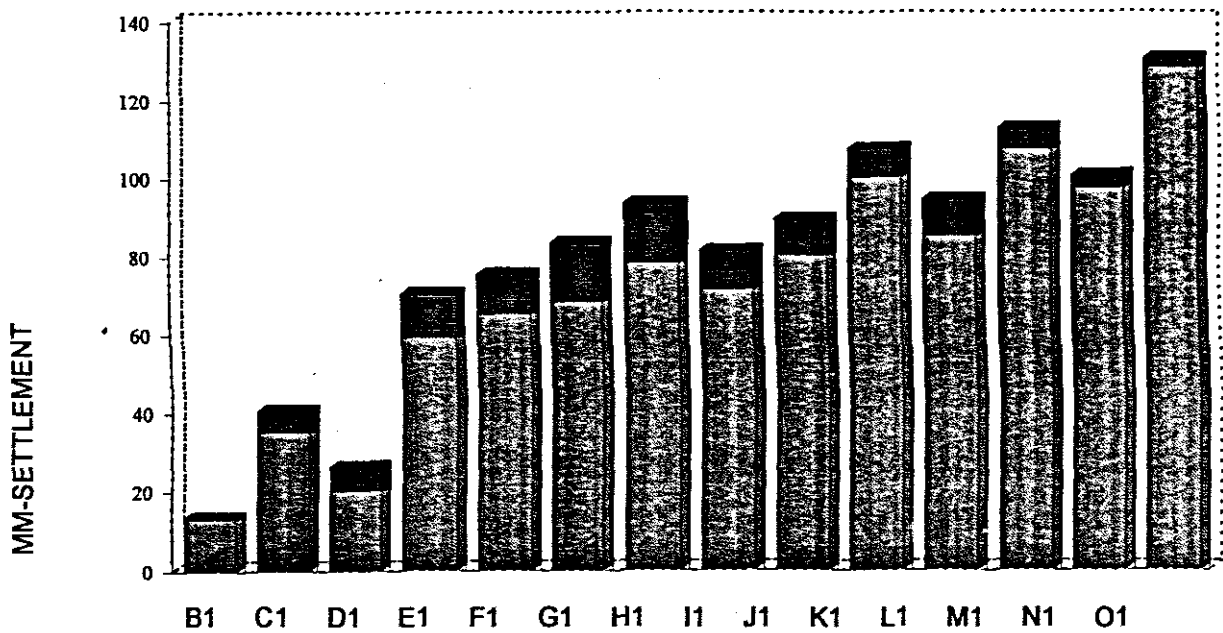
CAISSON BRASS STUD LEVELS-(harbour side)  
JUNE 1993 TO AUGUST 1995

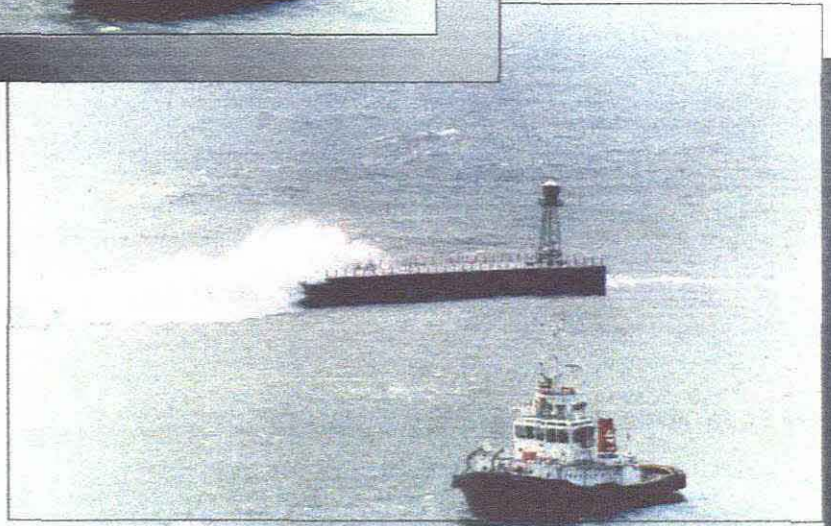
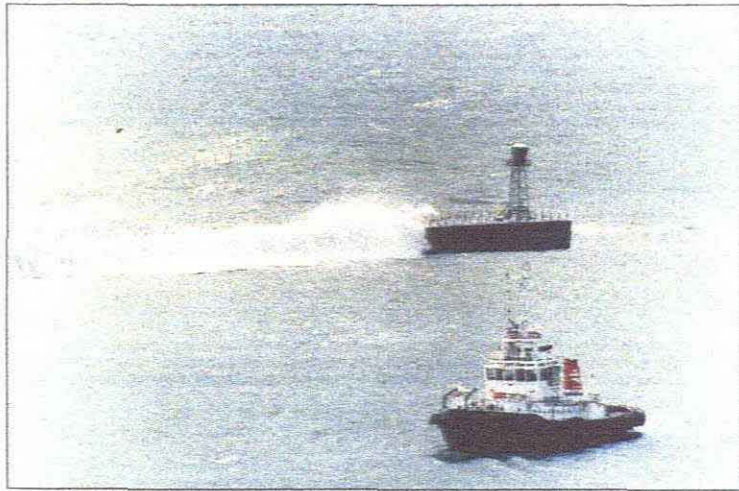
The wave overtopping continues  
to caisson M7. (20 June 1994)

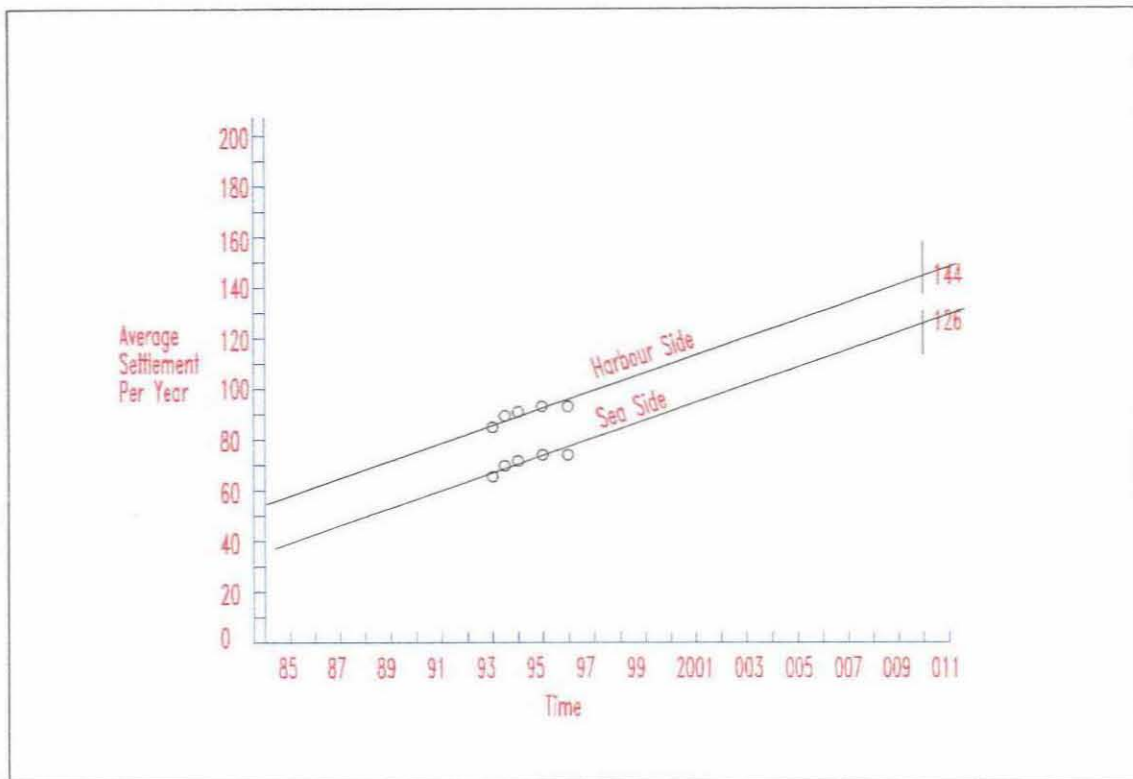
Possible predicted accumulated level settlement on the caisson corners, over the design lifetime of the structure.

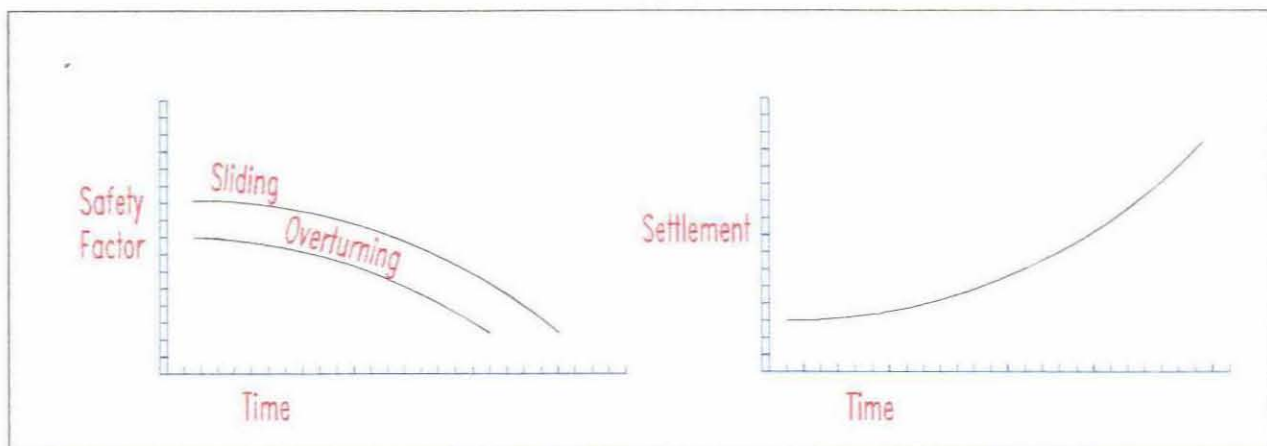
Possible predicted safety factor reductions trends, due to caisson structure deterioration.

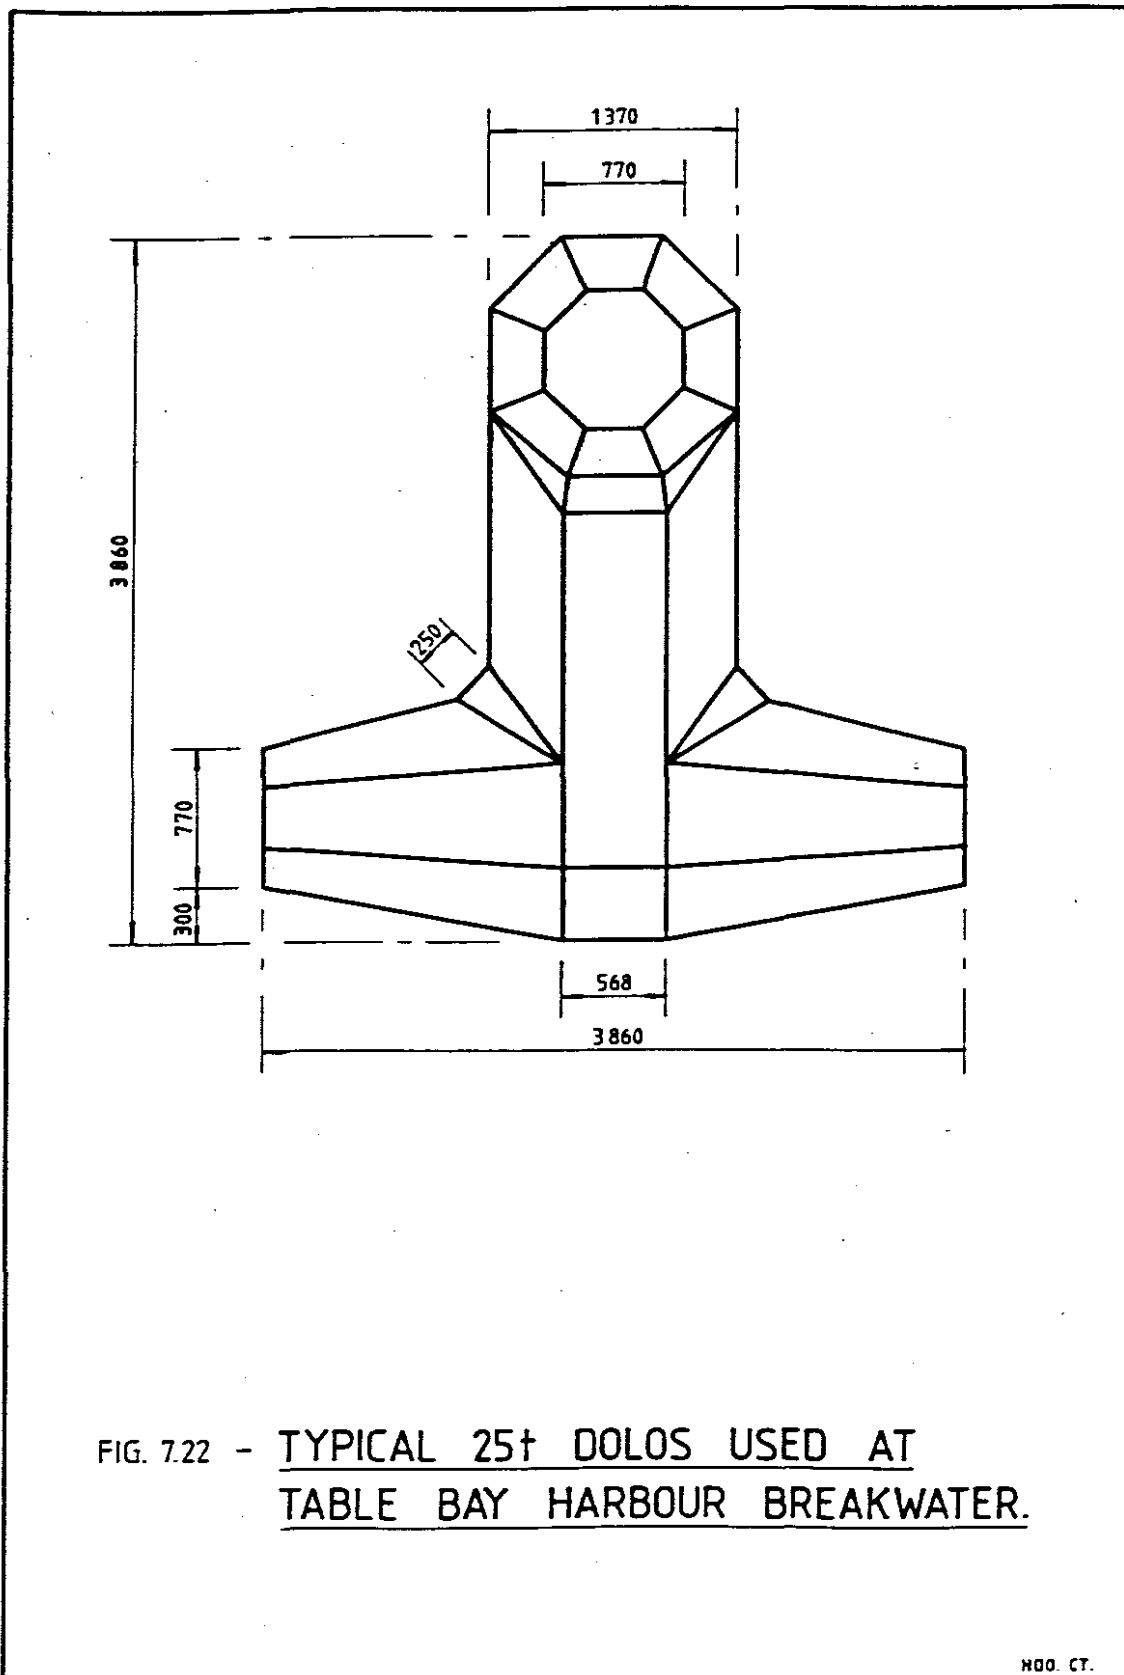
Fig 3.6

During 1984 and 1985 severe winter storms battered the Cape causing damage to the dolos protection of the breakwater. (See 25 ton Dolos, fig 3.6)

25 ton Dolos

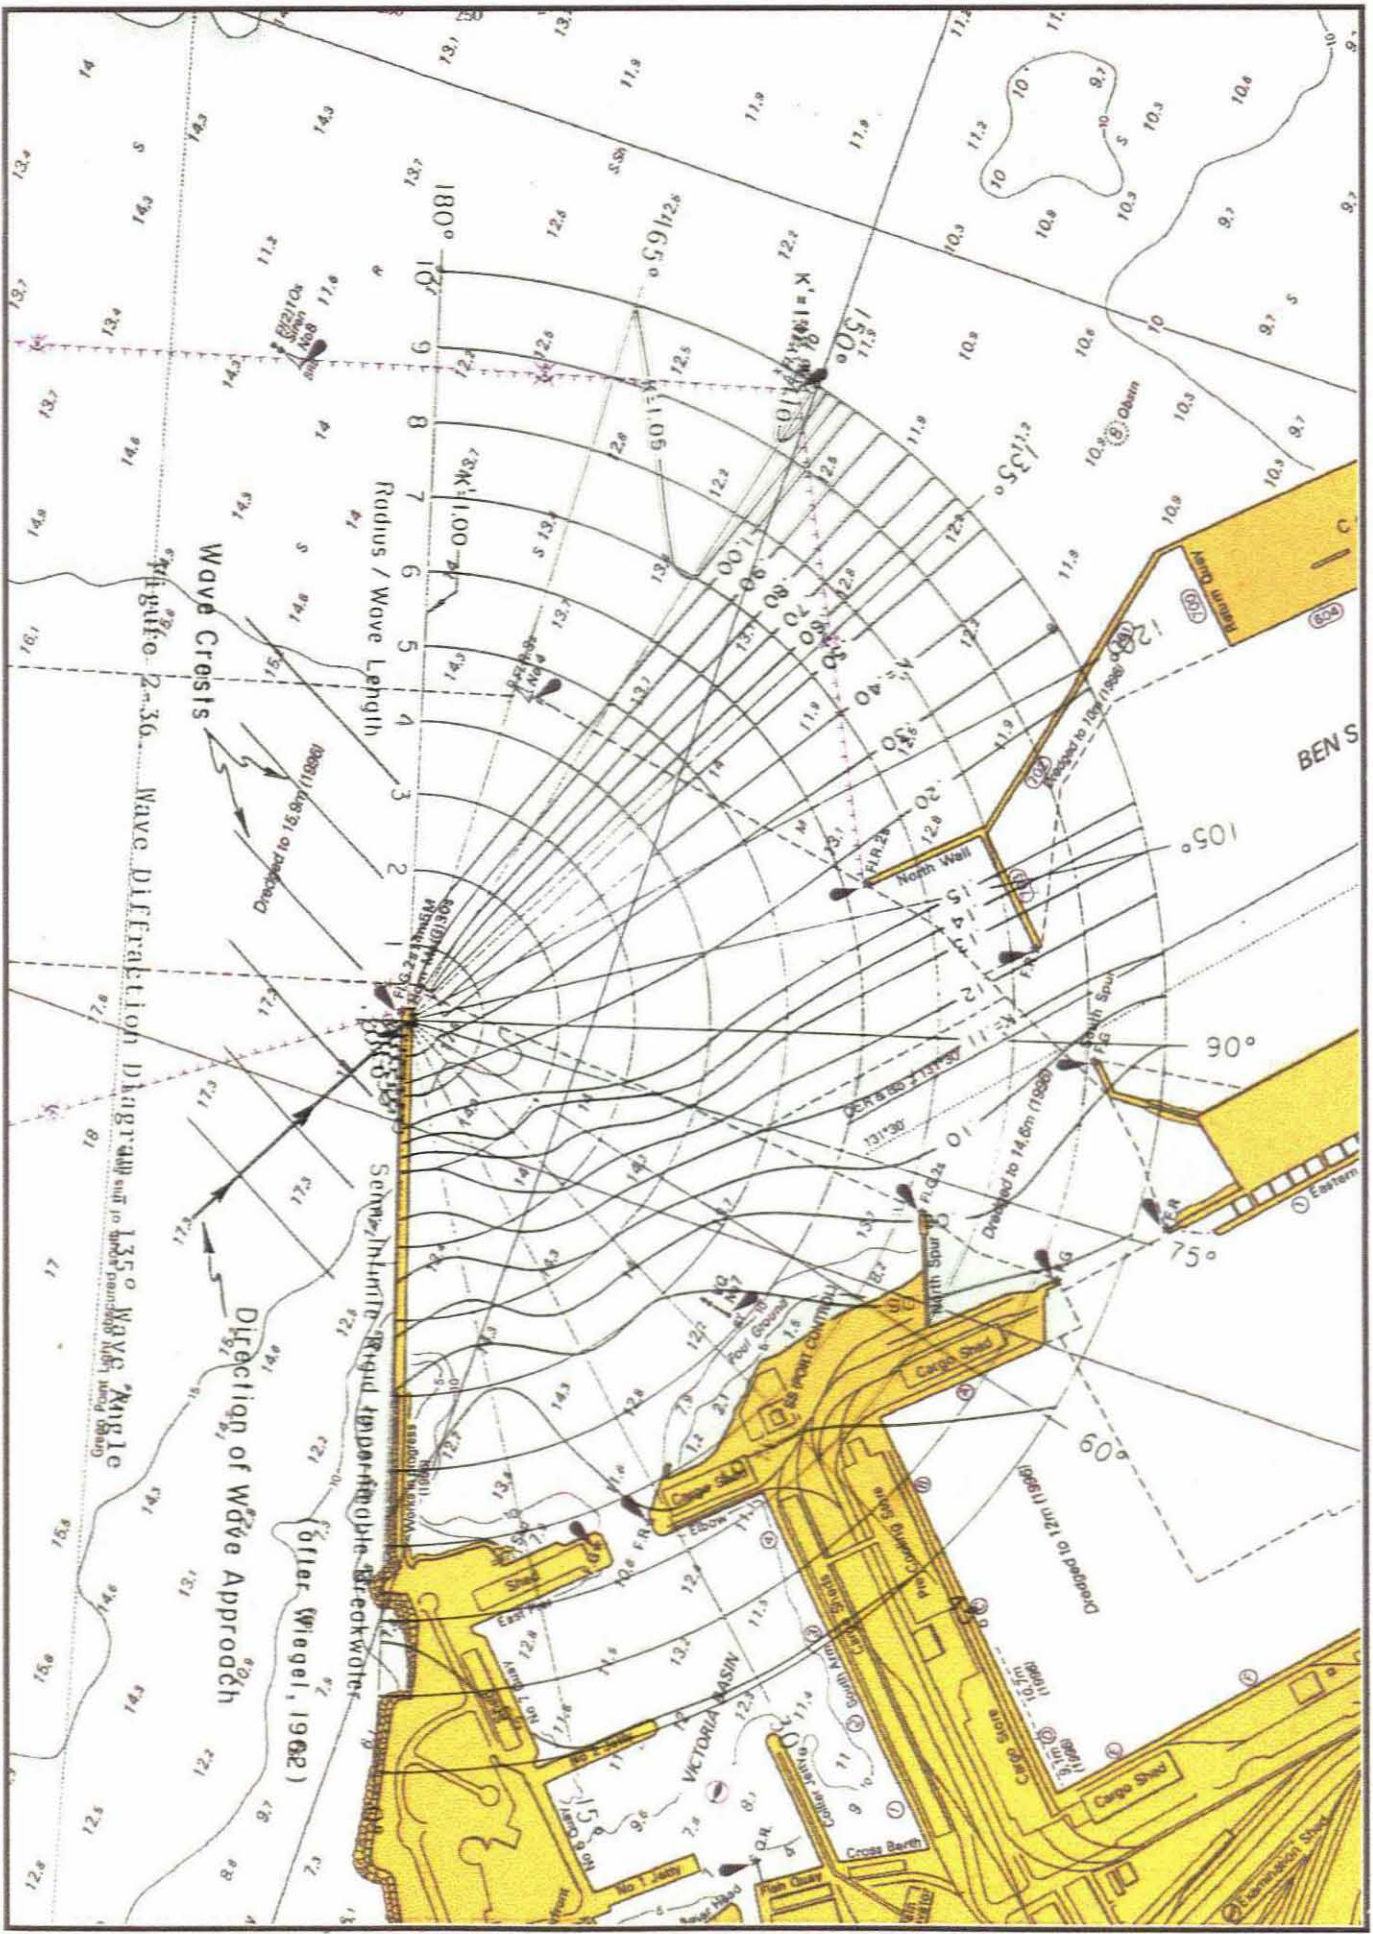
Fig 4.5

(See fig 4.5)

The 135 degree diffraction diagram can be seen at fig 4.5. Each arch from figures 1 to 10 represent a wave length. The distance from the breakwater to the BSD entrance is 1000 metres. The wave length of a 16 second period wave is 186 metres. (See previous table). That represents 5.4 wavelengths on the diffraction diagram. Using the direction and the scale of the harbour plan, can we determine the k' factor.

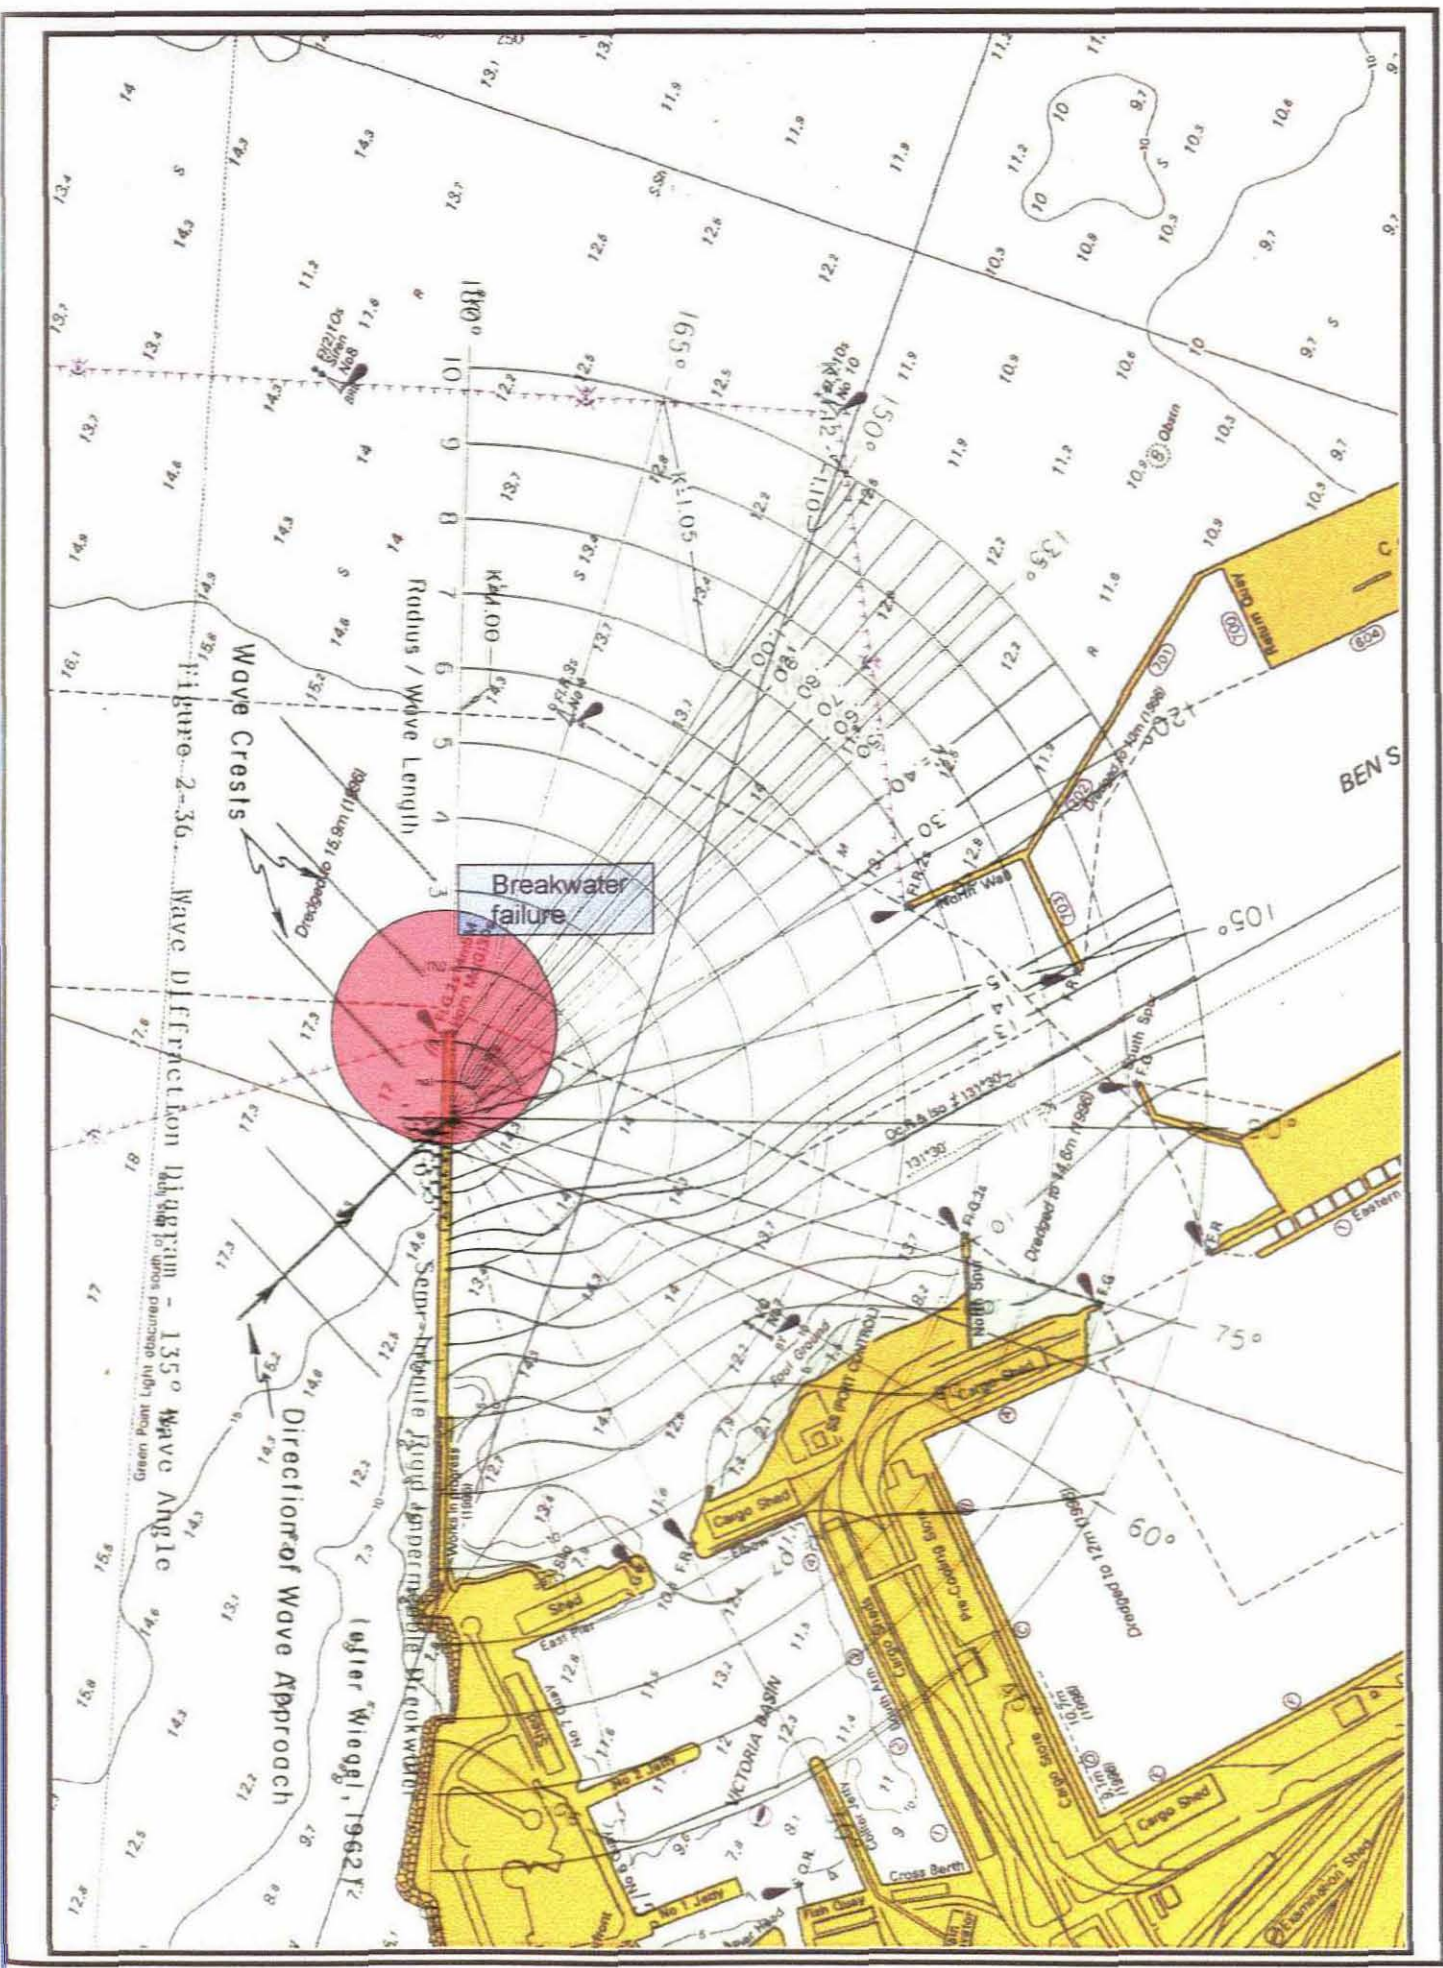
Fig 4.6

If complete failure of the caisson extension should take place the wave heights will be as follows (See fig 4.6):

The increase in wave height due to caisson failure is very small.
